# Plattsburgh Illicit Discharge Detection and Elimination Project

**Prepared by:** Stone Environmental, Inc.  
David Braun

# Plattsburgh Illicit Discharge Detection and Elimination Project Final Report

Project Period: May 4, 2022 - August 22, 2024  
Date Submitted: August 22, 2024  
Date Approved: September 3, 2024

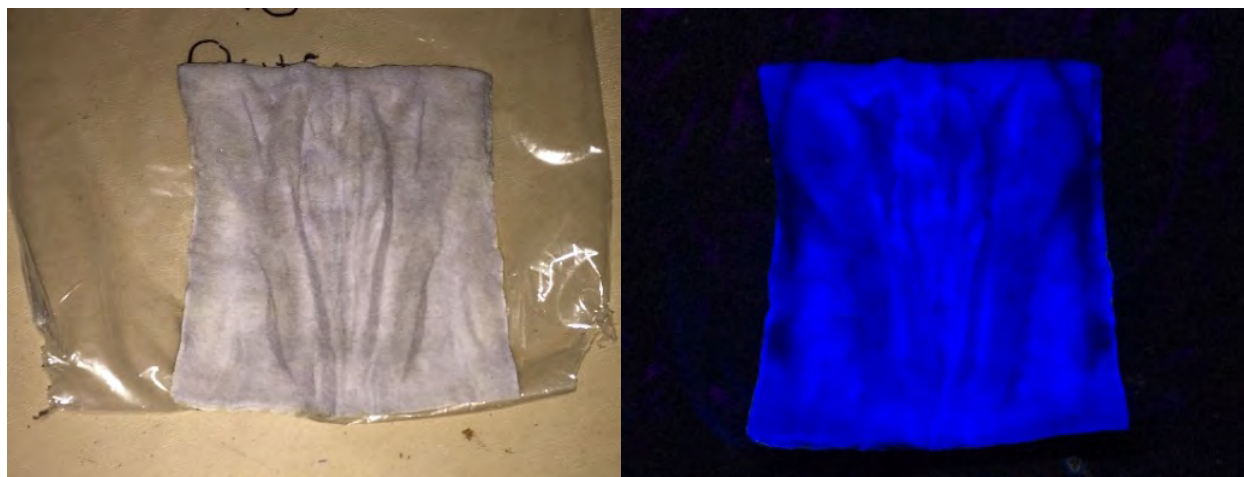
Figure 1. Positive OB monitoring pad under fluorescent (left) and UV (right) lamps.

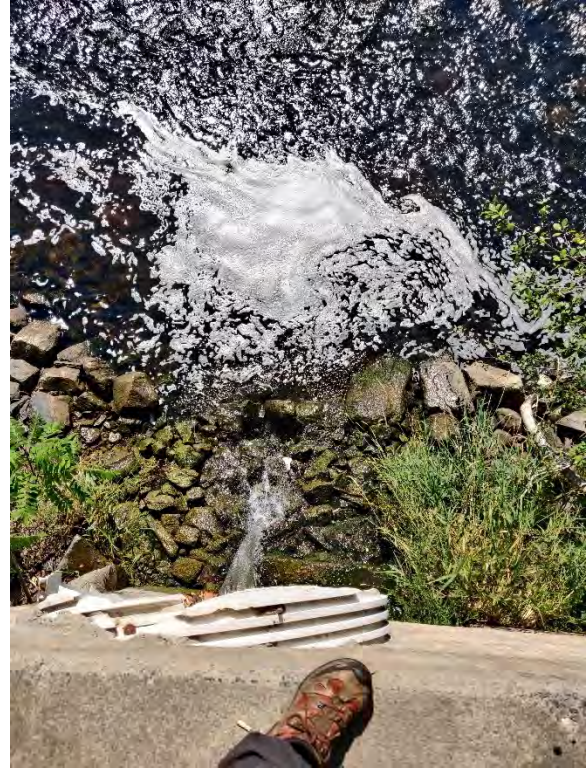
Figure 3. Suds at the outfall of PB03 in July 2020

- The following observations were made on July 29, 2020, when PB03 was first assessed:
  - Suds were observed in the Saranac River below the outfall (Figure 3), which are not necessarily attributable to PB03.
  - Low concentrations of free chlorine were measured at the outfall and at manhole MH03. No ammonia was detected.
  - OB was detected at the outfall and at MH03, although fluorescence of the pad at MH03 was weak. OB was not detected in the upstream branches of the system.

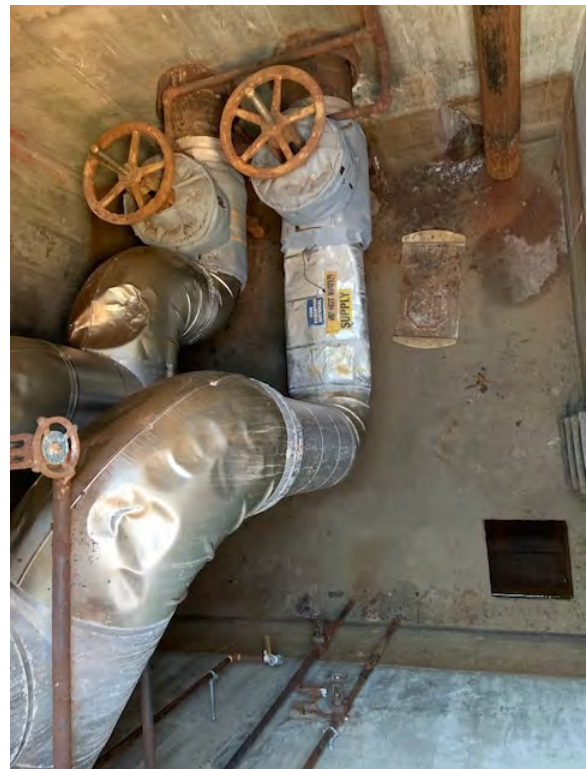
Figure 4. HVAC vault adjacent to PB03 stormdrain

- There is a large vault (Figure 4) located between MH03 and MH04, next to the sidewalk, which appears to contain HVAC (heating, ventilation, and air conditioning) system piping, presumably connected with SUNY Plattsburgh buildings. We suspect the inflow between MH04 and MH03 may be condensation from this HVAC system. The pool-like odor may be from the same source.

**Conclusion:** There are three findings in this system that warrant explanation. The source(s) of the inflow and the odor between MH04 and MH03 should be ascertained. It is possible both the flow and odor result from discharge of condensation from a SUNY Plattsburgh HVAC system. The source of the OB detected at MH03 should also be determined. It is likely the OB is from a leak or connection upstream of catchbasin CB5. PPCP testing is planned for this system in September 2024.

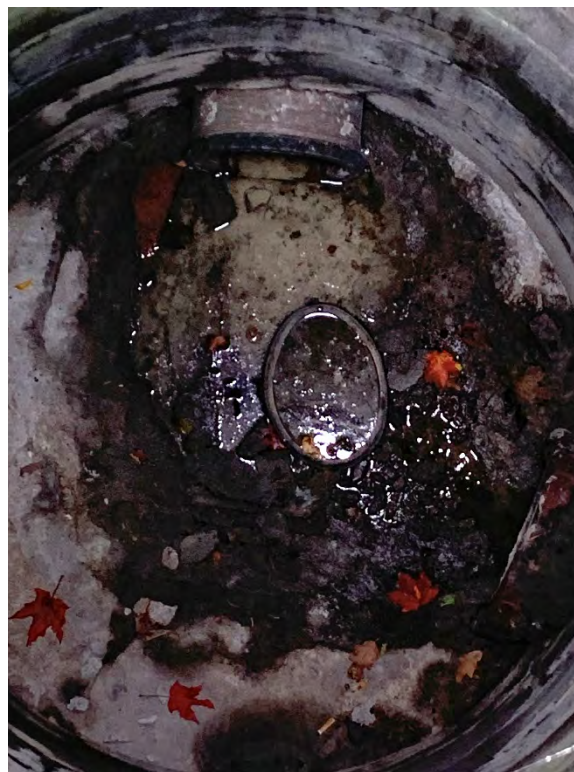
Figure 5. Catchbasin CB01 in the PB04 stormdrain

- MBAS and high specific conductivity (3,490  $\mu\text{S}/\text{cm}$ ) were measured when the PB04 outfall was first visited on August 13, 2020.
- The outfall was not flowing on July 27, 2021.
- On September 1, 2022, samples collected at the outfall had relatively low concentrations of *E. coli* (200 MPN/100 mL) and TP (0.2 mg/L; Table 27), and elevated ammonia and specific conductivity.
- On October 12, 2022, the outfall and catchbasin CB01 (Figure 5) were both flowing, while CB02 was dry. Low concentrations of ammonia were detected at CB01 and the outfall.
- On November 17, 2023, the outfall was trickling. The specific conductivity was comparable to prior data; MBAS was rather low, and ammonia was not detected.

**Conclusion:** We do not believe there is a chronic wastewater discharge in this stormdrain. Consistently high specific conductivity likely interfered with the MBAS test, even considering the correction. There was no odor at any structure, and no OB was detected at the outfall. This is a small stormdrain and catchbasin CB01 is a deep structure. We suspect that groundwater containing chloride and possibly ammonia infiltrates the stormdrain at catchbasin CB01. Out of an abundance of caution, PPCP testing is planned for this system in September 2024.

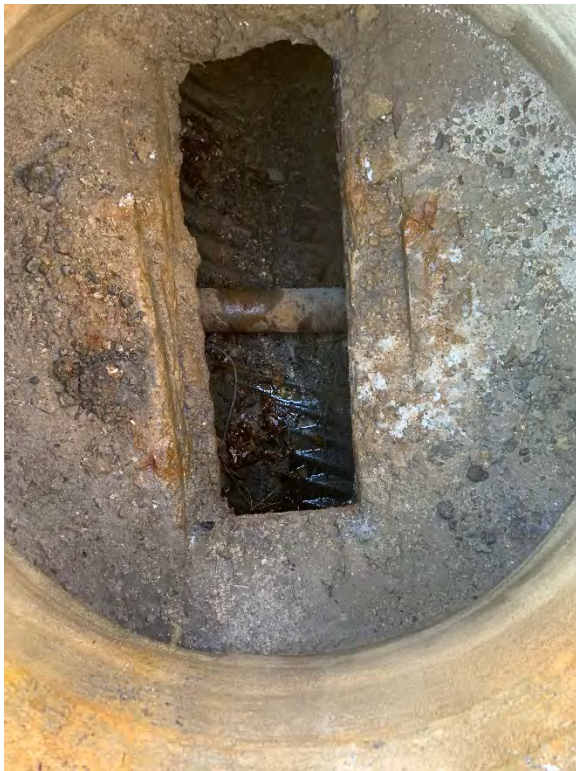
Figure 6. Sanitary sewer lateral crossing Elizabeth Street stormdrain

- At least three sanitary sewer laterals cross through the Elizabeth Street stormdrain (Figure 6). A sewer lateral was also seen in manhole JohnsonMH01 (Figure 7). These laterals were visible within stormwater manholes. Similar laterals may cross the stormdrain between manholes.

- We observed racoon prints and/or scat in several structures in the PB07 system. Scat is visible in Figure 6 on the concrete bench above the manhole channel.

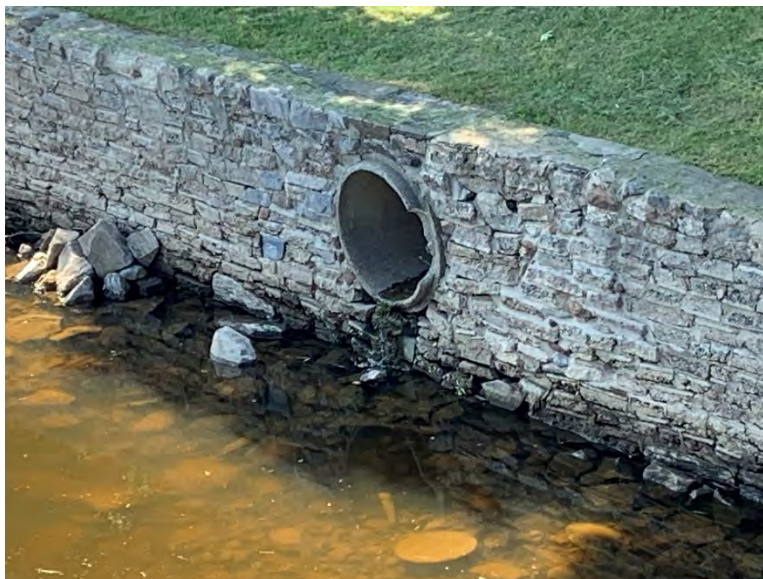
Figure 8. PB11 outfall

- When the PB11 outfall was first visited on July 29, 2020, a wastewater odor was noted, the specific conductivity was quite high (5,000 μS/cm), and OB was detected.

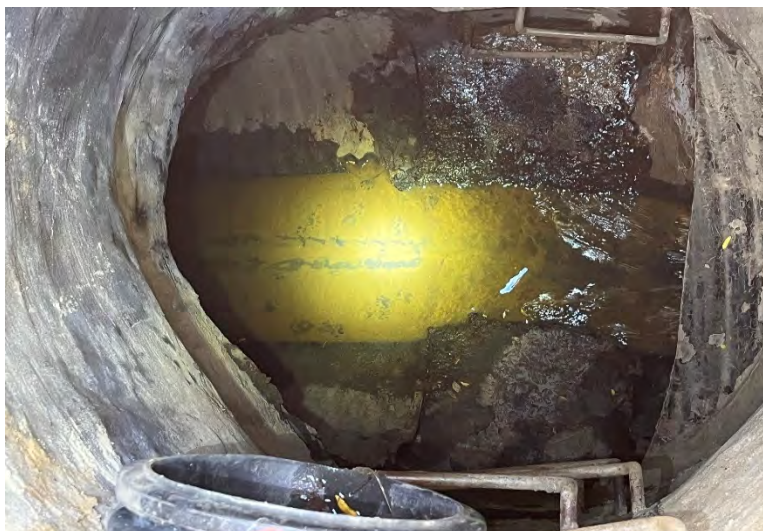
Figure 9. Tracks in manhole MH02.

- Raccoon tracks were observed in manhole MH02 on October 19, 2022 (Figure 9).

**Conclusion:** We do not believe there is a chronic, illicit discharge to this stormdrain. OB and ammonia were not detected. Extensive sampling for *E. coli* did not yield a consistent pattern, which suggests that fecal contamination was intermittent, therefore likely resulting from pet or wildlife feces. Out of an abundance of caution, PPCP testing is planned for this system in September 2024.

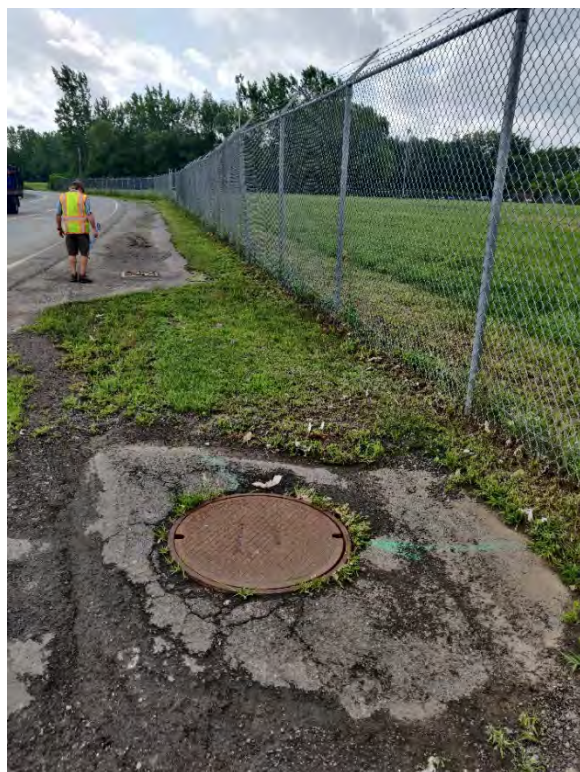
Figure 10. Sanitary manhole SAM01

- This system was first visited on August 11, 2020. It was apparent that a sanitary sewer overflow had occurred during a recent storm. The cover of sanitary manhole SAM01 (Figure 10; Appendix C, Map 12) was ajar, toilet paper was seen on the surrounding ground, and a wastewater odor prevailed. More toilet paper was visible on the grate of catchbasin CB01 (Figure 11), indicating

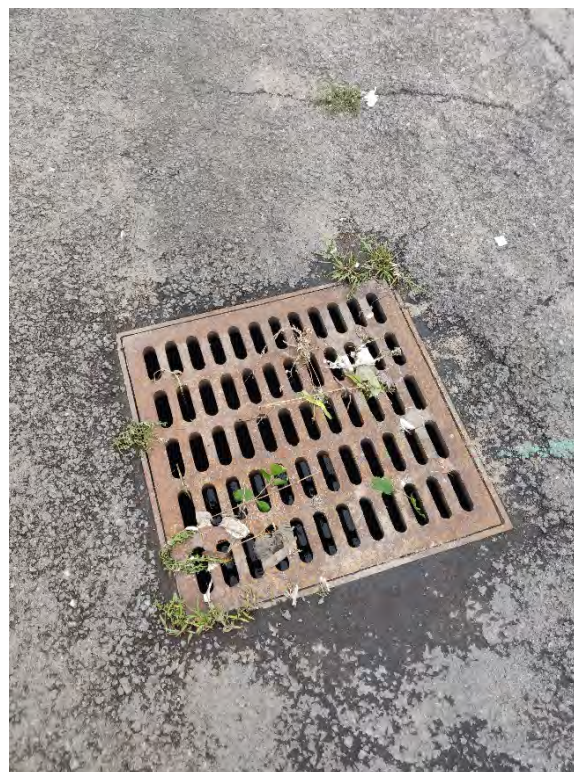
Figure 11. Toilet paper on catchbasin CB01 grate following sewer overflow event

that wastewater had entered the PB19 stormdrain at this inlet. Note that the location of catchbasin CB01 indicated in Map 12 is incorrect; the catchbasin is actually located about 20 ft. south of SAM01.

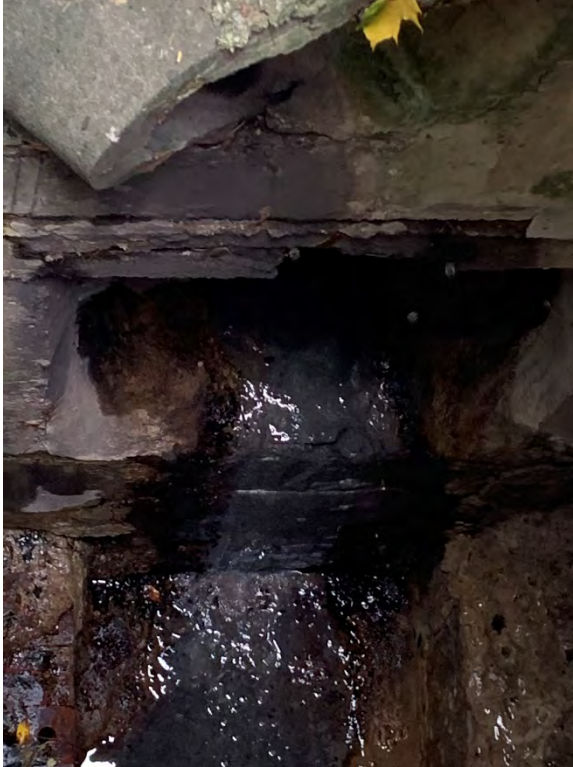
*Figure 12. Wastewater in stormdrain on Couch Street*

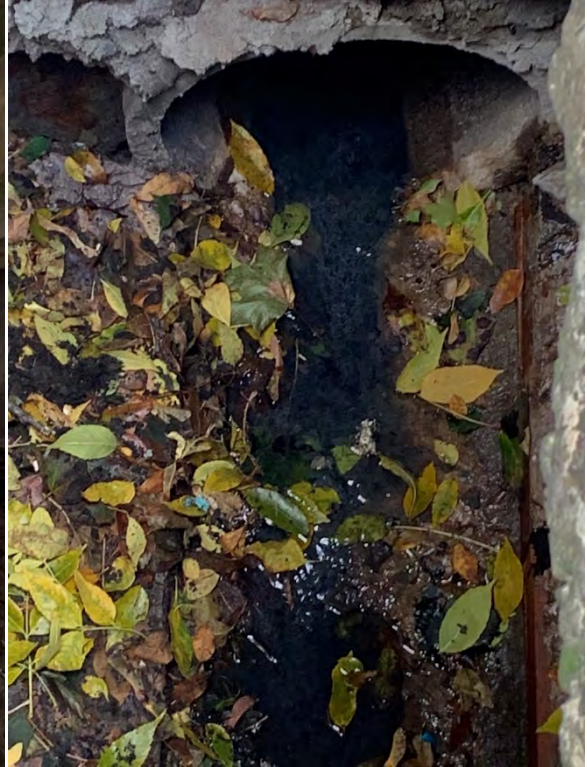
*Figure 13. Wastewater in stormdrain at the intersection of Brinkerhoff and Helen Streets*

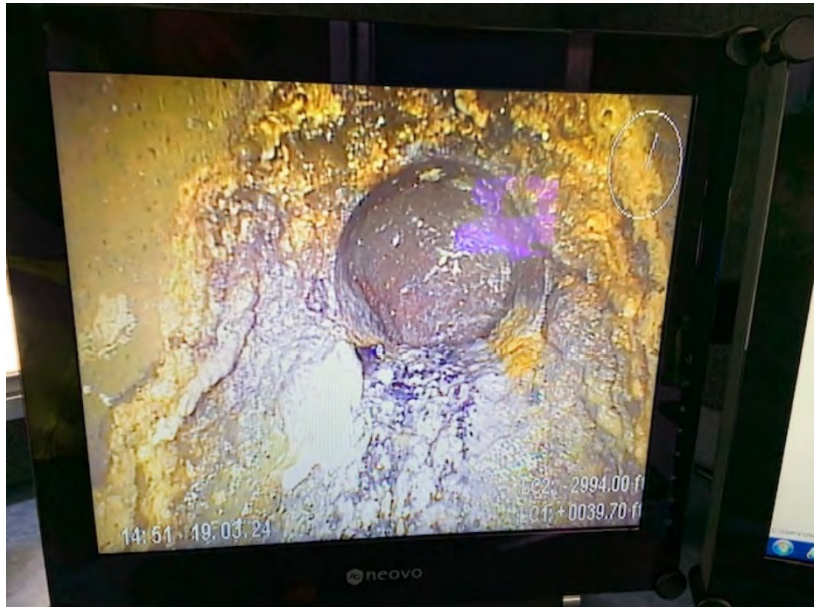
- On March 19, 2024, Stone and a Plattsburgh DPW crew inspected the stormdrain on Brinkerhoff St. between the Pleasant St. and Helen St. intersections. Starting at the manhole on Brinkerhoff St., a wastewater lateral from #89 Brinkerhoff St. was identified 39 feet into the stormdrain (Figure 14). #89 Brinkerhoff is a two-unit apartment house. Feces and toilet paper were seen in the stormdrain downstream of this connection. There were no other connections to this section of stormdrain.

Figure 14. Sewer lateral connection to PB22 stormdrain on Brinkerhoff

**Conclusion:** A residential wastewater lateral from 89 Brinkerhoff Street was connected to the stormdrain. The Plattsburgh DPW eliminated this improper connection and connected the building lateral to the sanitary sewer in July 2024.

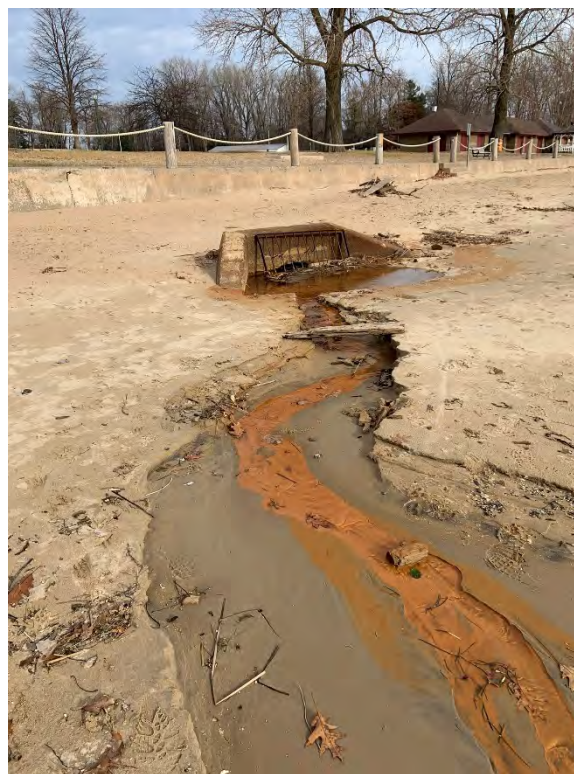
- Low concentrations of MBAS were measured at the outfall and in manhole MH03 when the stormdrain was first assessed on July 28, 2020.
- On September 1, 2022, the *E. coli* concentration (920 MPN/100 mL) at the outfall was elevated (Table 27). Geese were observed in the parking lot.
- Samples collected at the outfall and at junction manhole MH03 on October 19, 2022 had low *E. coli* concentrations.
- On October 6, 2022, manhole MH03 was accessed to independently evaluate the five stormlines draining to it. MBAS concentrations were negligible. Iron staining was evident.
- When the outfall was resampled on November 17, 2023, iron staining was pronounced (Figure 15). Ammonia and MBAS concentrations were negligible.

Figure 15. Iron staining from PB23 entering Lake Champlain

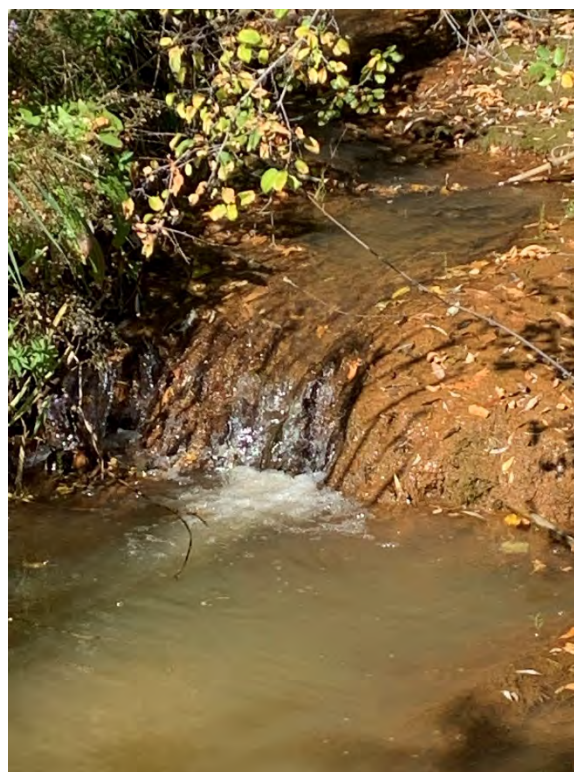
Figure 16. Stream channel downstream of PB29 outfall, October 6, 2022

- An elevated chlorine concentration was measured at catchbasin CB02 when this stormdrain was first assessed on August 11, 2020.
- On September 1, 2022, samples collected at the outfall had elevated *E. coli* (610 MPN/100 mL) and TP (0.44 mg/L) concentrations (Table 27).
- In follow-up sampling on October 6, 2022 at the culvert inlet downstream of the outfall (DSCulv), the *E. coli* concentration was low (100 MPN/100 mL).
- The water and sediment downstream of the outfall were stained by iron (Figure 16), suggesting contamination from past land uses or petroleum releases.

**Conclusion:** We do not believe there is a chronic, illicit discharge to this stormdrain. No OB was detected, and MBAS concentrations were negligible. Given the extent of the system, nuisance fecal contamination by pets and wildlife likely caused the elevated *E. coli* measurement on September 1, 2022.

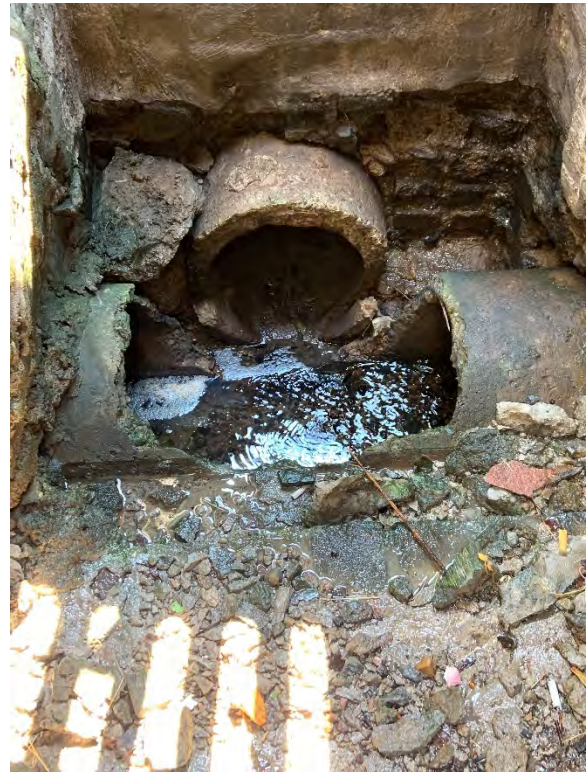
- A sample collected at the outfall on September 1, 2022 had exceedingly high *E. coli*, >2420 MPN/100 mL (Table 27). Follow-up samples collected on October 19, 2022 at the outfall and catchbasin CB08 had negligible *E. coli*.
- On September 14, 2022, significant foam was observed in catchbasin CB07 (Figure 17). OB pads deployed at the outfall and six catchbasins were all negative.
- Foam was not observed in this stormdrain on October 6, 2022, November 17, 2023, or several other dates when brief inspections were made.
- There is an unmapped concrete pipe entering catchbasin CB08 from the direction of the Georgia Pacific plant. Camera inspection of this pipe was planned but was not conducted.

Figure 17. Foam in PB31 catchbasin CB07

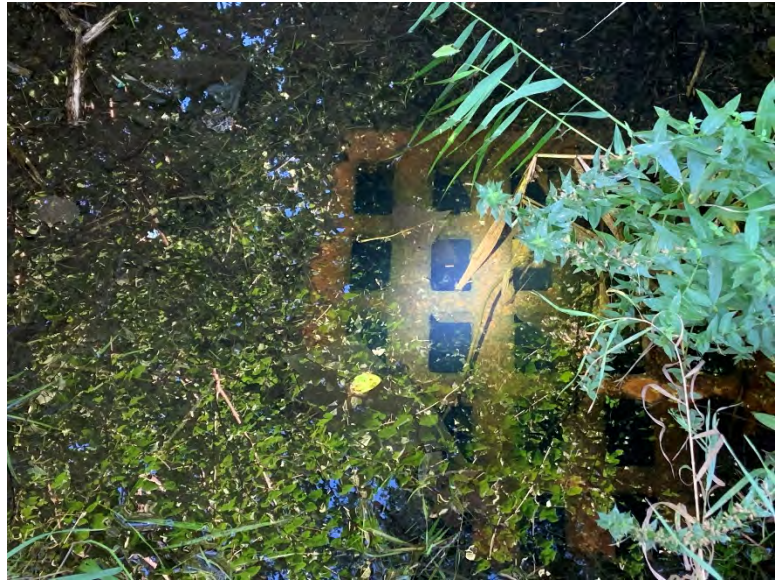
- The high MBAS and ammonia concentrations at CB01 were confirmed a week later, on August 5, 2021, and the *E. coli* concentration was very high, 2,420 MPN/100 mL (Table 27). A foul odor was noted and CB02 was flooded.
- There were no similar indications of wastewater contamination on two dates in 2022 and one date in 2023. No optical brightener was detected at CB04 and CB05 on September 29, 2022. On October 6, 2022, the lower portion of the system was flooded (Figure 18), and negligible *E. coli* was measured at CB01 (1 MPN/100 mL).
- The prevalence of iron staining at CB01, CB02, MH01, MH02, and the outfall (Figure 19) suggests contaminated groundwater from historic uses on the oval enters the stormdrain.

Figure 18. Flooded catchbasin CB01

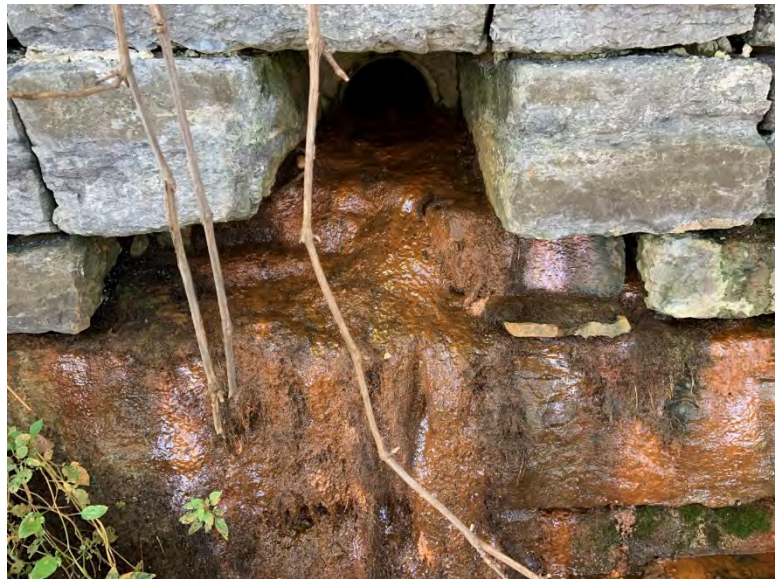
Figure 19. PB48 outfall

**Conclusion:** After repeated visits and testing throughout the system, we have concluded that there is no current illicit discharge in this system. We are not sure how to explain the apparent change between the 2021 and 2022-2023 sampling events. It is possible there was a sanitary wastewater leak or accidental discharge to the stormdrain that was corrected. Out of an abundance of caution, PPCP testing is planned for this system in September 2024.
