2014 Water Chestnut Management Program: Lake Champlain and Inland Vermont Waters

FINAL REPORT

A Report Prepared for the Lake Champlain Basin Program

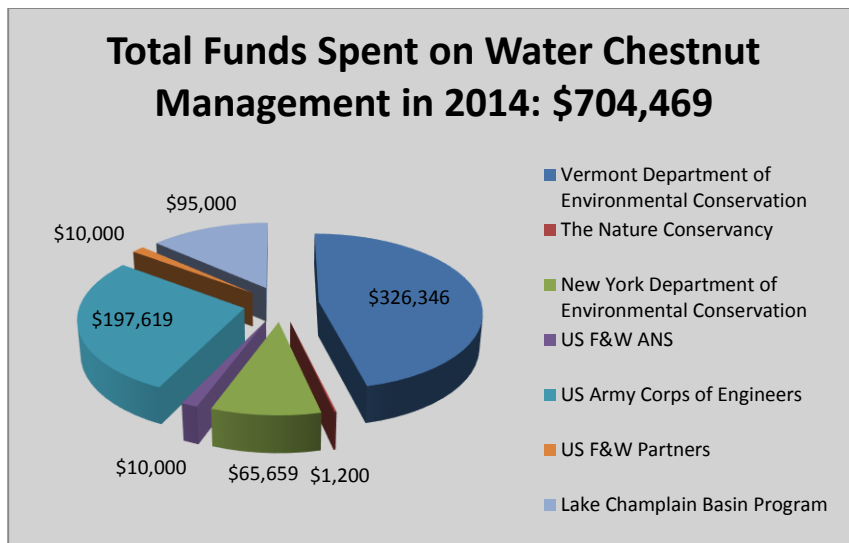
Figure 1-1: Summary of funds spent managing water chestnut in Lake Champlain and in other Vermont water bodies in 2014

Funds spent on water chestnut management efforts in Lake Champlain and other waters in Vermont in 2014 totaled \$704,469 (Figure 1-1). Funds spent on management since 1982 are estimated at almost 11.5 million dollars (Table 1-1).

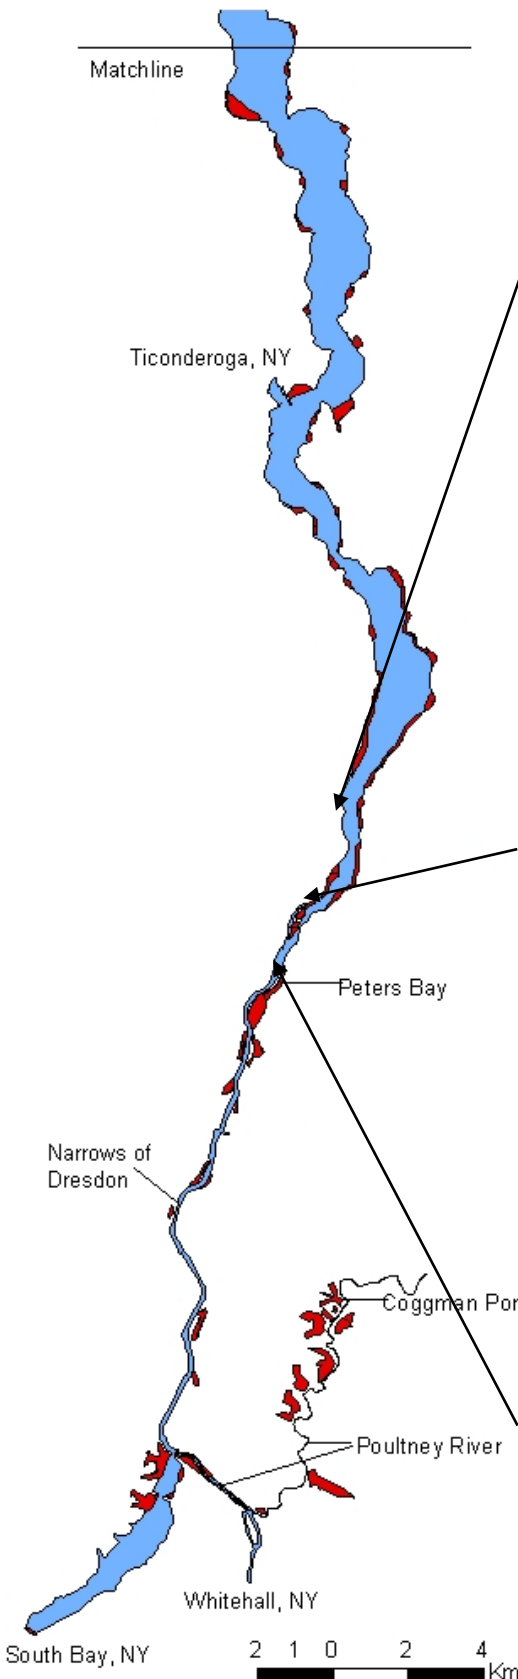
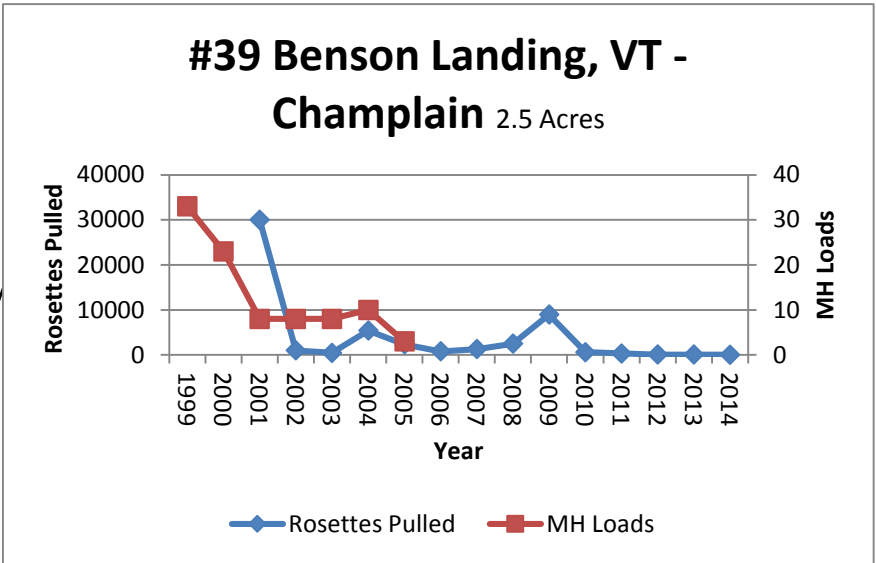
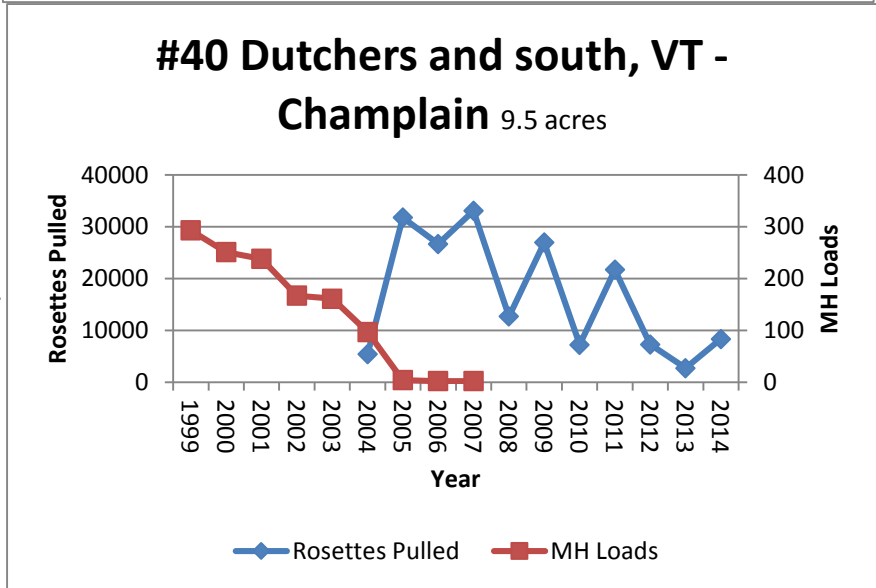
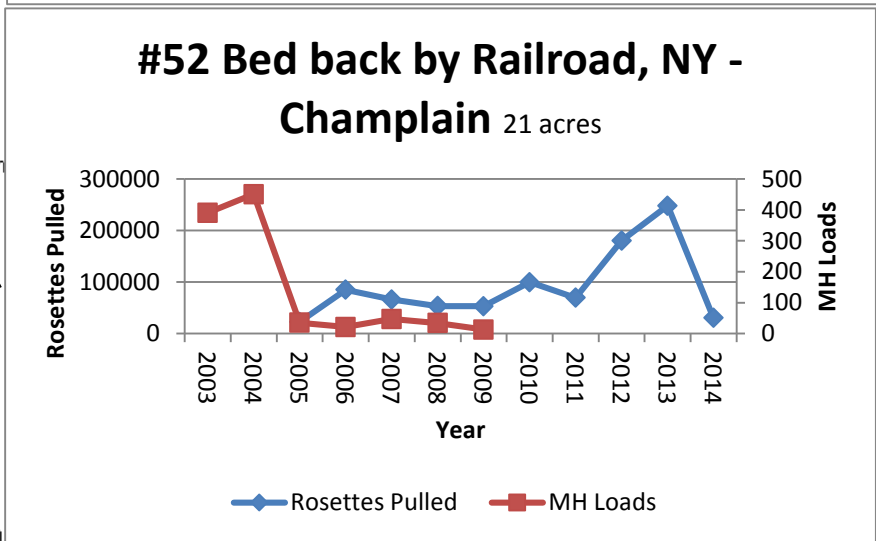
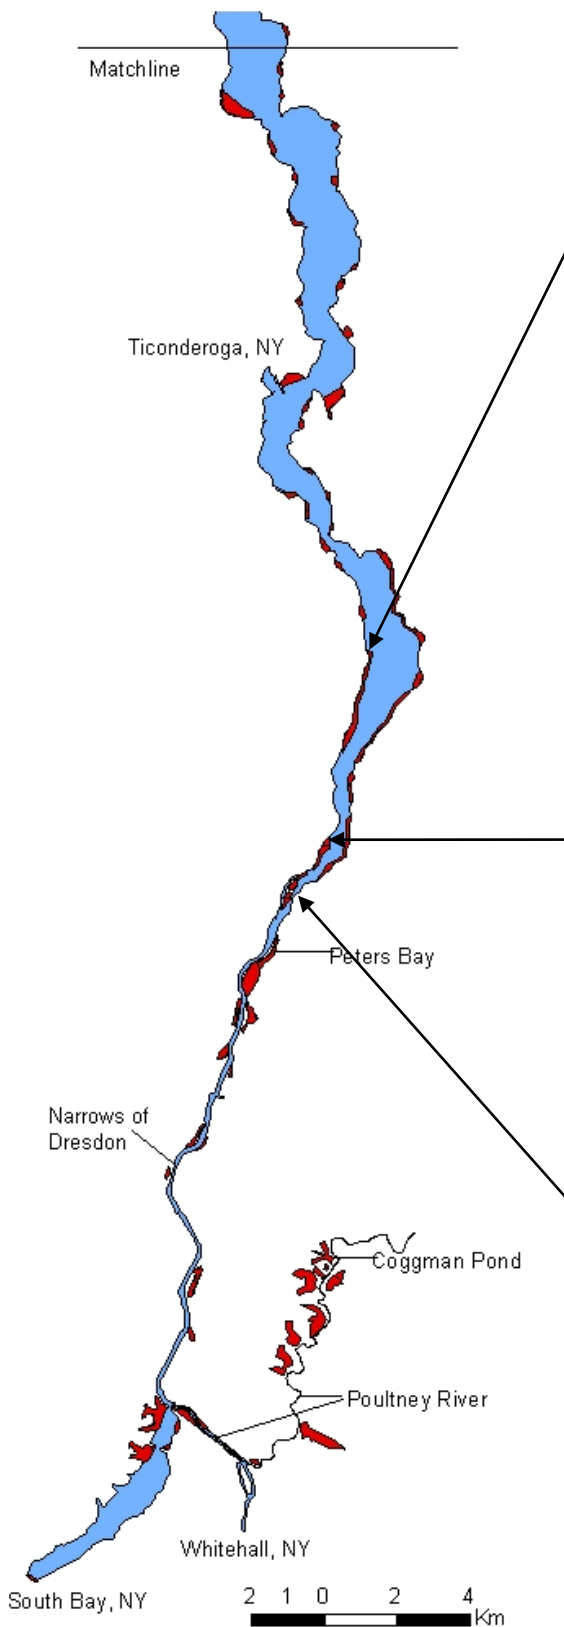
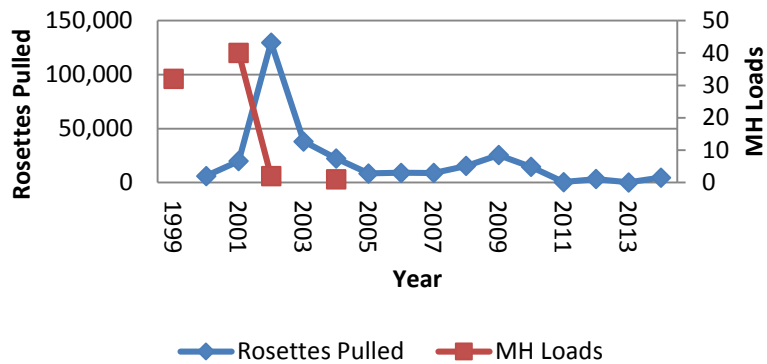
Figure 2-2: Six long-term Lake Champlain mechanical harvesting sites trending to handpulling

- Six long-term Lake Champlain mechanical harvesting sites continued to require handpulling only. One of these six, site #53 New York Light 4, needed mechanical harvesting in 2012, but was handpulled only in 2013 and 2014 (see Figure 2-2).

- At 20 Lake Champlain water chestnut sites, 10 or less rosettes were found and removed. Figure 2-2 provides trends in handpulling data for six long-term handpulling sites in Lake Champlain.

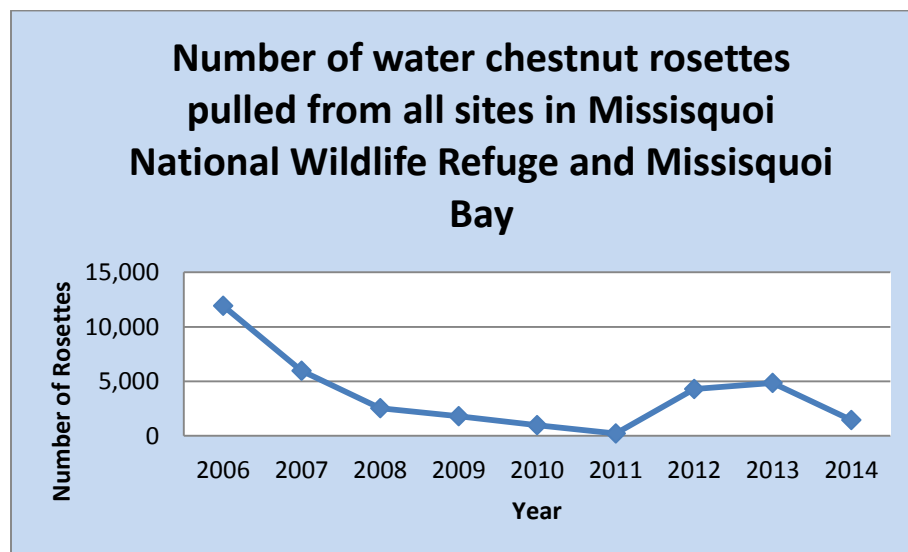
Table 4-3: Number of water chestnut rosettes pulled from Missisquoi National Wildlife Refuge and Missisquoi Bay, 2006 – 2014

A total of 776 acres were surveyed during the 2014 season. Three hundred and ninety seven hours were spent removing 1,451 water chestnut rosettes (4,657 in 2013) which weighed 154 lbs. Though numbers were down considerably from 2013, most of the water chestnut rosettes were in areas that had been infested for years. Results from all sites in the Missisquoi Bay area are shown in Appendix 1 and 2. Table 4-3 shows the total number of rosettes pulled from all Refuge sites by year. The non-Refuge site totals are also included in the 2013 and 2014 year’s data.

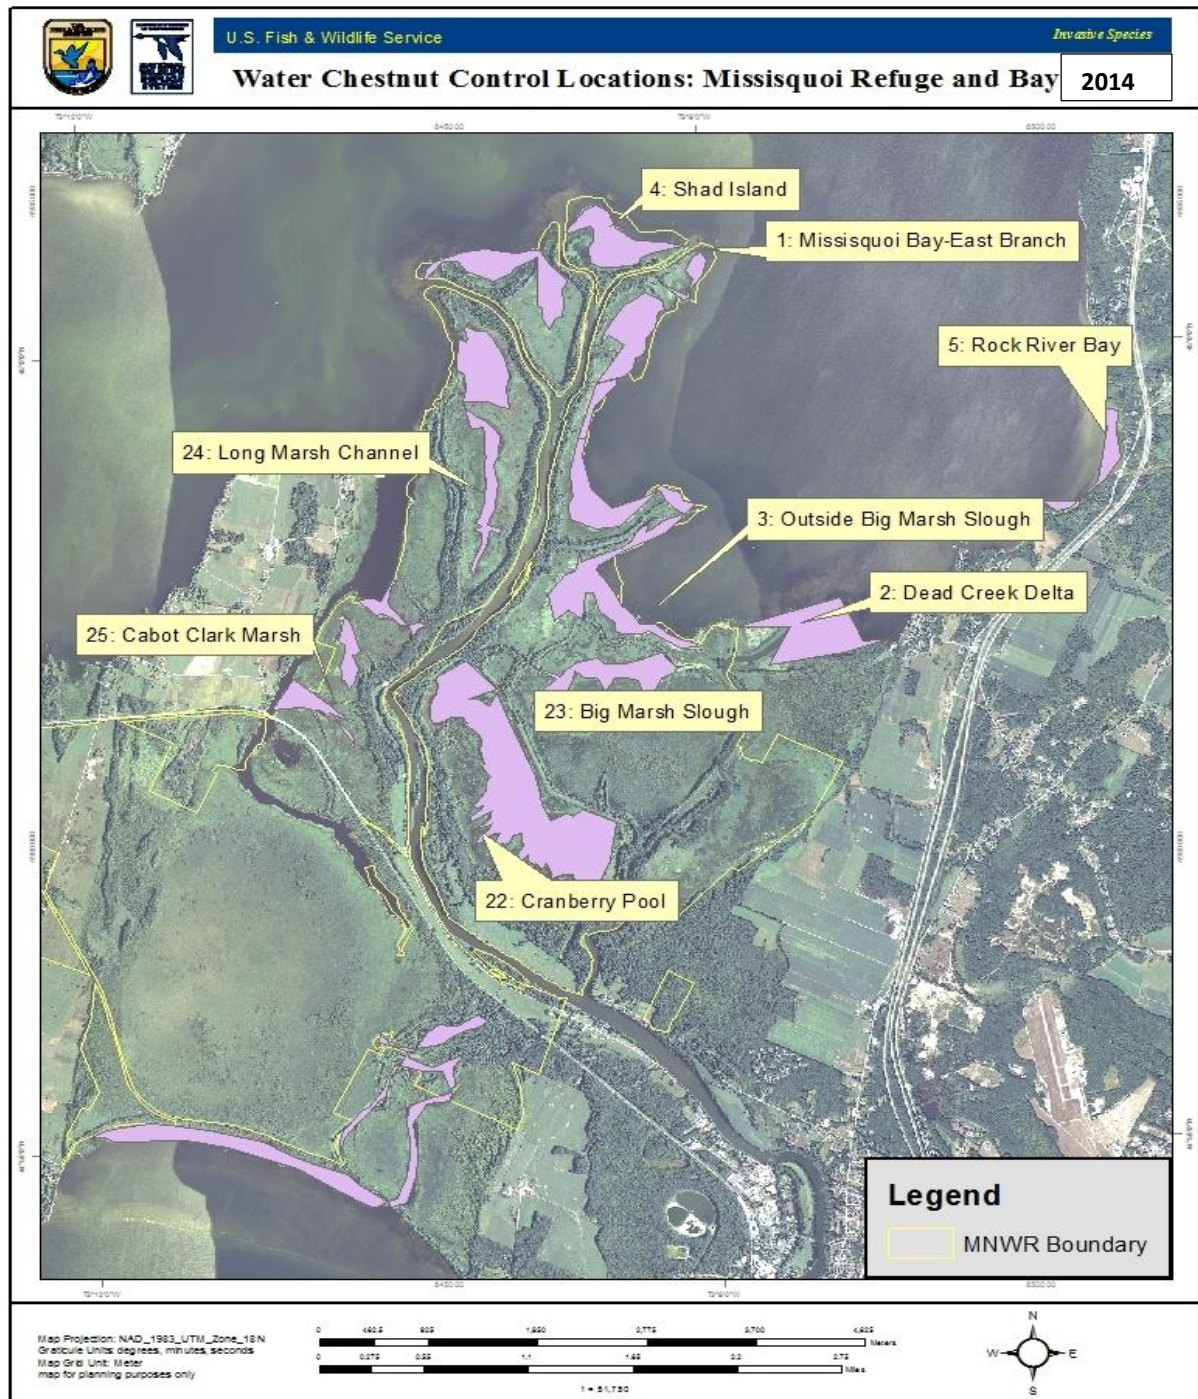
Map 1. Northern Lake Champlain sites: Missisquoi Bay

Key: =Management sites and areas surveyed by USFWS for water chestnut in 2014
