Ticonderoga's Floating Drawbridge; 1871-1920.

**Lake Champlain
Basin Program**

Prepared by Peter Barranco, Jr.

for Lake Champlain Management Conference

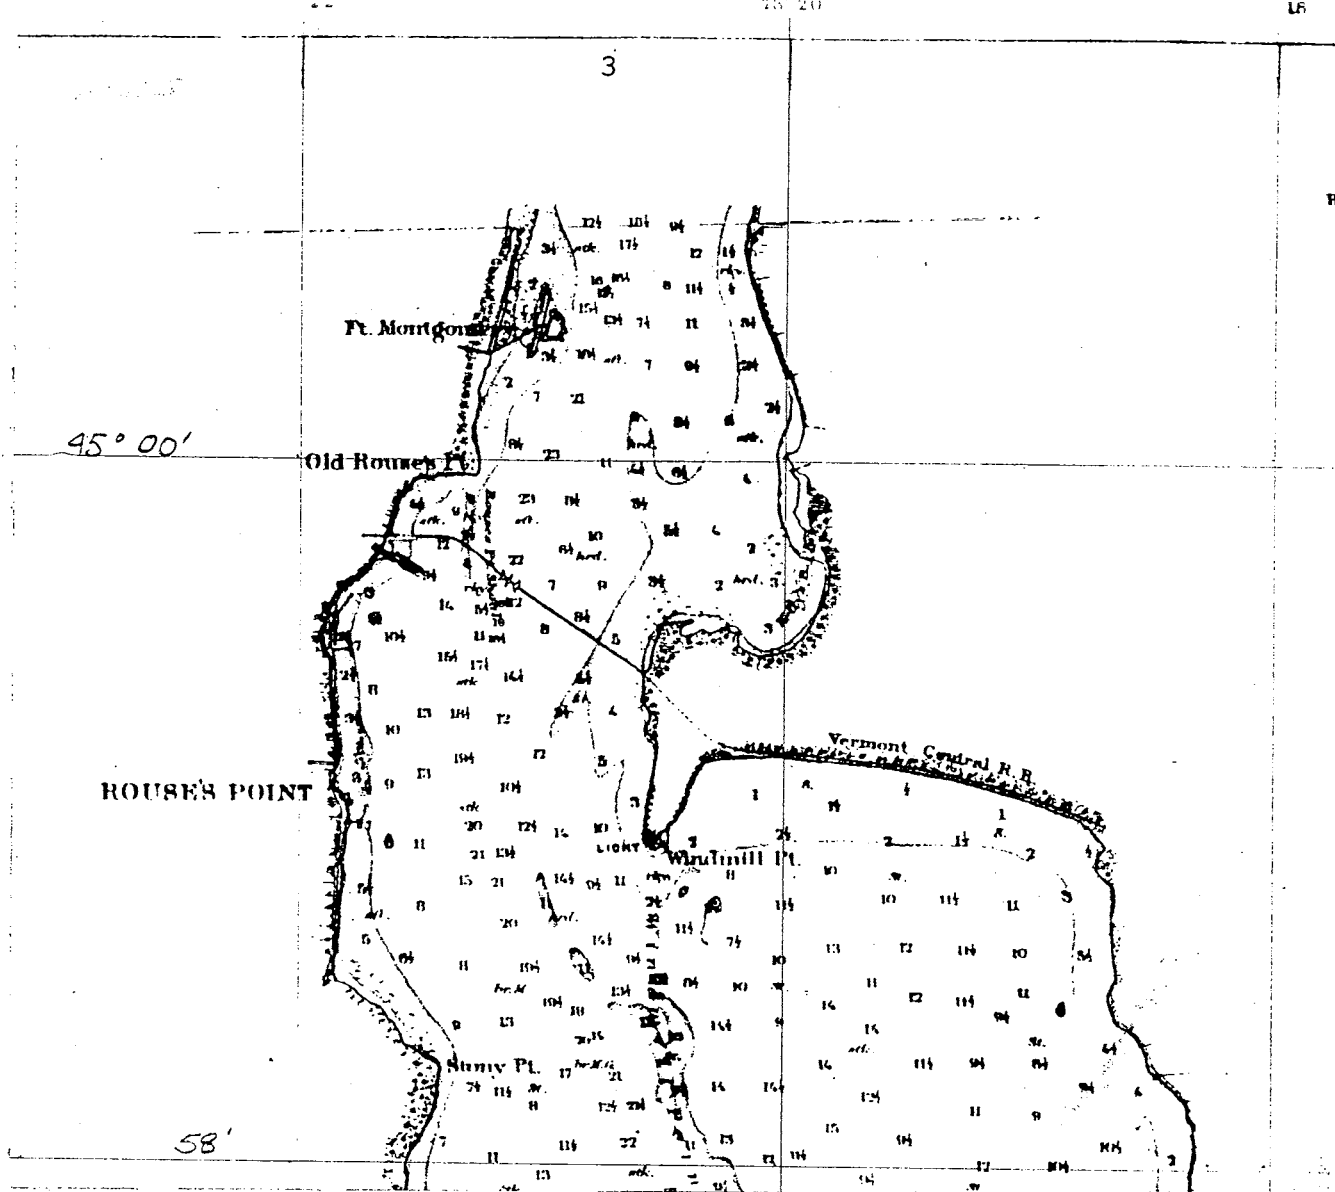
Lake chart of the Rouses Point area showing the Vermont Central trestle and center pivot drawbridge across Lake Champlain in 1879.

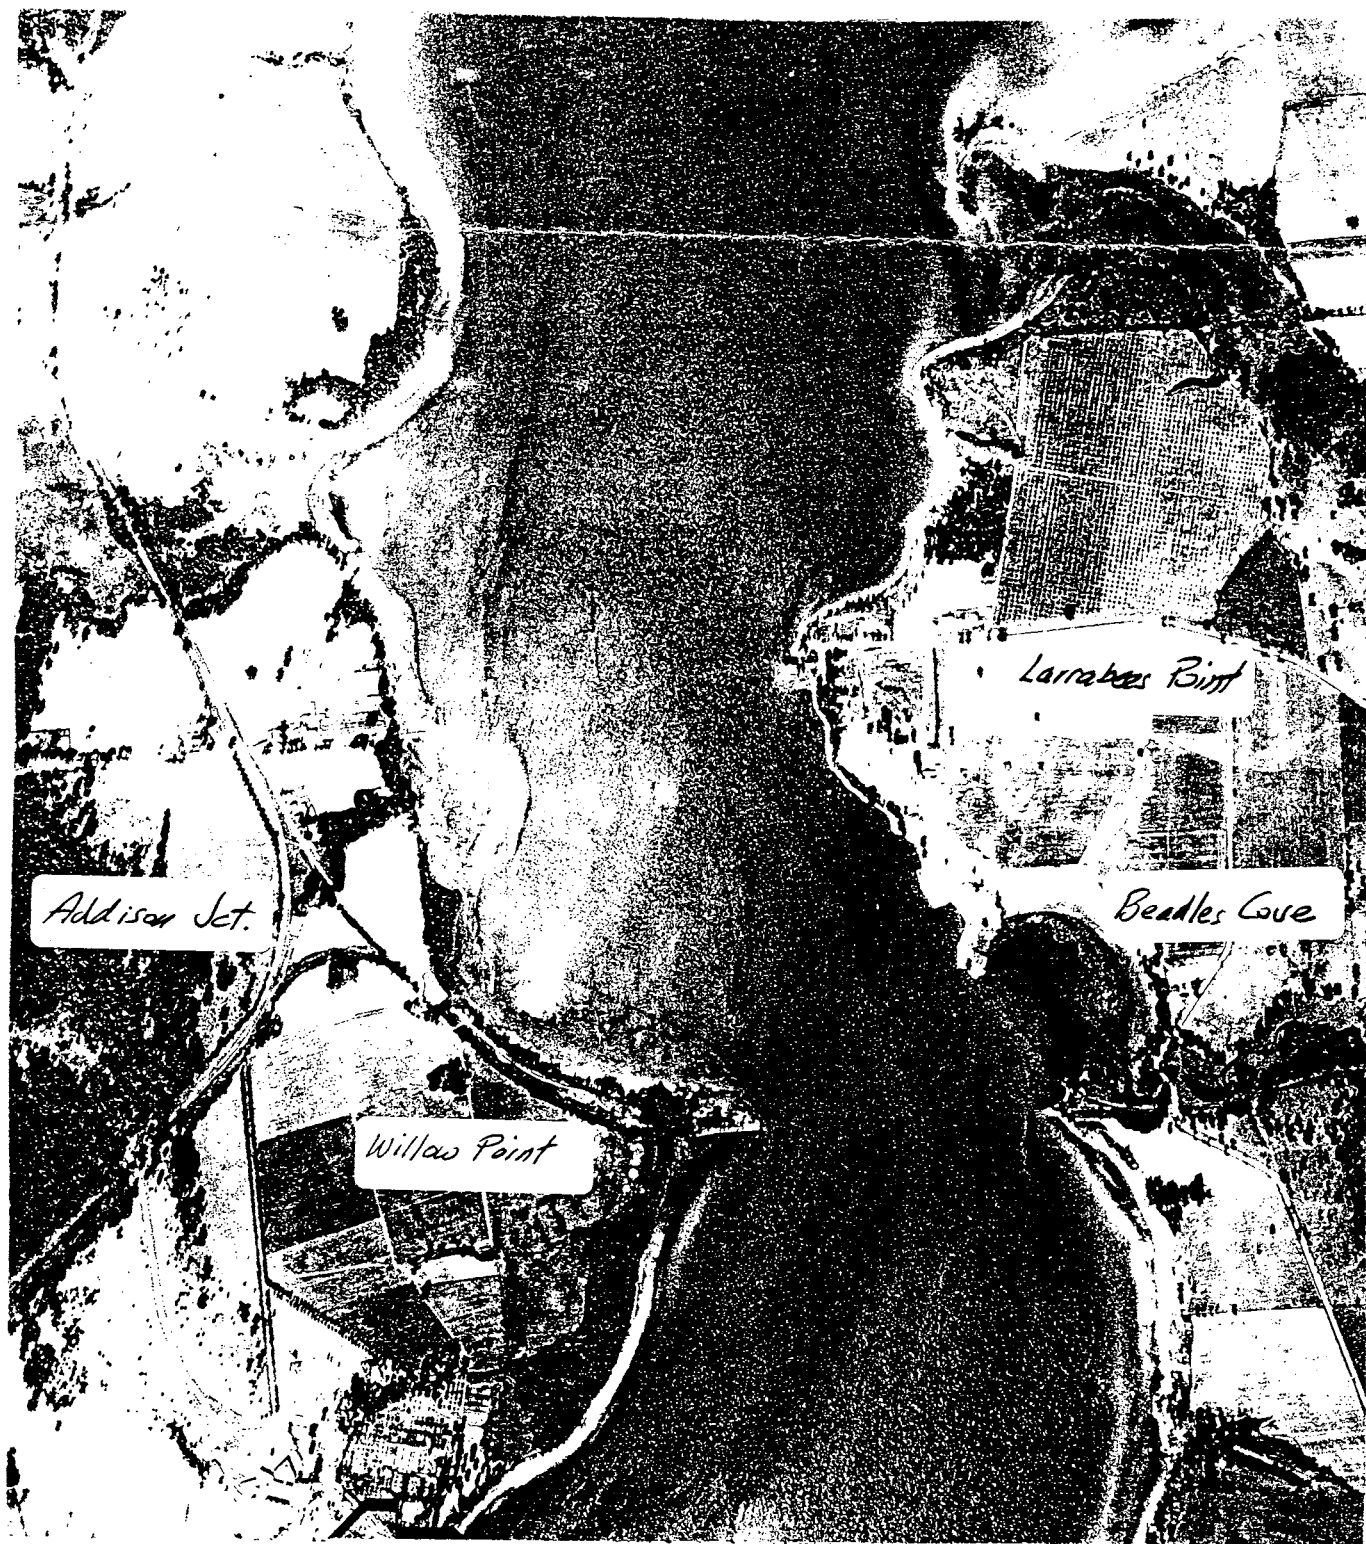
Air photo of the Larrabee Point-Ticonderoga area taken September 2, 1942, during a time of low lake level (93.94 feet NGVD on this date). The road bed for the former Addison Branch Railroad between Willow Point and Addison Junction is clearly visible. The Branch is dead ended on the Vermont side at the south point of Beadles Cove at the end of the former Burleigh trestle across the mouth of the cove. The line of piling marking the trestle across the cove is visible in the photo under these low water conditions. (Air photo number DCC-9-60)

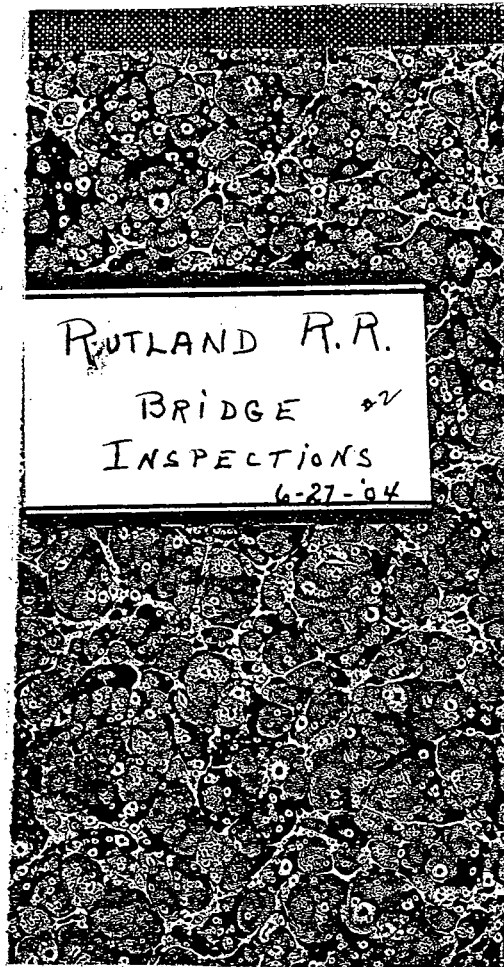
Rutland Railroad Company bridge inspection report for the Addison Branch trestle and drawbridge for the period 1902-1904. The burning of the drawboat on February 7, 1902, and its replacement with a new boat in the fall of that year is recorded. (Rutland R.R. Bridge Inspections, #2, 6-27-04)

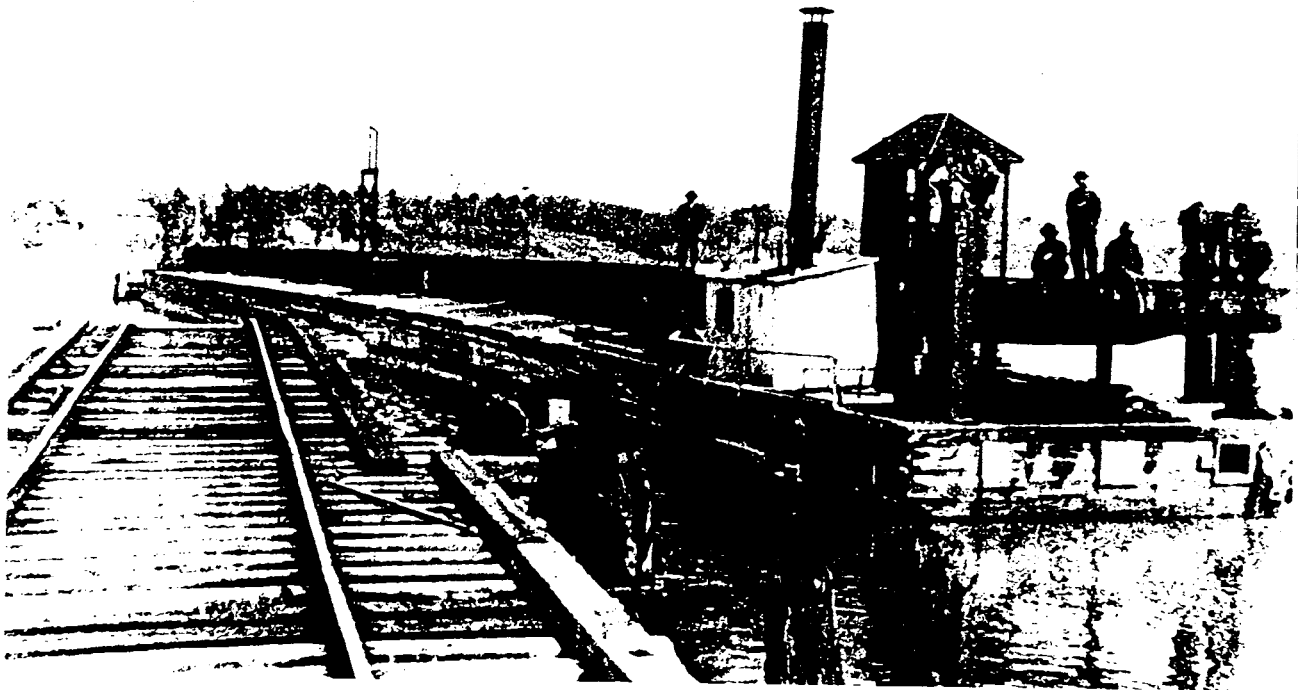
Undated photo of what is probably the section gang aboard the 1902 drawboat which is shown partially swung open. Boiler house and stack, control house for donkey engine and winch, and apron for adjusting track height are clearly visible. Chain is visible just to right of the open port leading down into the lake. View looking east towards Vermont. Large building at left center is the ice house.

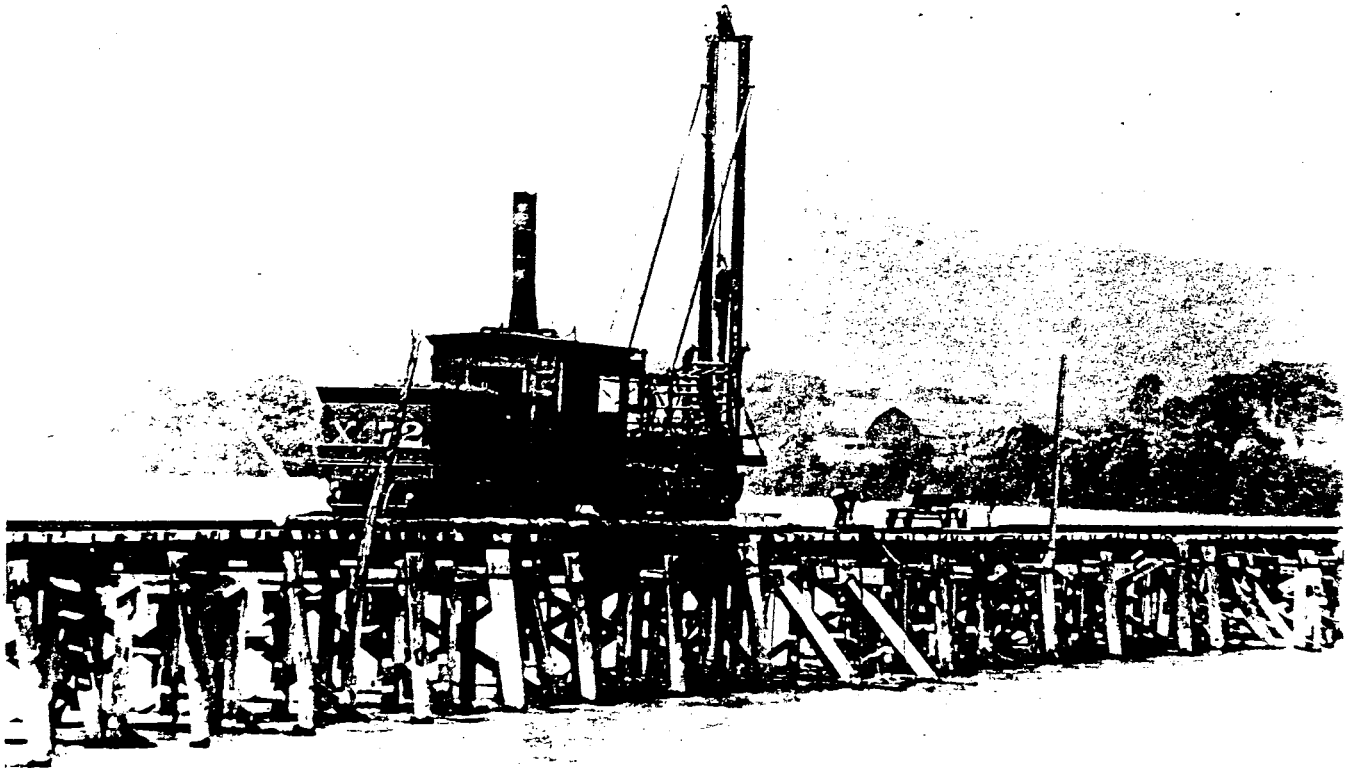
Rutland Railroad pile driver X472 at work on the Larrabees Point-Ticonderoga trestle c.1905. This view is from the Vermont side looking towards Mt. Defiance and the New York shore.

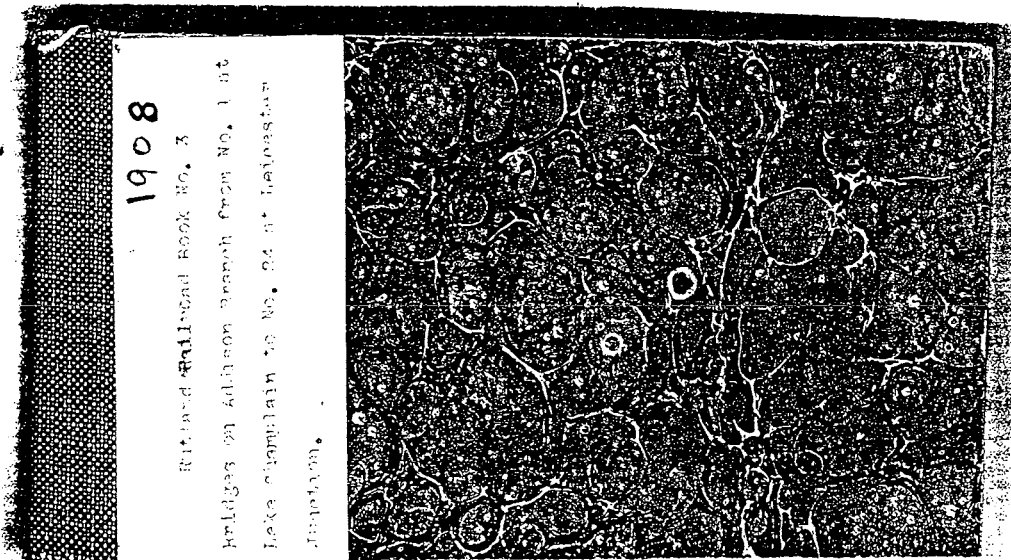
Rutland Railroad Company bridge inspection report for the Addison Branch trestle and drawbridge for the period 1905-1908 showing repairs made to the bridge in 1905. (Rutland Railroad Book No. 3 Bridges on Addison Branch from No. 1 at Lake Champlain to No. 24 at Leicester Junction)

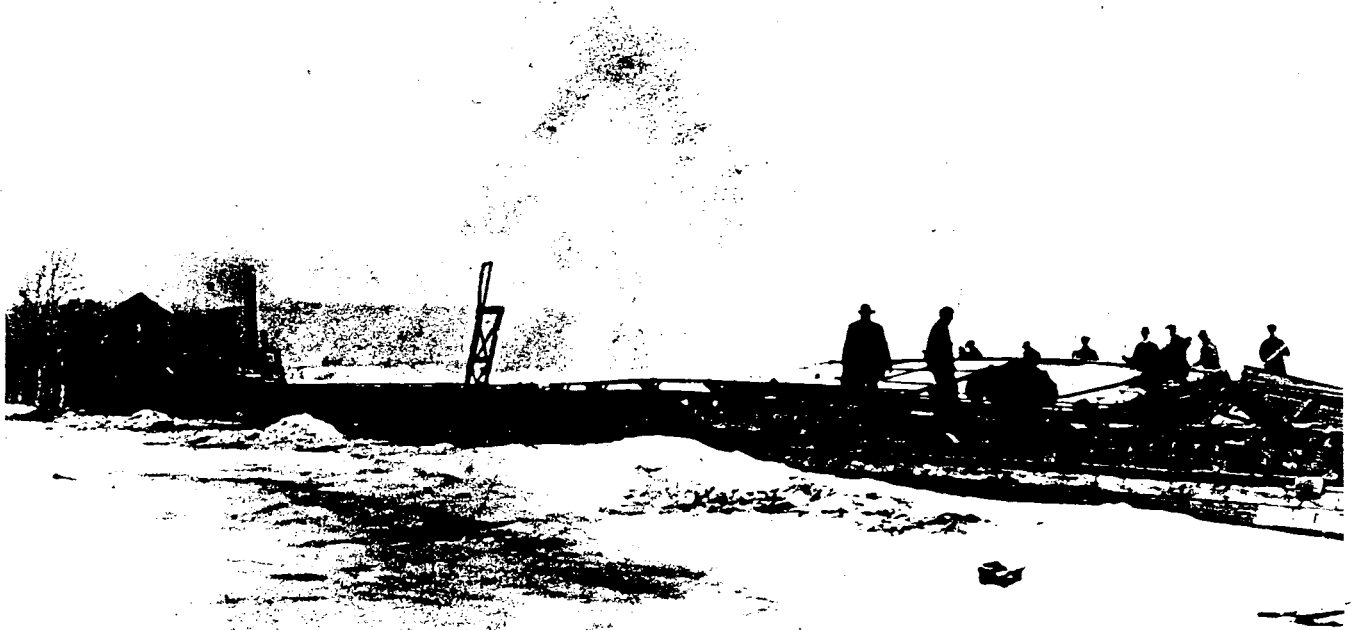
Photo of March 20, 1918, accident to floating drawbridge showing drawboat submerged to deck level and two box cars partially submerged. View is from the south side of the draw looking northwesterly towards the New York shore.

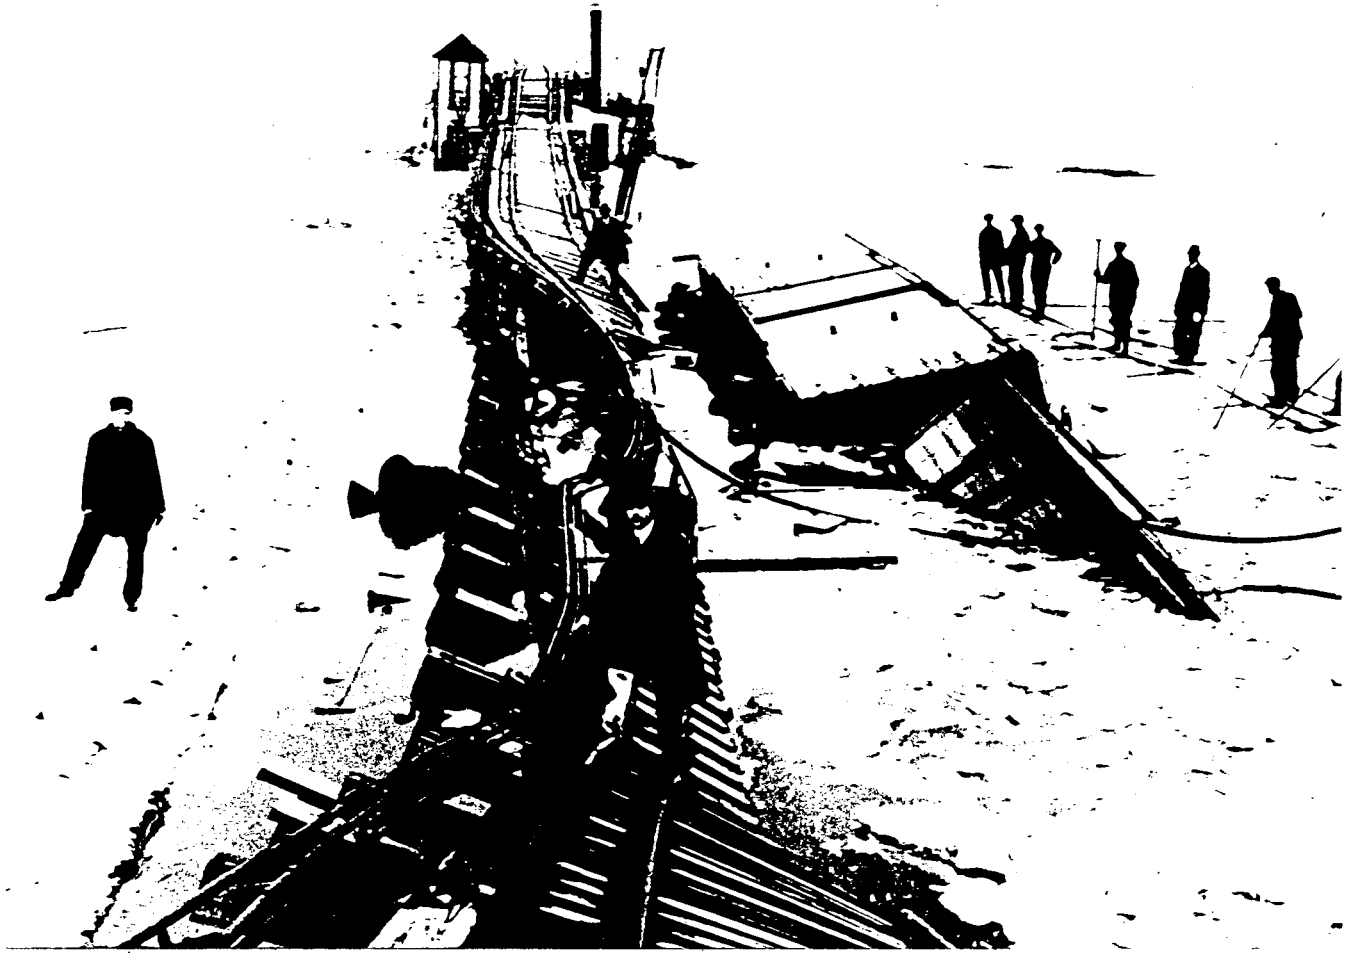
Photo of March 20, 1918, accident to floating drawbridge. View is looking due west towards the New York shore.

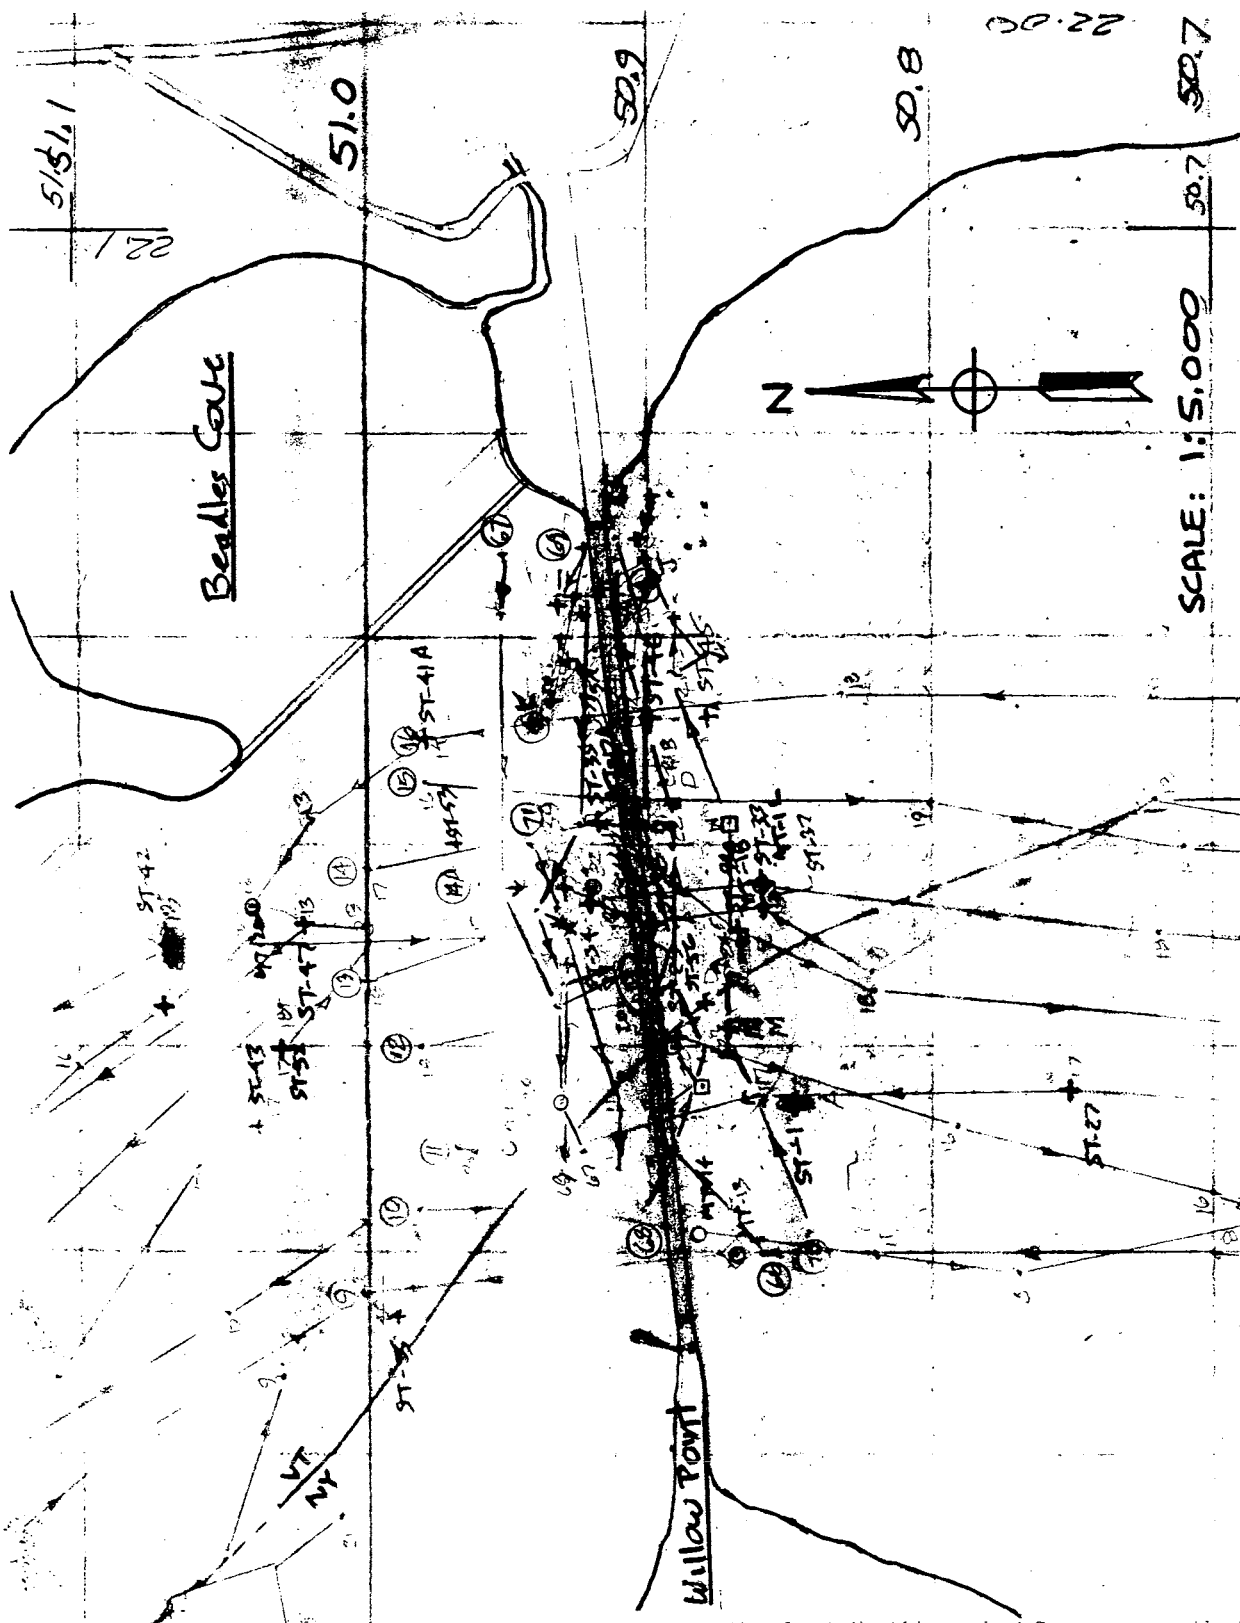
Underwater survey of the Addison Branch Railroad crossing between Ticonderoga and Larrabees Point showing uncorrected vessel tracks, soundings and sonar targets for lines 9-16 (May 26, 1992 - R/V BALDWIN) and lines 66-71 (May 26-27, 1992 - R/V NEPTUNE). North-south runs appear fainter due to mylar overlay of east-west runs. Data later was reduced (corrected) and replotted at a larger scale to develop final survey chart.

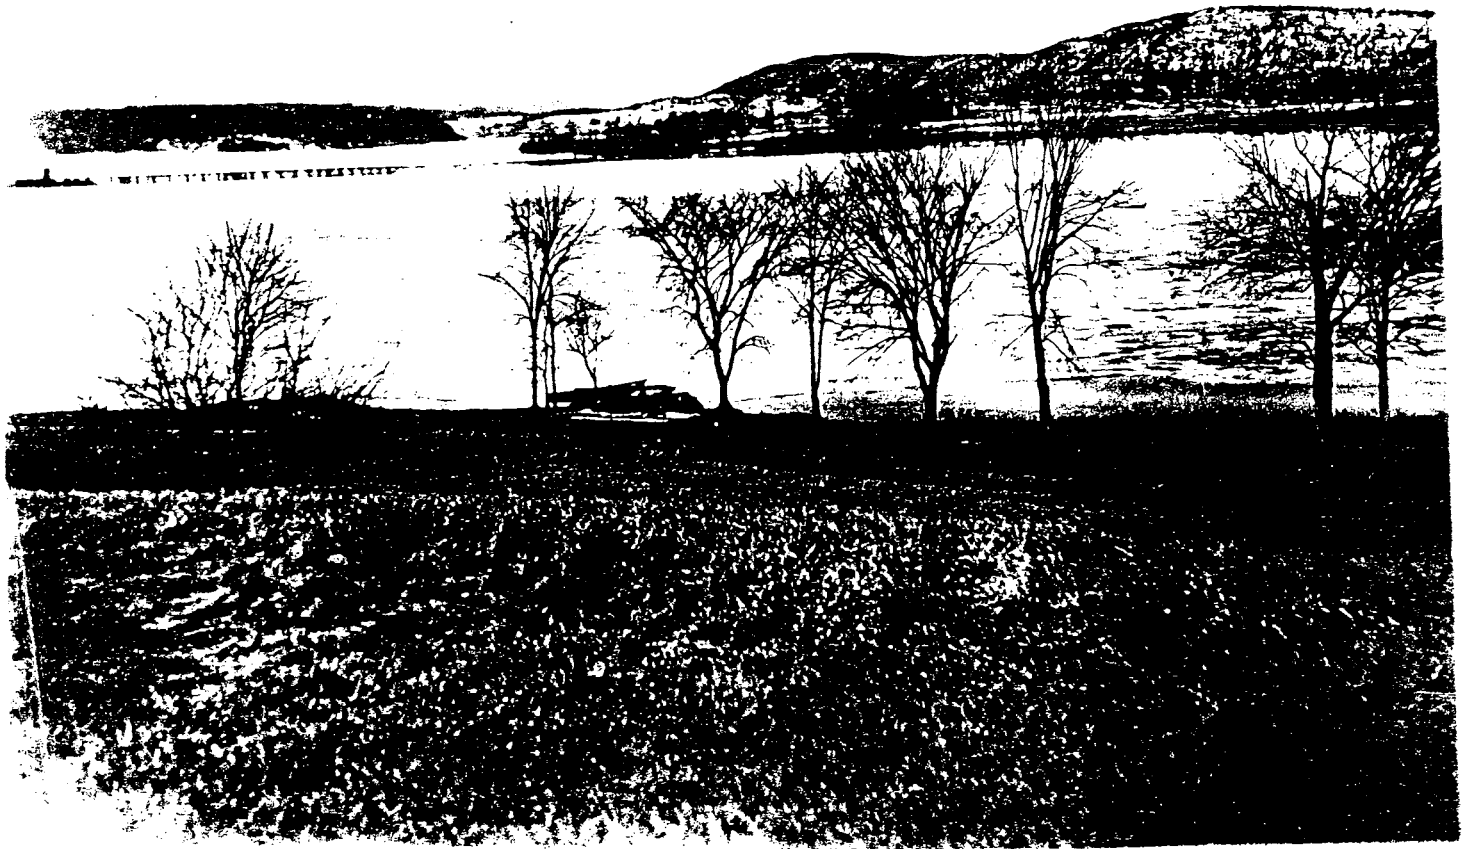
Undated photo of the Addison Branch Railroad trestle and drawbridge. Looking southwesterly from Larrabees Point. From what little can be seen of the drawboat in the original photo, the size and location of the control house and the location of the boiler stack appear to be different from the 1902 drawboat. It may show the 1888 drawboat.
