Flood Resilience in the Lake Champlain Basin and Upper Richelieu River

A comprehensive review of the 2011 flooding impacts on a watershed level to inform flood resilience policies and management strategies in the Lake Champlain Basin

Learning from
the Past,
Preparing for
the Future

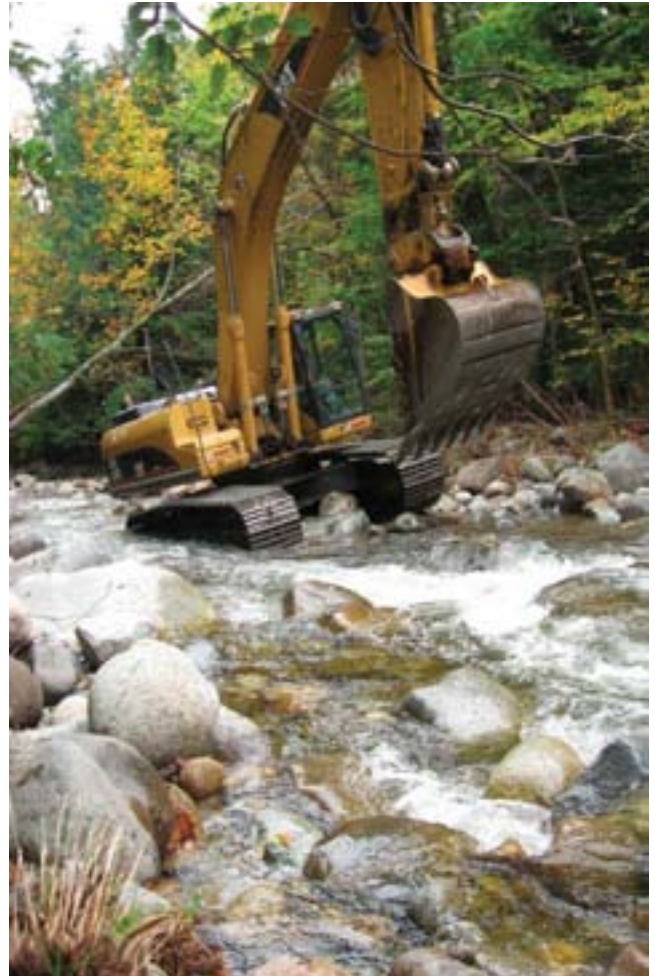
An example of post-Irene river repair work in the Boquet River, NY. Photo: Boquet River Association

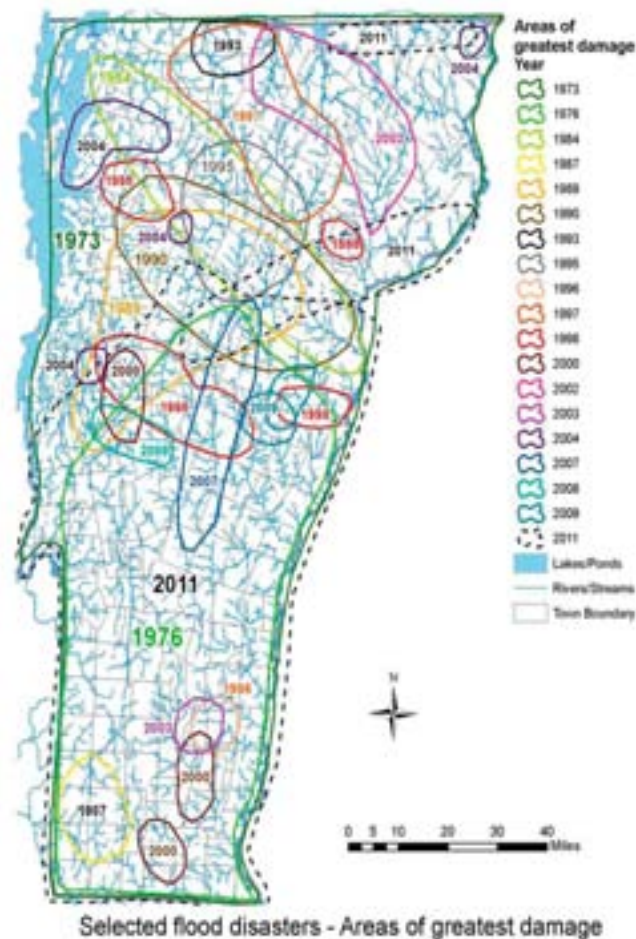
Figure 2. Areas of major flood damage from prior flood events illustrating the history of flooding in the region. Courtesy: VT ANR

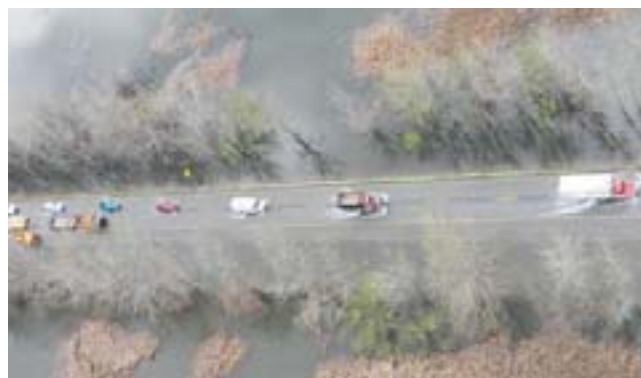
U. S. Route 2 causeway between South Hero and Milton, VT.
Photo: LCBP

Statewide, over 200 towns reported transportation damages in Vermont as a result of Tropical Storm Irene. According to the Vermont Agency of Transportation, Irene damaged over 500 miles (800 km) of State roads and 200 State bridges of the Vermont state highway system, costing \$175 - \$250 million to rebuild statewide.⁷⁸ Local road damages included 2,260 road segments, closing 175 roads and 90 bridges. Damage was done to over 960 culverts and

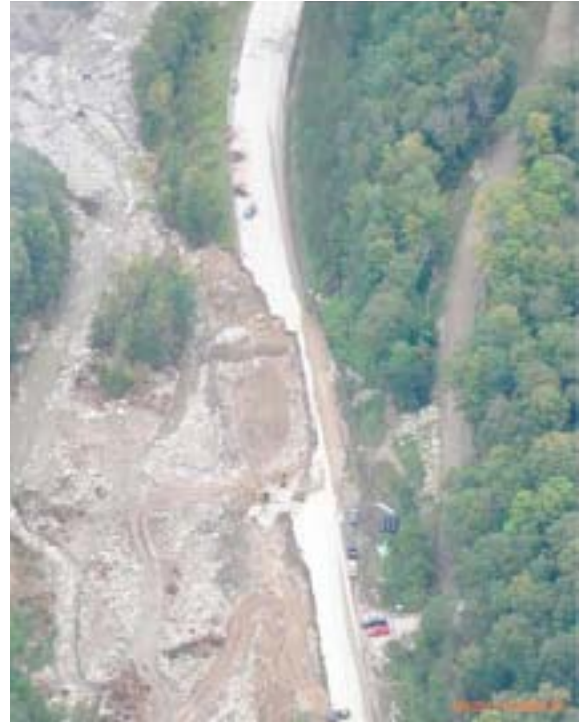
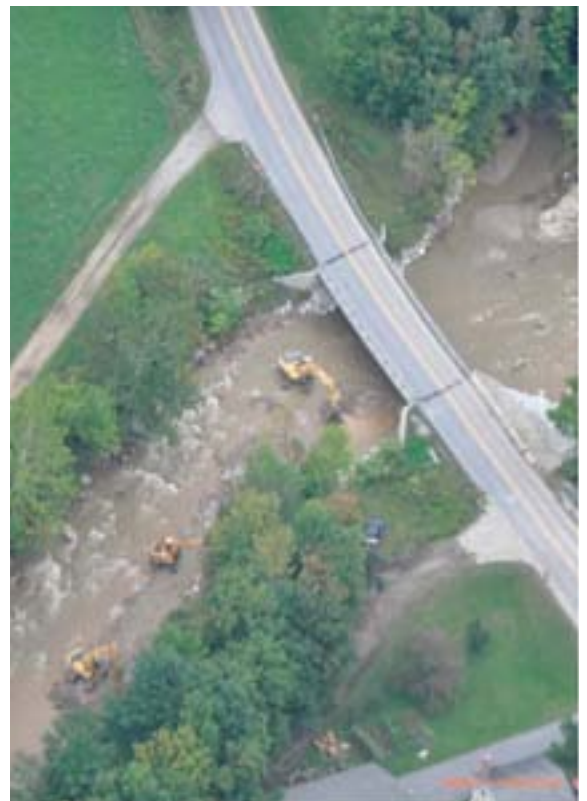
Some impacts of Tropical Storm Irene on Route 4 in Vermont. Photo: VT ANR
