Fish Passage and Connectivity in the Ausable Watershed using GIS Prioritization and Field Assessment Tools

Final Report

FINAL REPORT

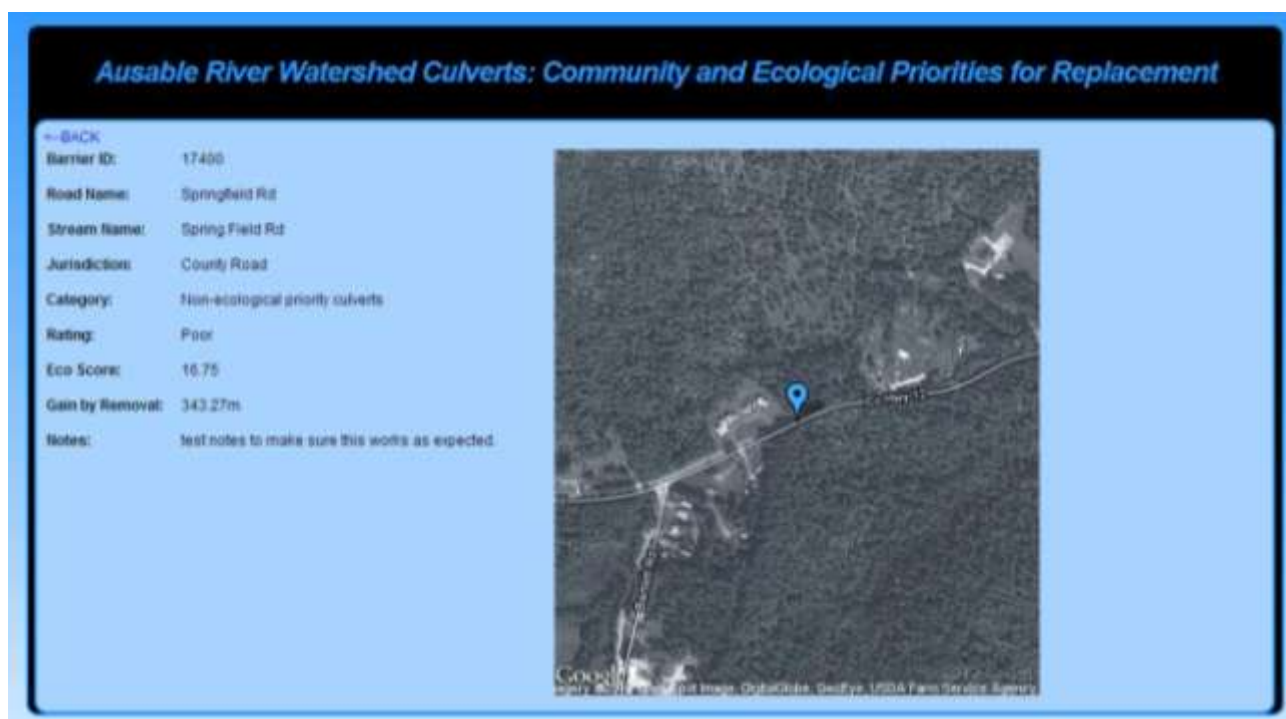
Figure 13. Google map showing detailed data that is available through the online tool.
