Assessment of Tile Drainage Systems in Addison County and the Jewett Brook Watershed

Lake Champlain Basin Program

FINAL REPORT

ASSESSMENT OF TILE DRAINAGE SYSTEMS IN ADDISON COUNTY AND THE JEWETT BROOK WATERSHED

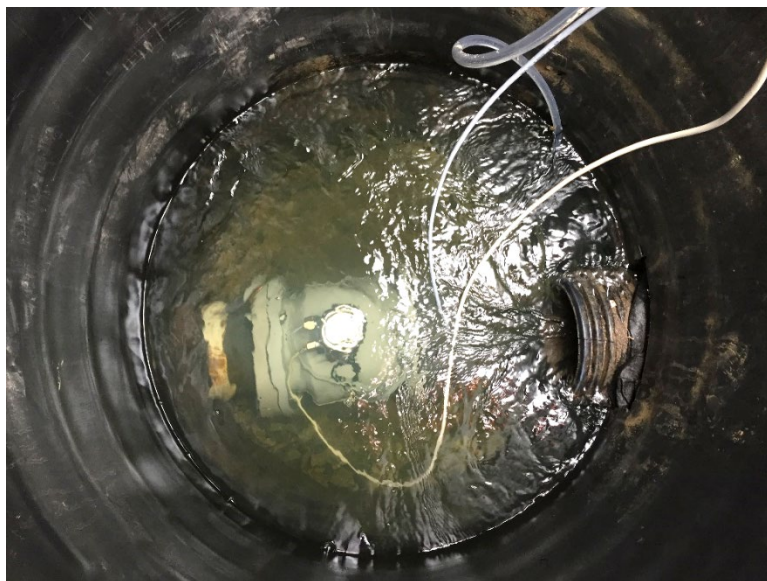
Figure 7. 8-inch Waterflux 3000 flowmeter in JBT11 manhole

All stations except JBT06 and ACT3 were equipped with Waterflux 3000 electromagnetic flowmeters (Figure 7). Each Waterflux 3000 flowmeter was cabled to a Krohne IFC-100W signal converter, which processes electrical signals into meaningful flow data. The signal converter was connected to an ISCO 2105ci datalogger/modem for continuous storage and transmission of flow data and to an ISCO 6712 autosampler for collection of flow-paced composite water samples. The wiring and programming of these instruments were highly customized for this monitoring application.

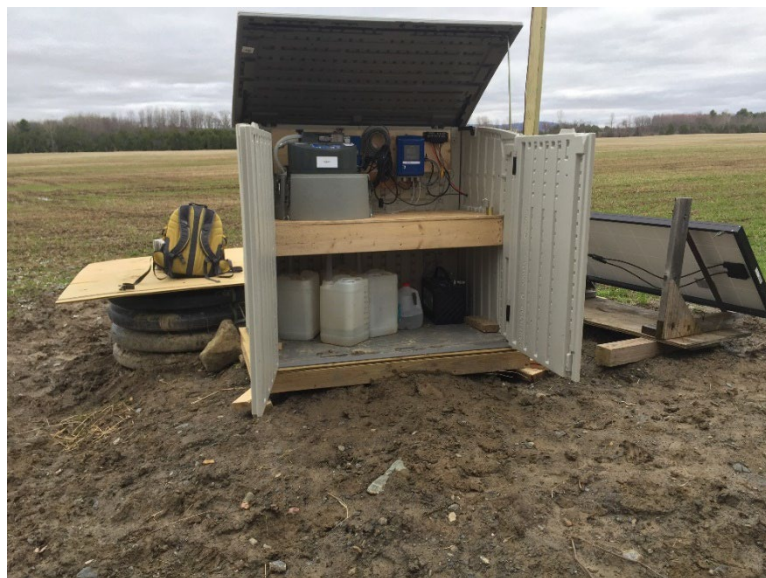
Figure 8. JBT11 monitoring station

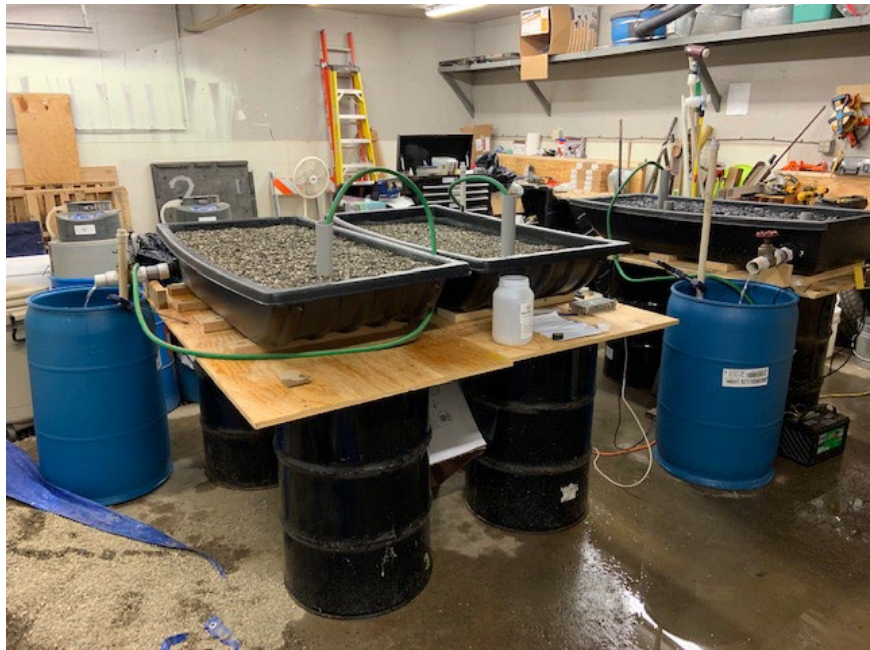
Figure 10. Three filter sleds recirculating P solution

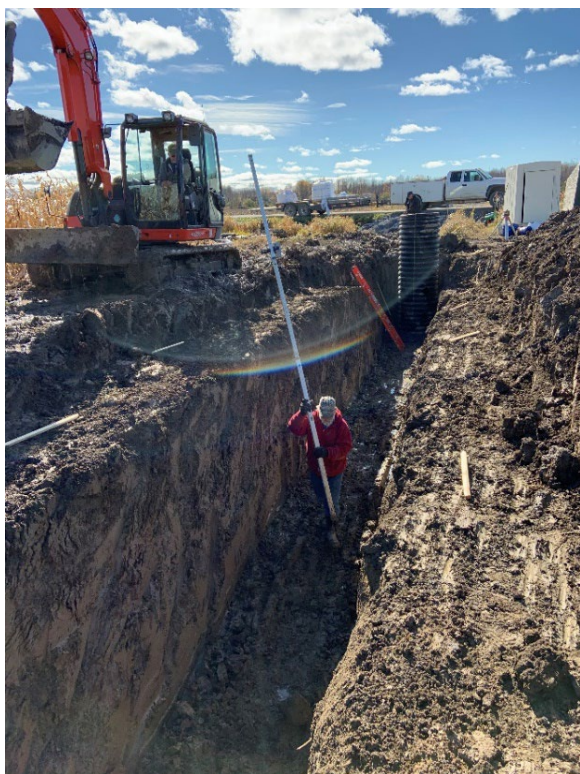
Figure 12. Excavating trench for Filter B

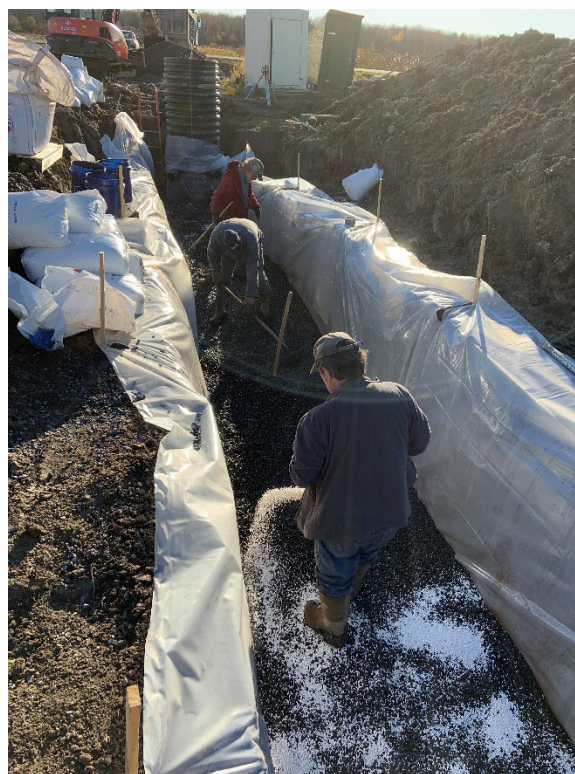
Figure 13. Spreading and raking in activated alumina and iron

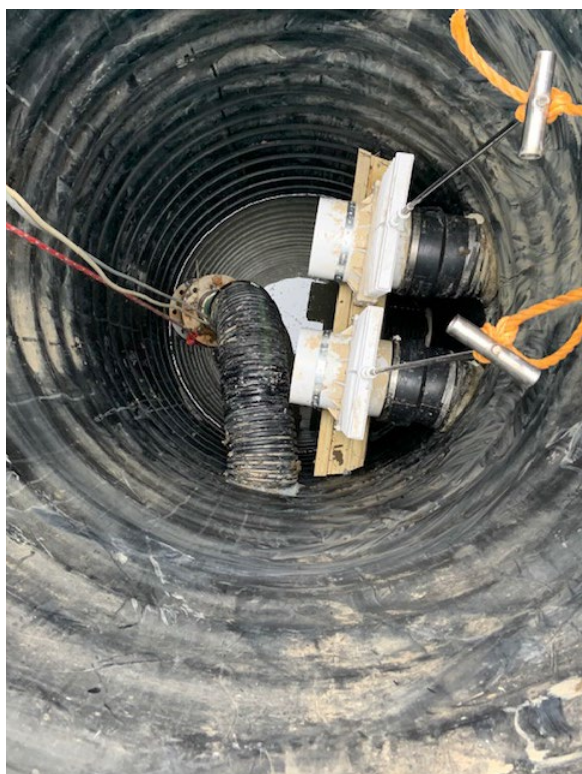
Figure 14. View down filter outlet manhole

Drainage water flows out the perforations in the distribution pipes, up through the media bed, and into the collection pipes, which discharge to a monitoring manhole at the end of the filter (Figure 14). Treated water then flows from the monitoring manhole through a pipe to the receiving ditch. Both filter outlets and the bypass pipe from the JBT05 manhole are typically submerged in the receiving ditch.

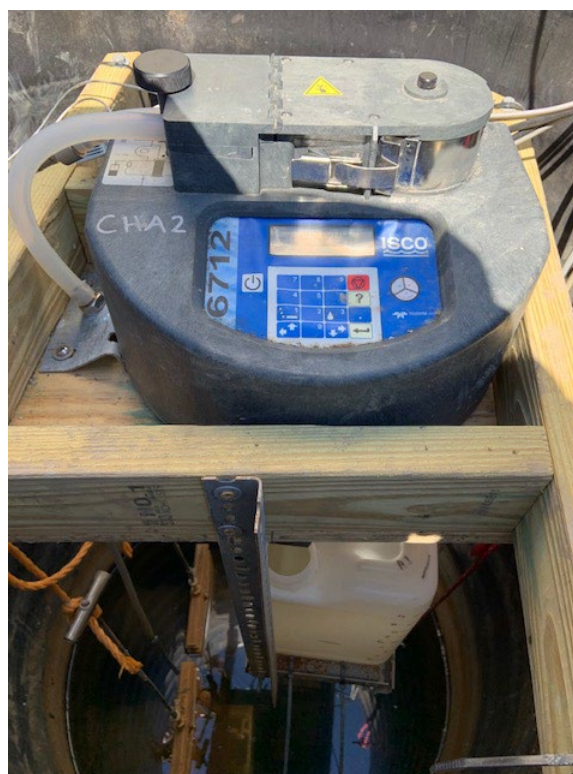
Figure 15. Custom autosampler rack in monitoring manhole
