2021 Lake Champlain STATE of the LAKE and Ecosystem Indicators Report

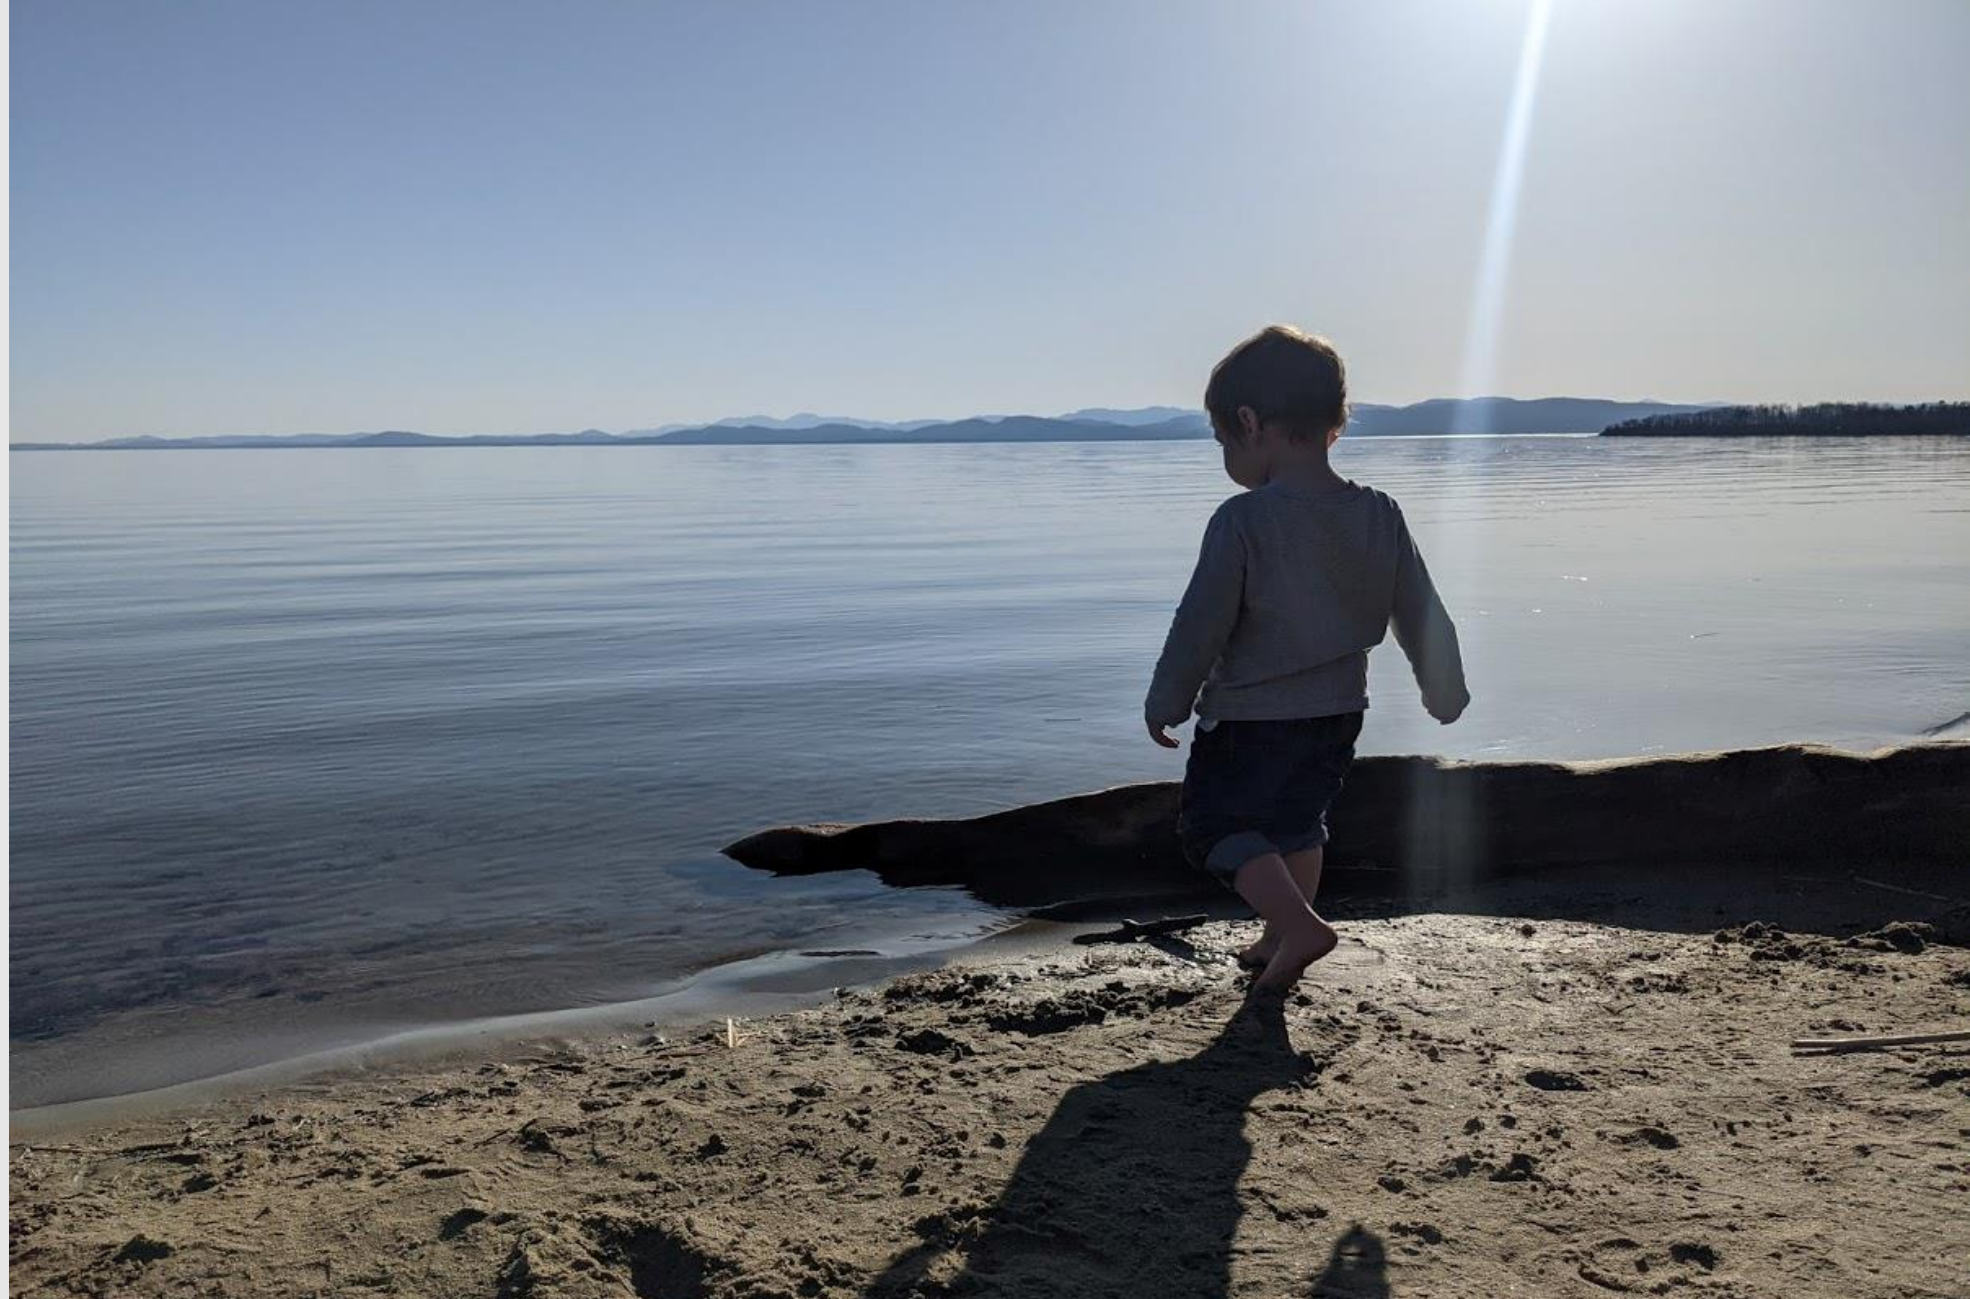
Figure 2.

Reported public
beach closures on
Lake Champlain
Page 8

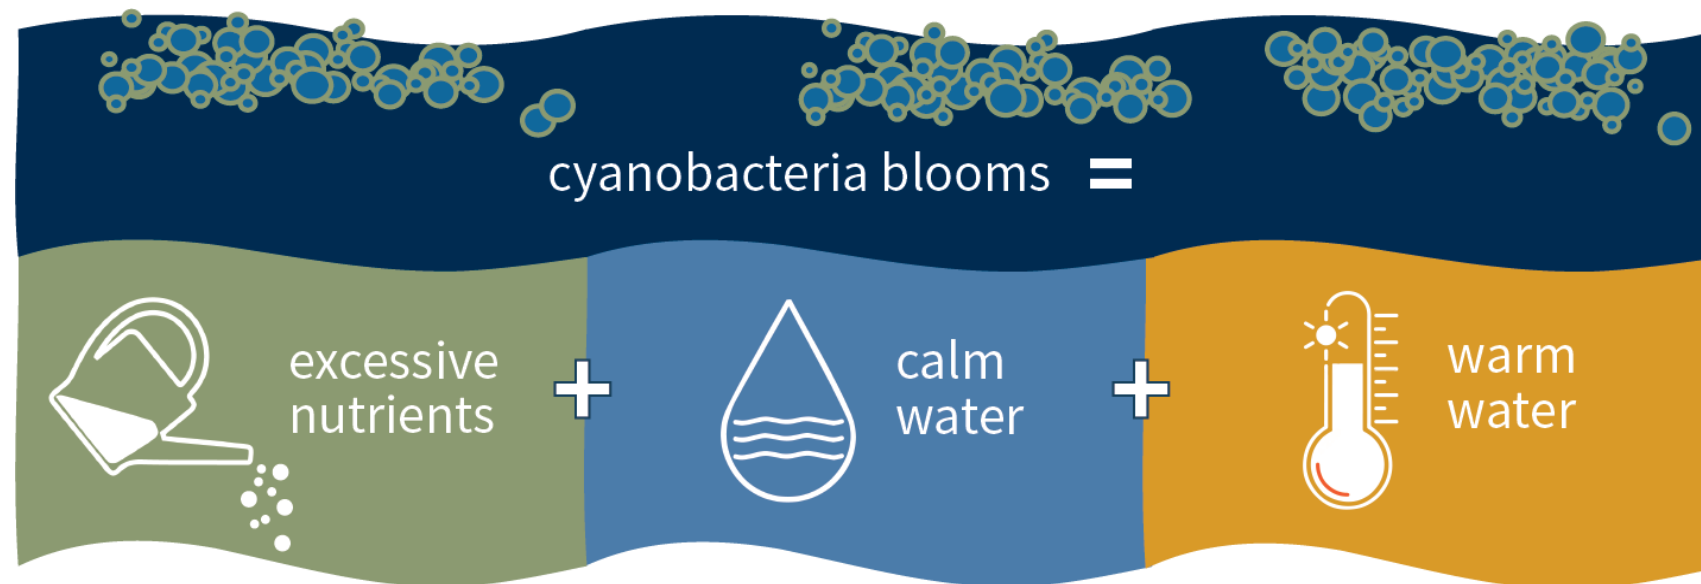
Figure 4.

Cyanobacteria
monitoring on
Lake Champlain
Page 11

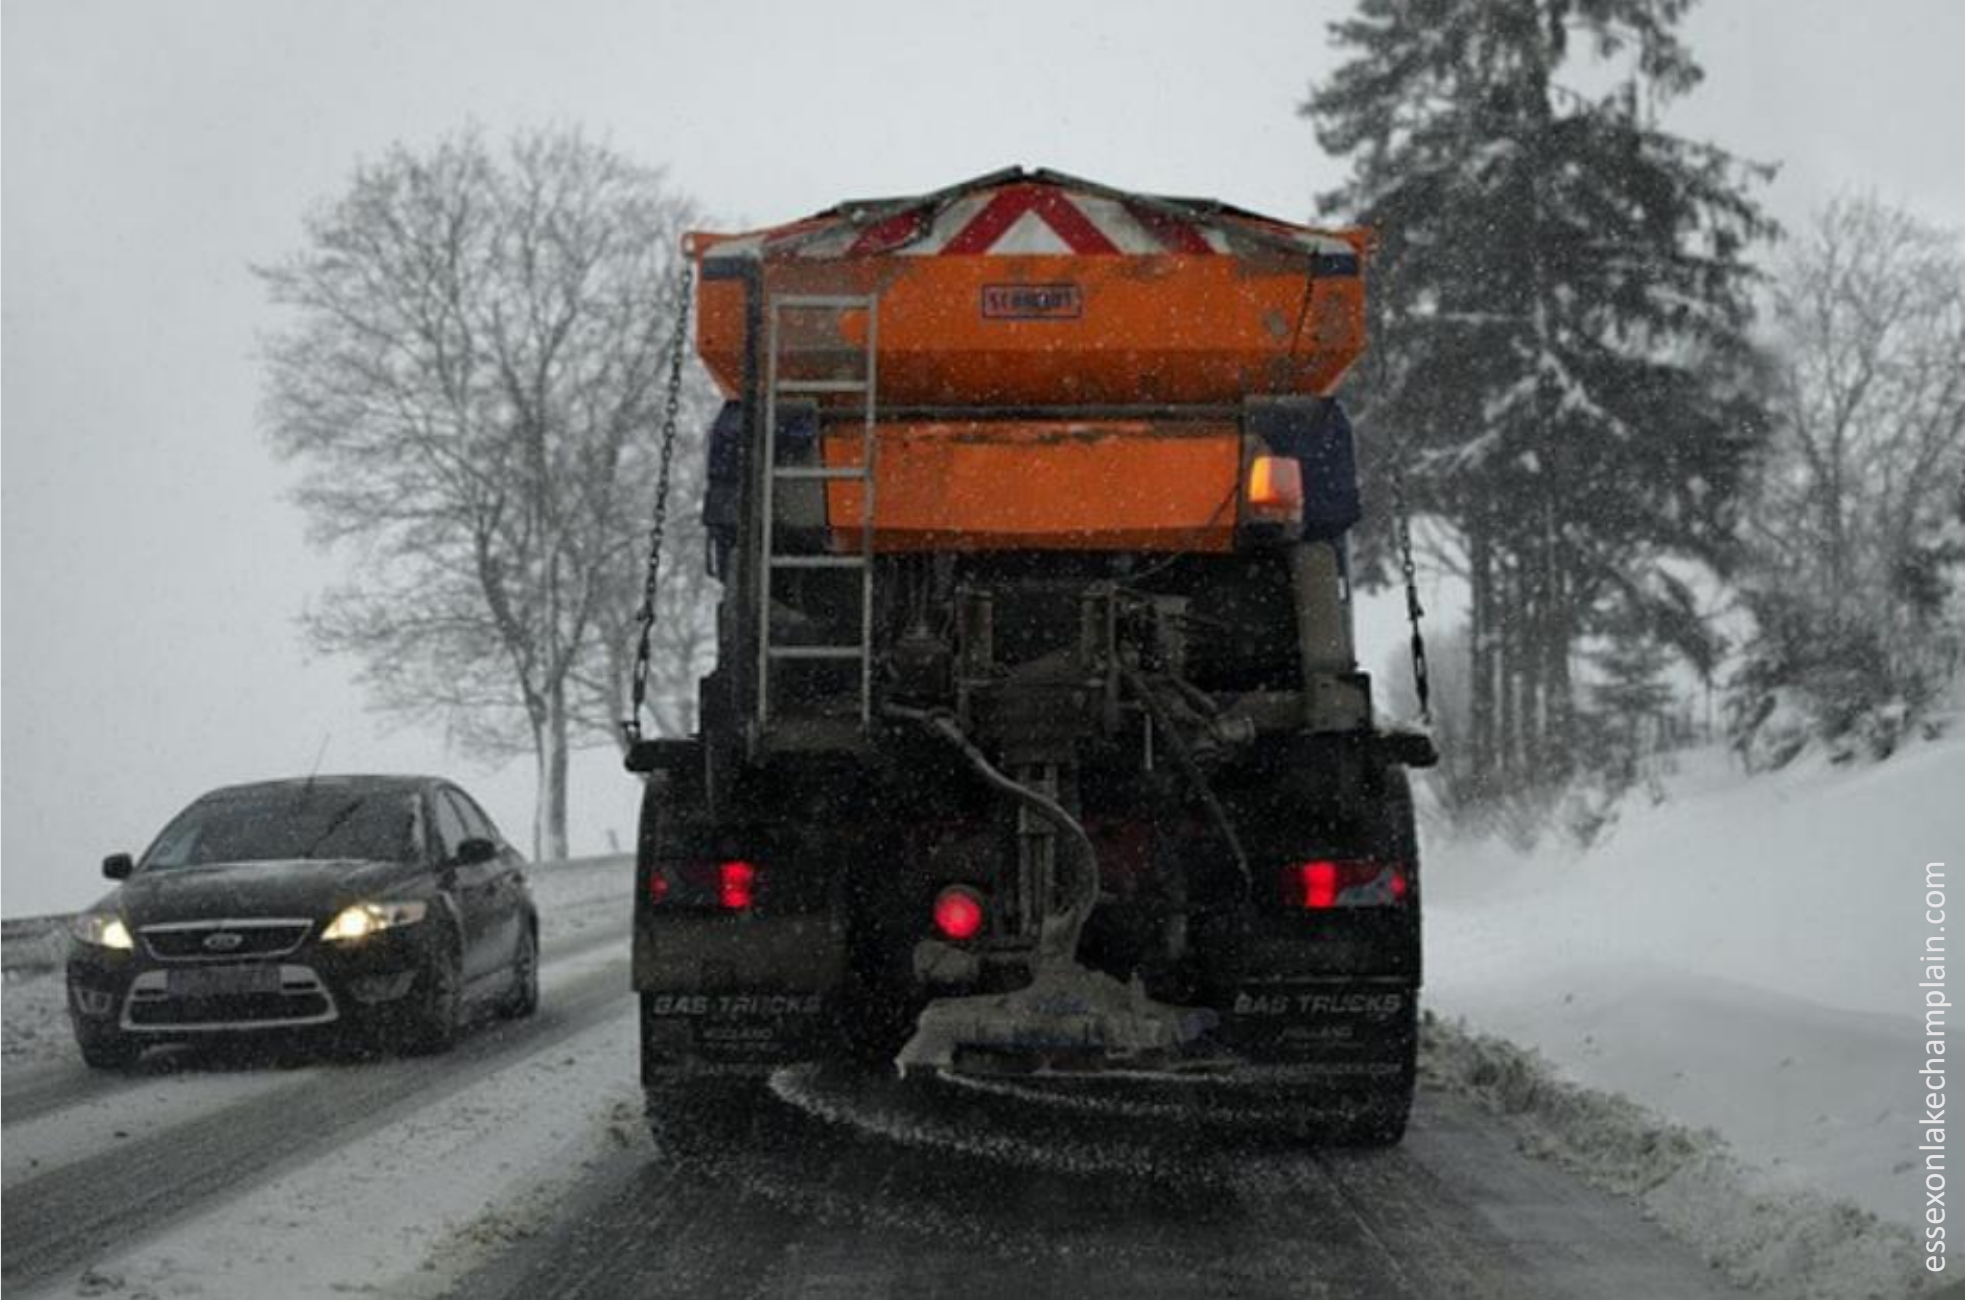
Figure 10.

Annual average
chloride concentration
in Lake Champlain

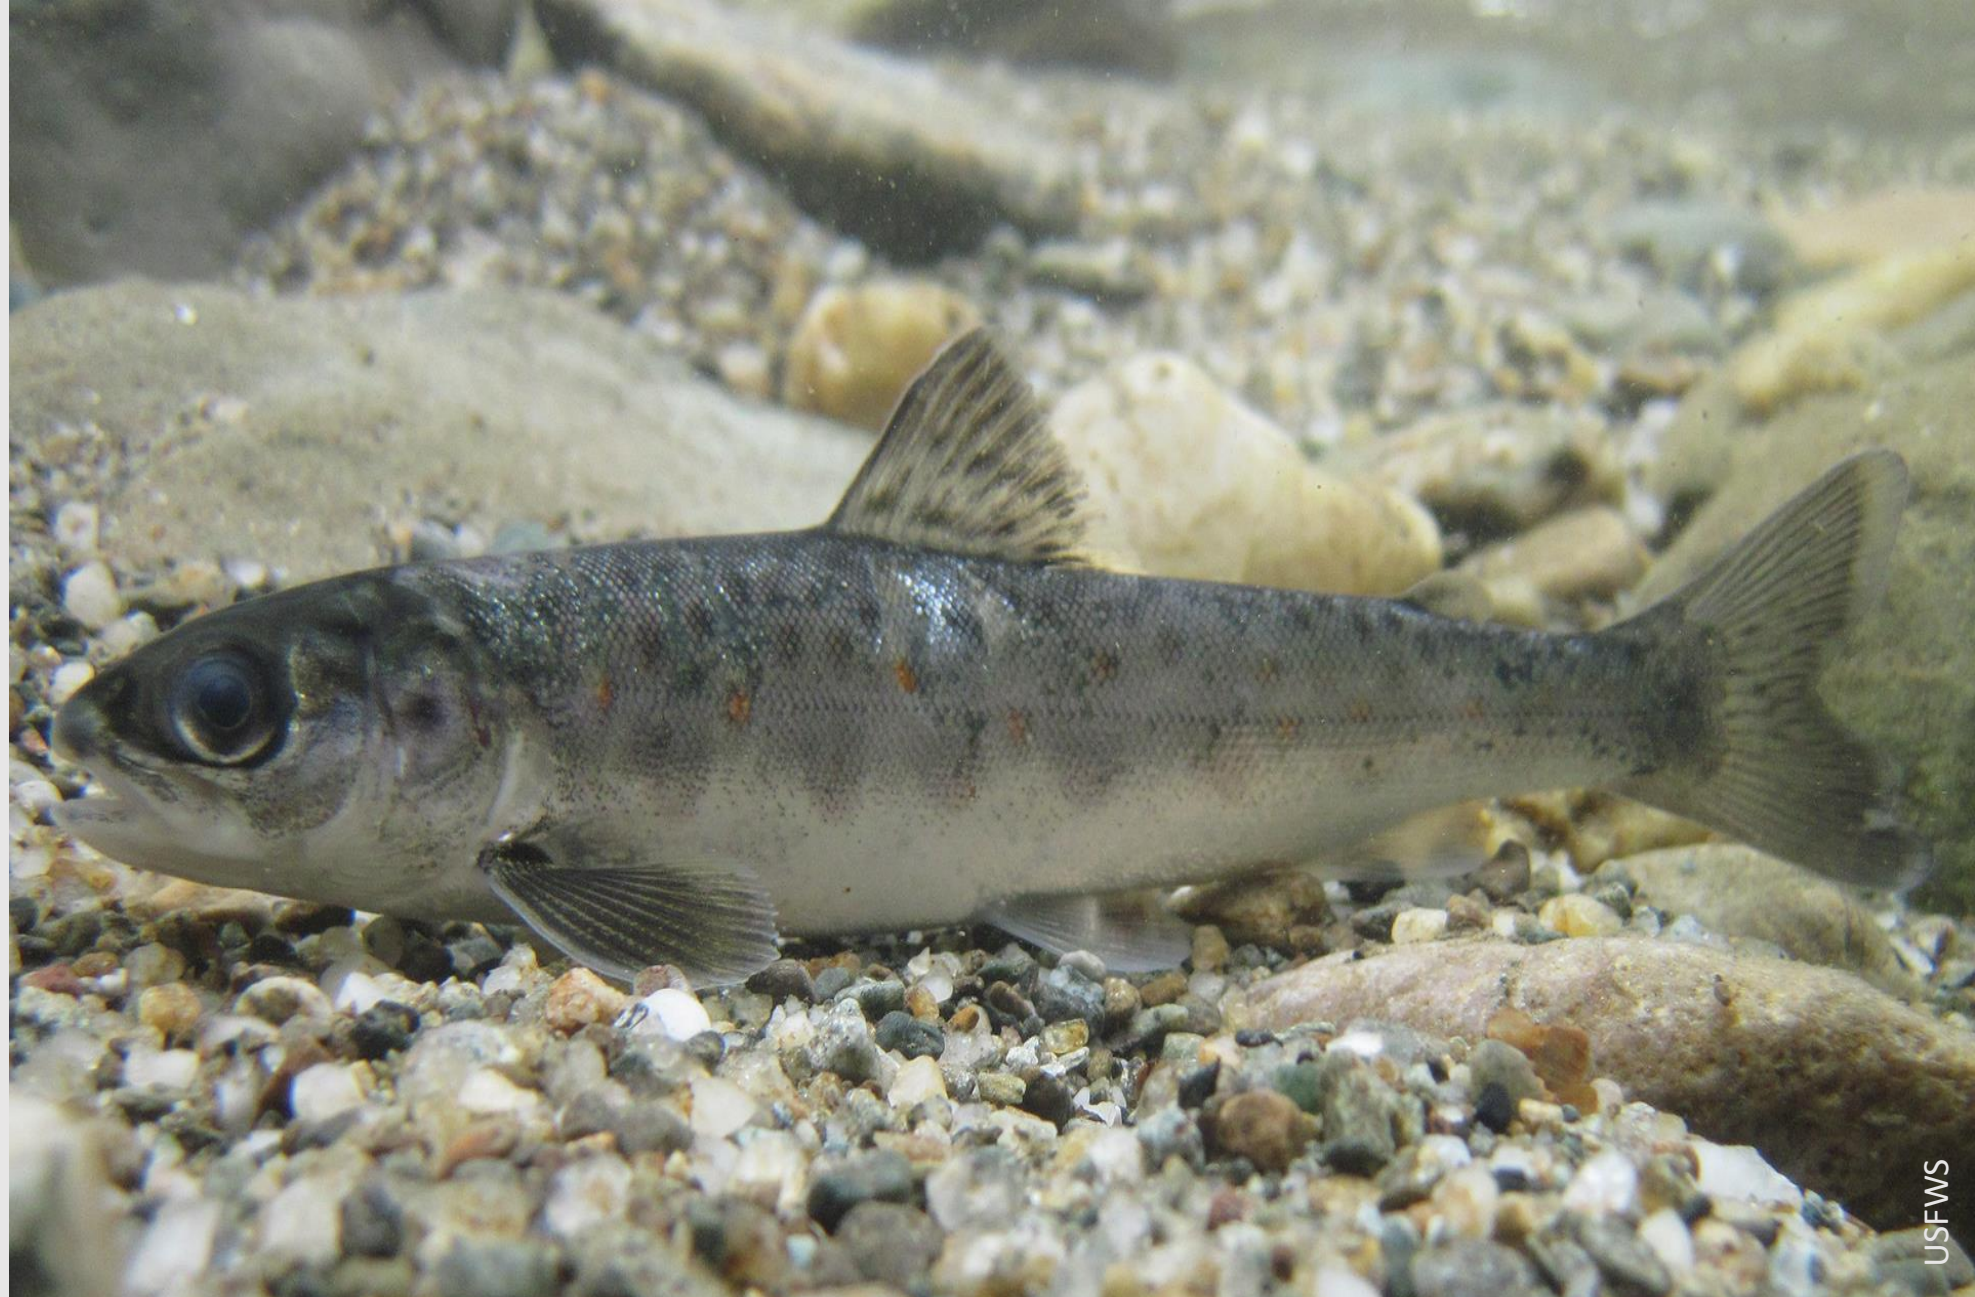
Figure 11.

- Accessible historic range
- Inaccessible historic range
- Not historic range
- Natural barrier/falls
- Dam
- Removed dam

Landlocked Atlantic salmon habitat access in Lake Champlain tributaries

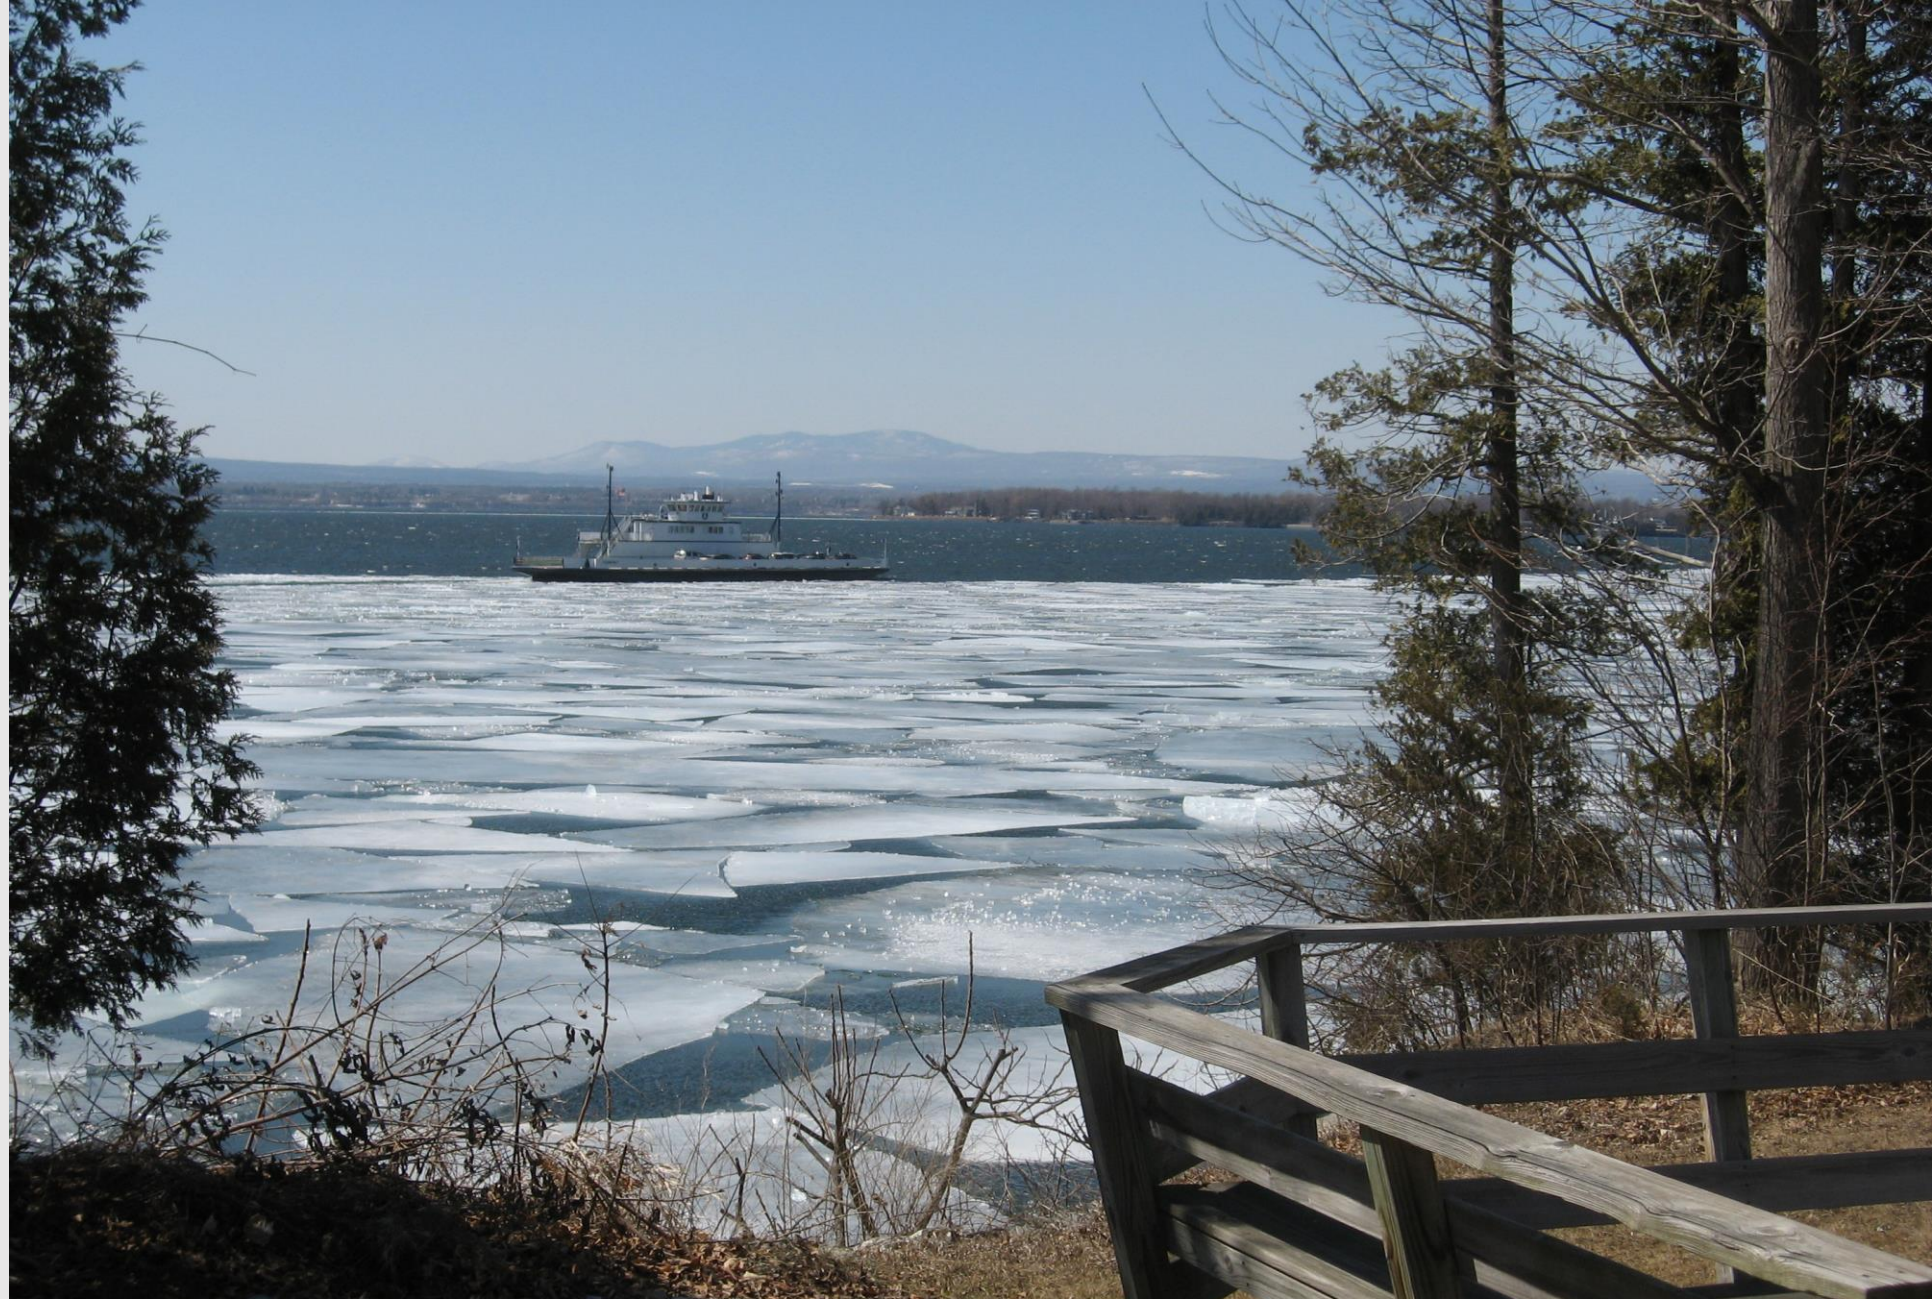
Figure 13.

Surface freeze-over
of Lake Champlain
Page 21

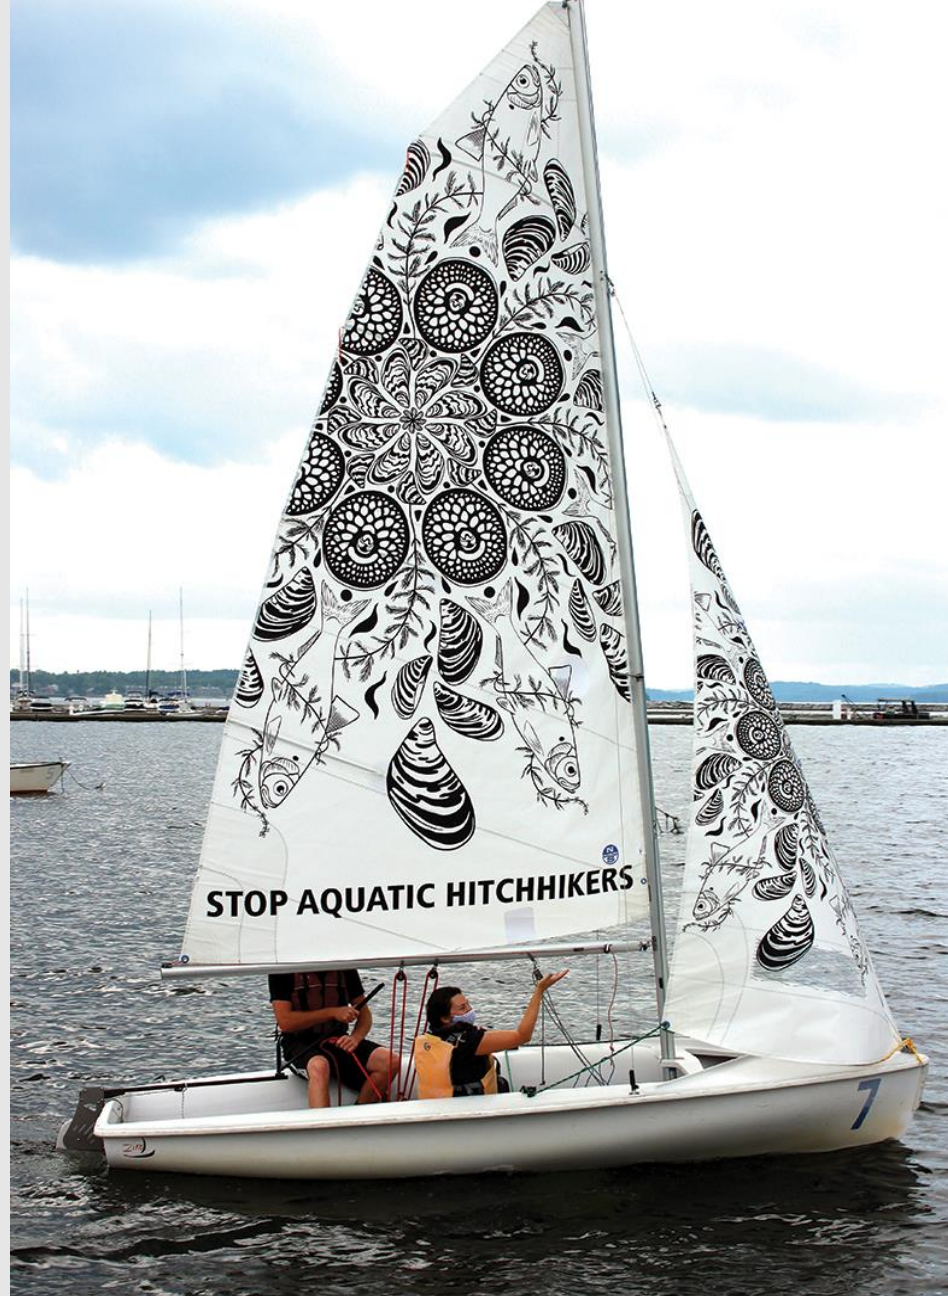
Figure 15.

First detection of
aquatic non-native
and invasive species
in Lake Champlain

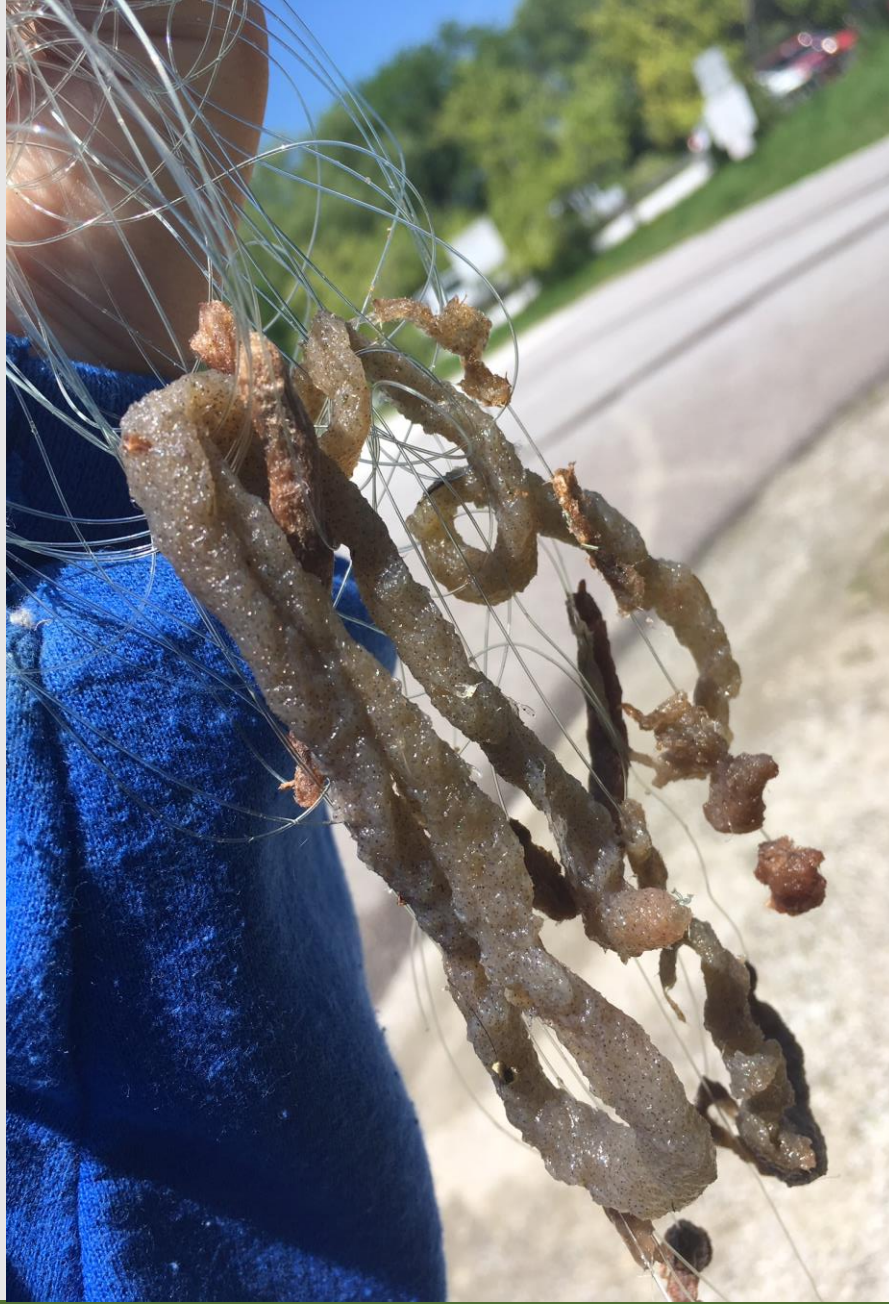
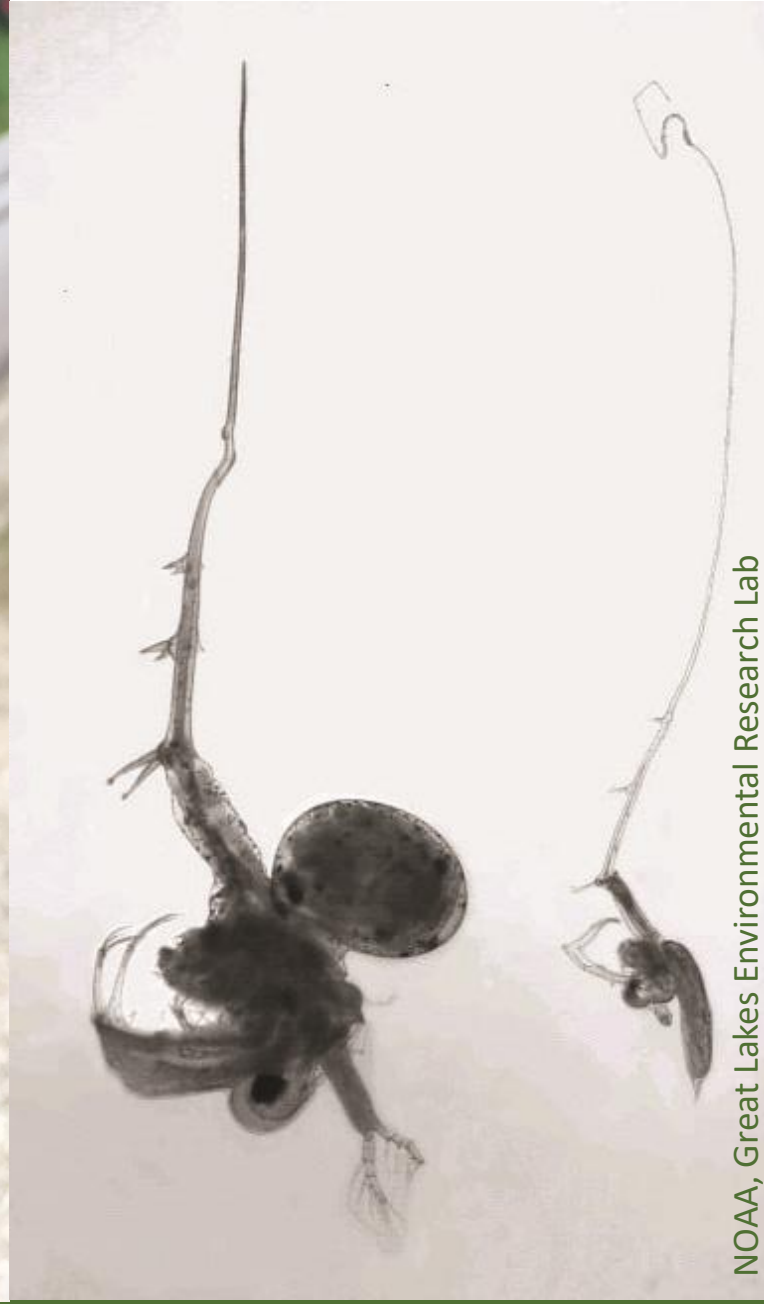
Figure 16.

Non-native species threats to Lake Champlain Basin from connected waterways

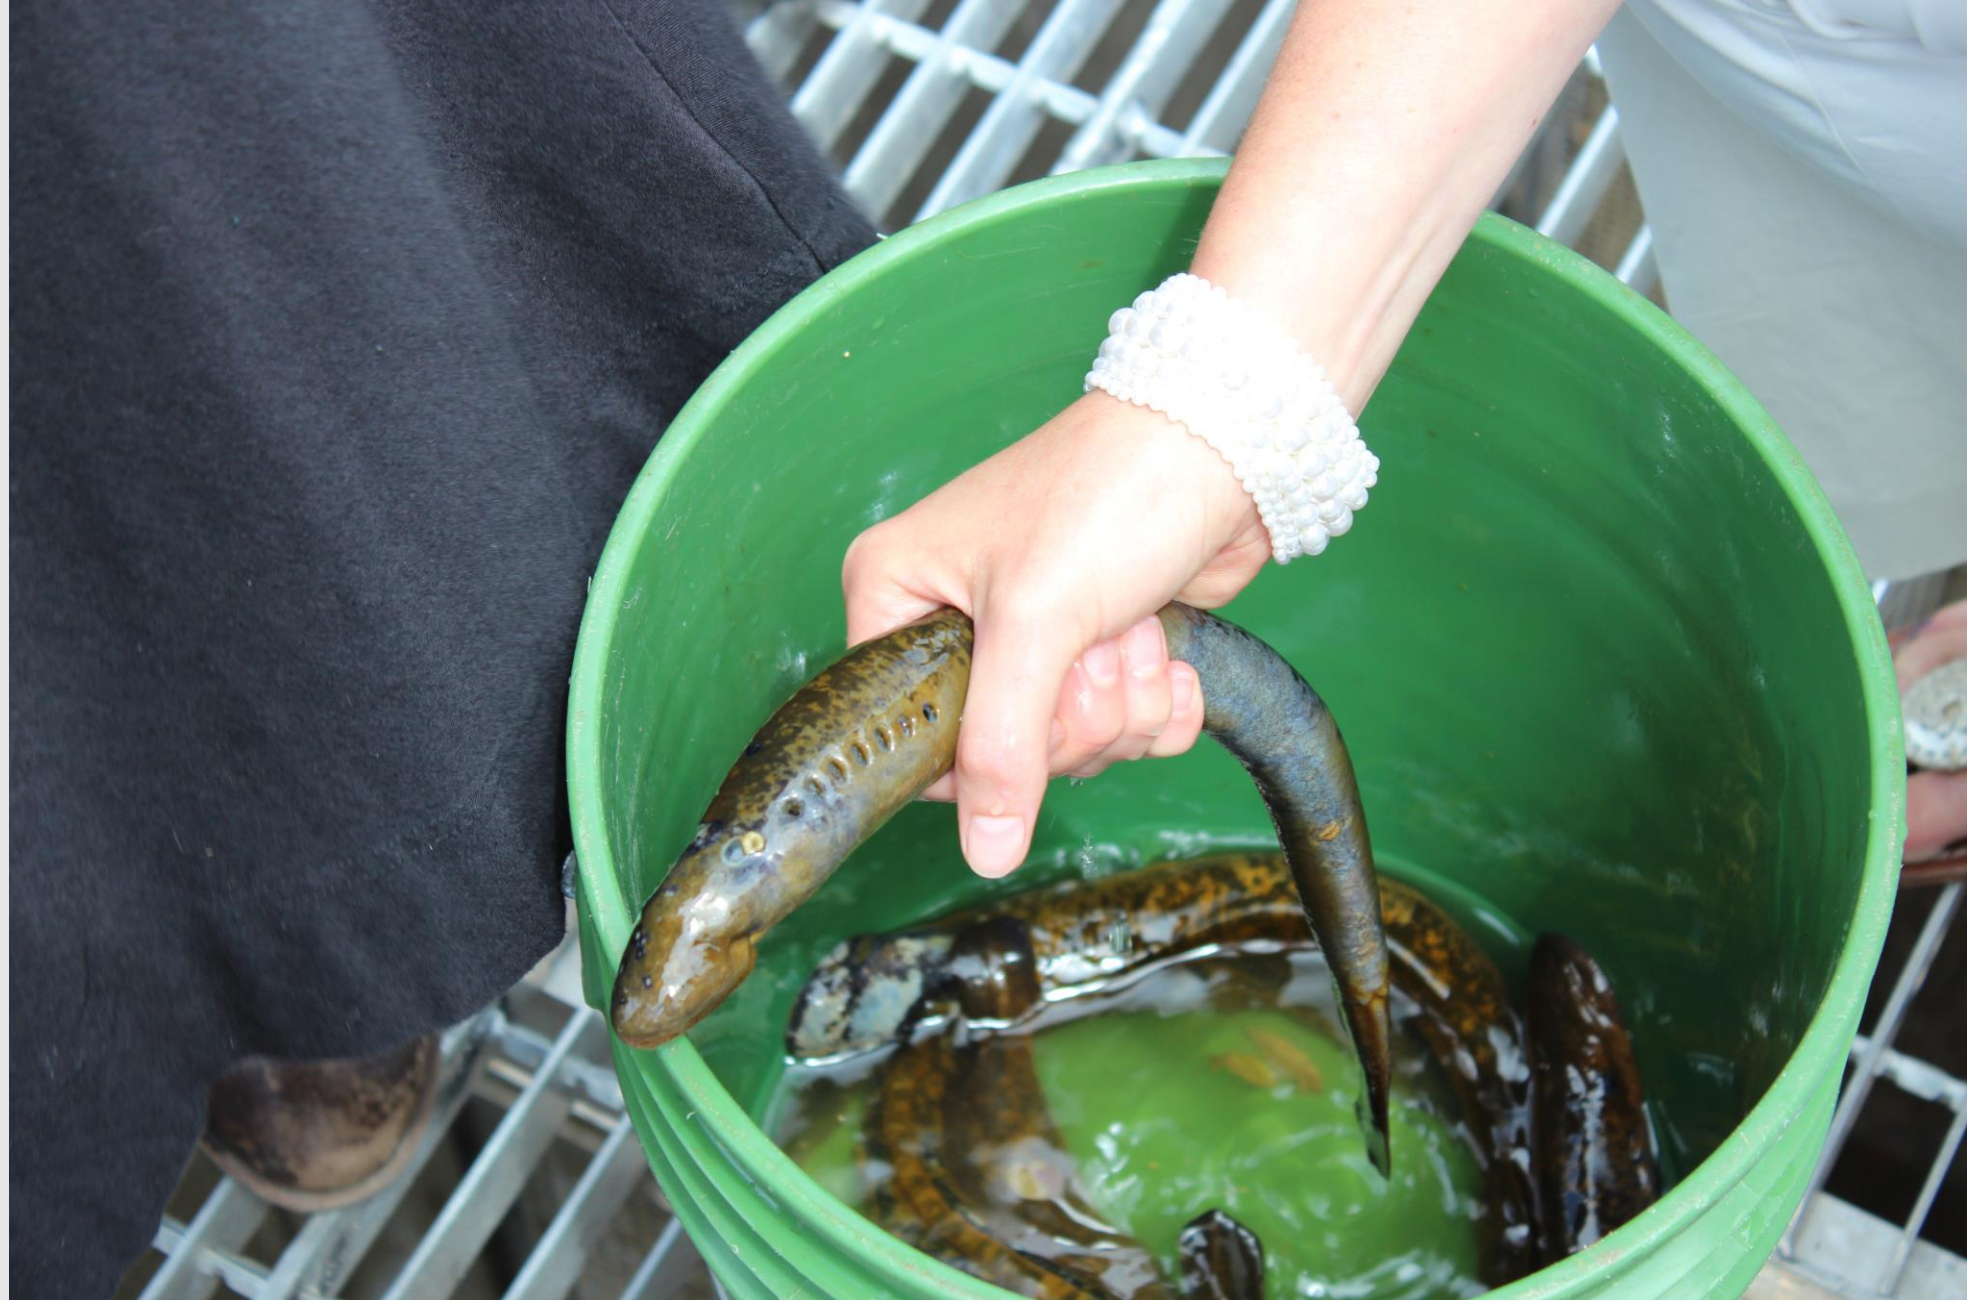
Figure 17.
Annual sea lamprey
wounding rate in
Lake Champlain
Page 24

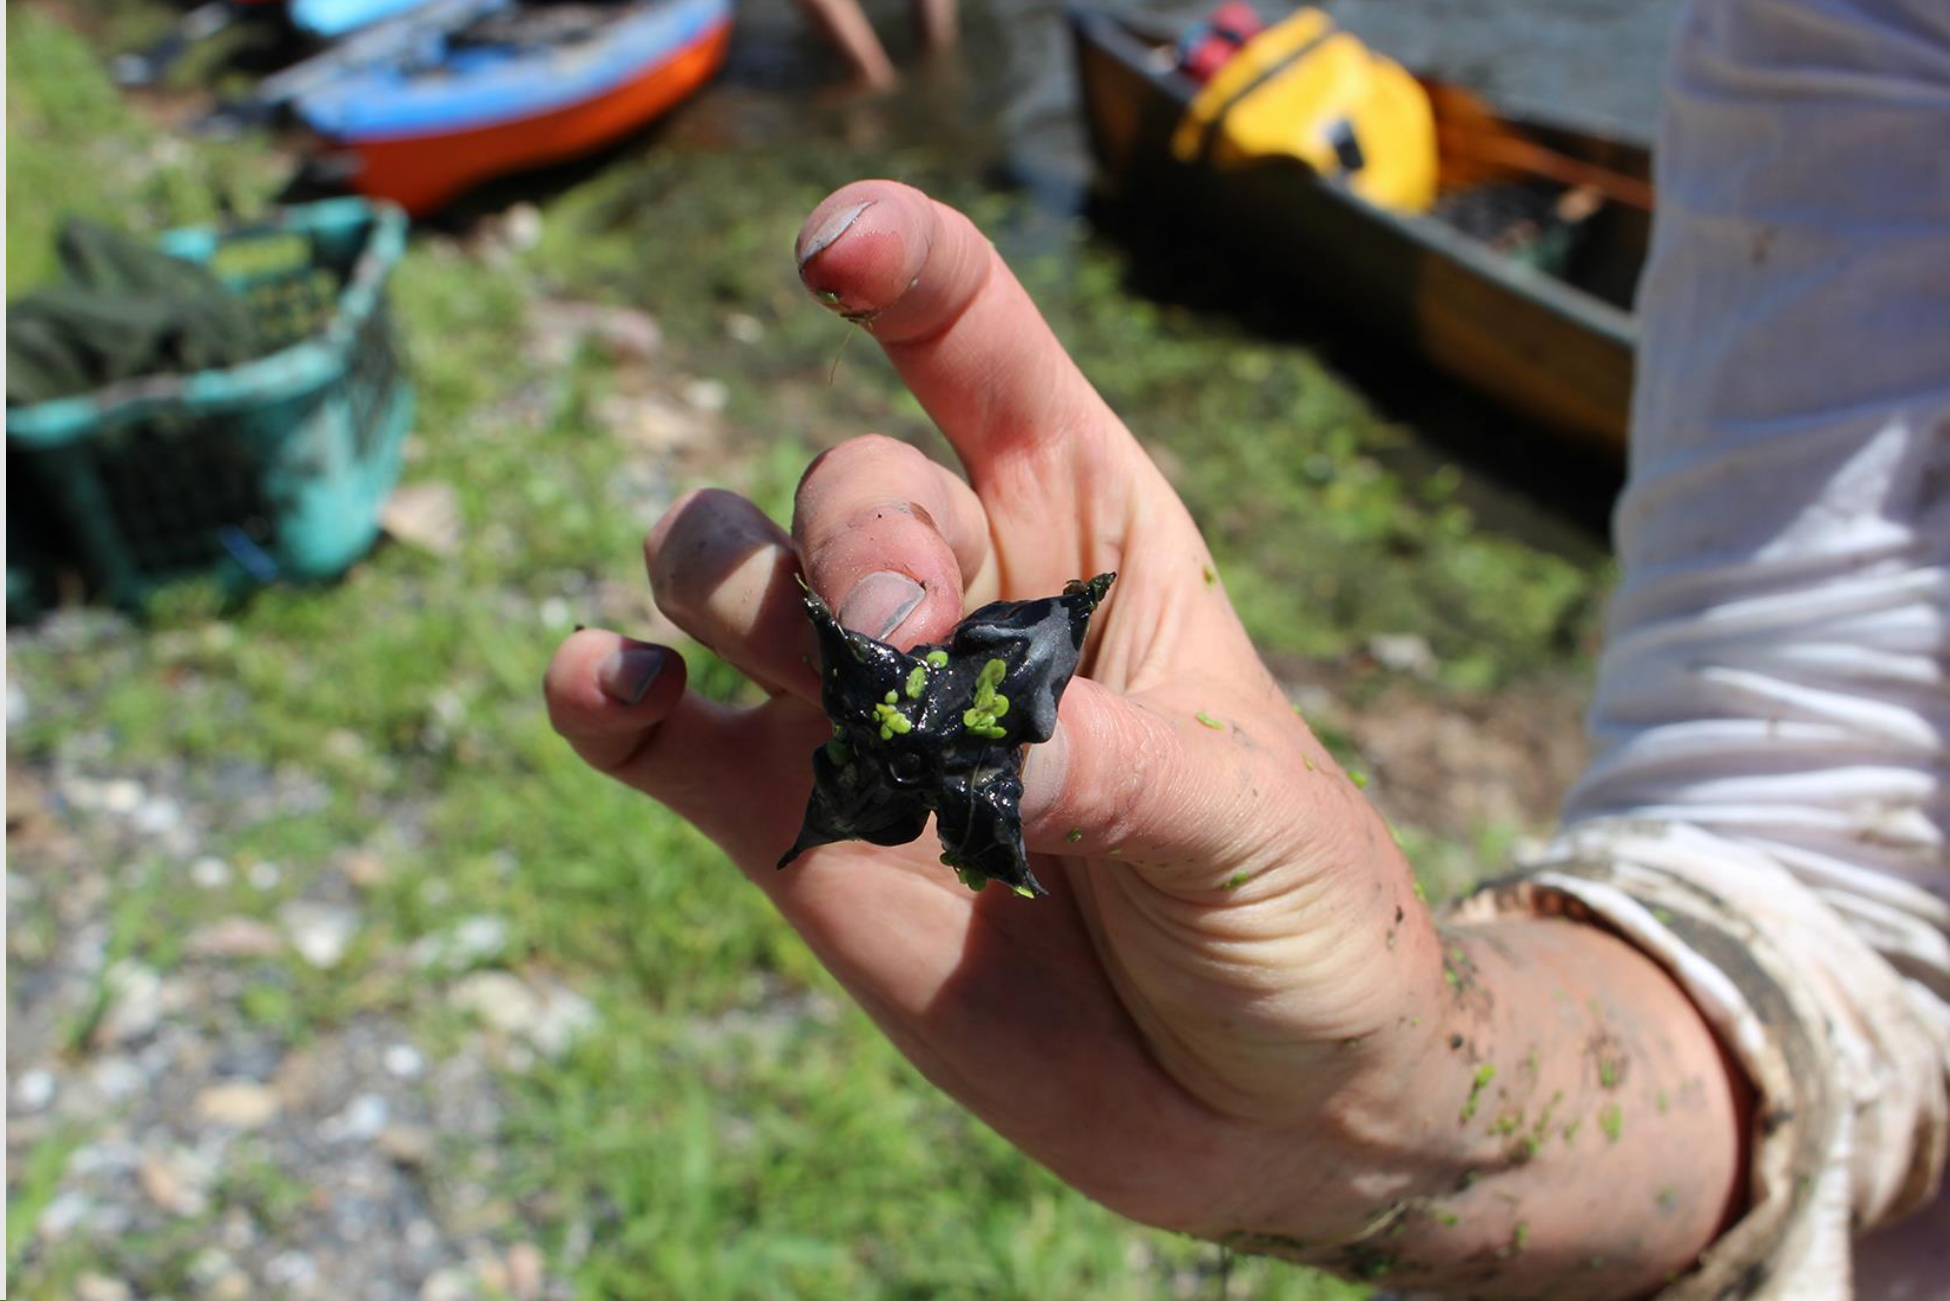
Figure 19.

Water chestnut coverage in Lake Champlain
Page 26
