Lake Champlain Basin Program Training Webinar

Lake George and NYSDEC Lake George Beach Day-Use Facility

June 29, 2017

Presented by Thomas Baird, P.E.

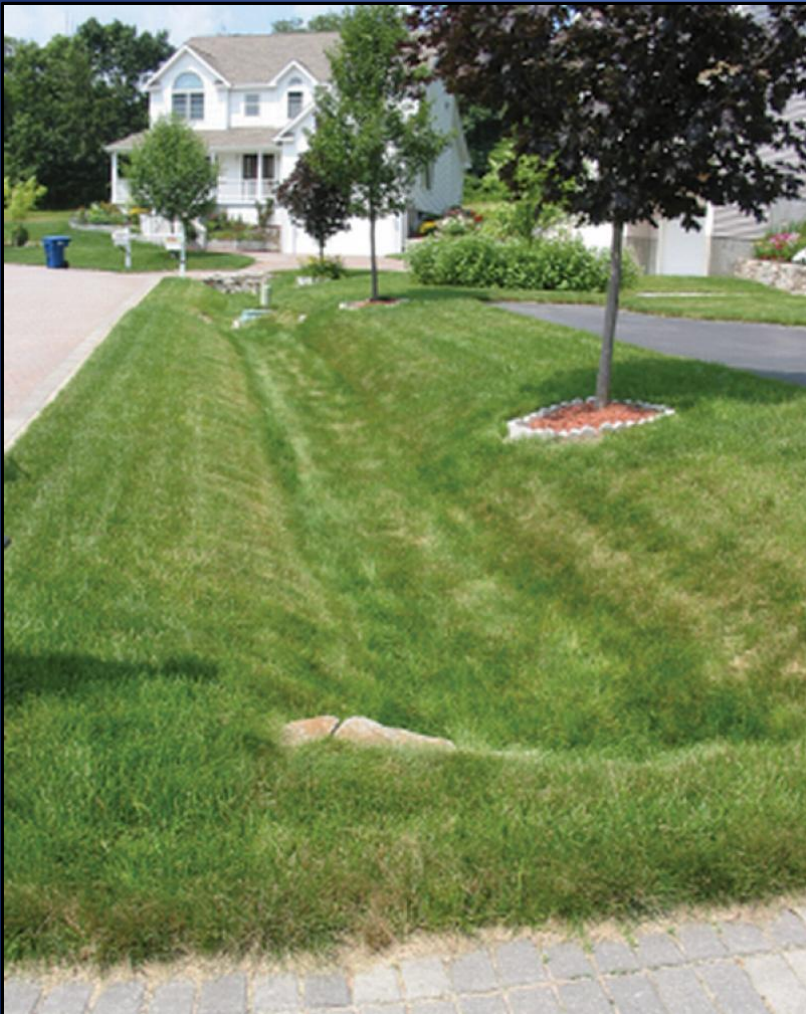
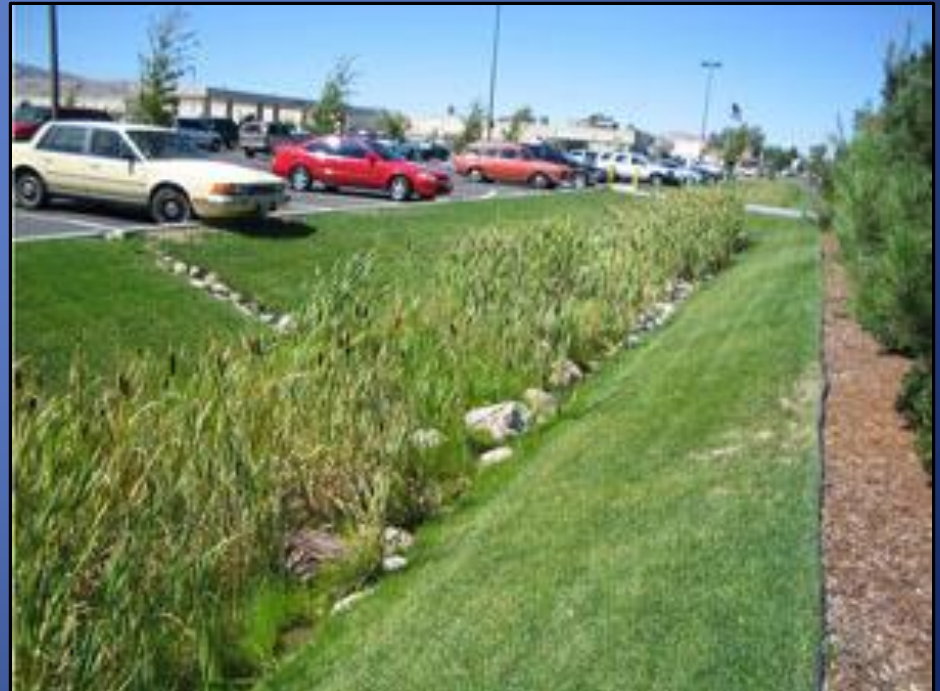
Vegetated Swales

**Pre-Treatment
Helps Preserve Primary
System
Turf Lined or Planted**

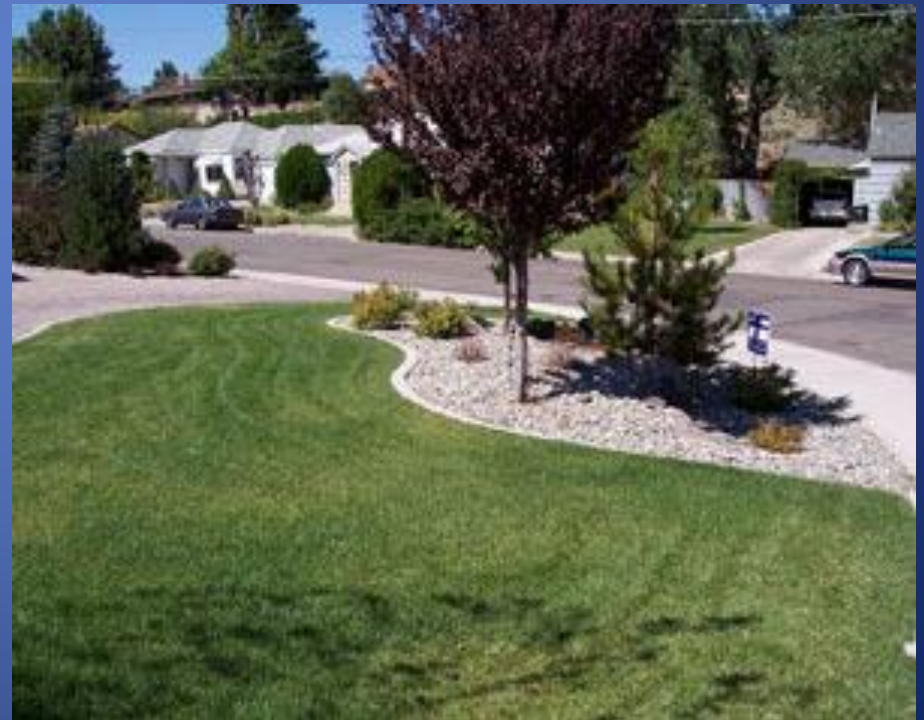
Rain Gardens

Provide Filtration
Reduce Runoff Volumes
Aesthetically Pleasing

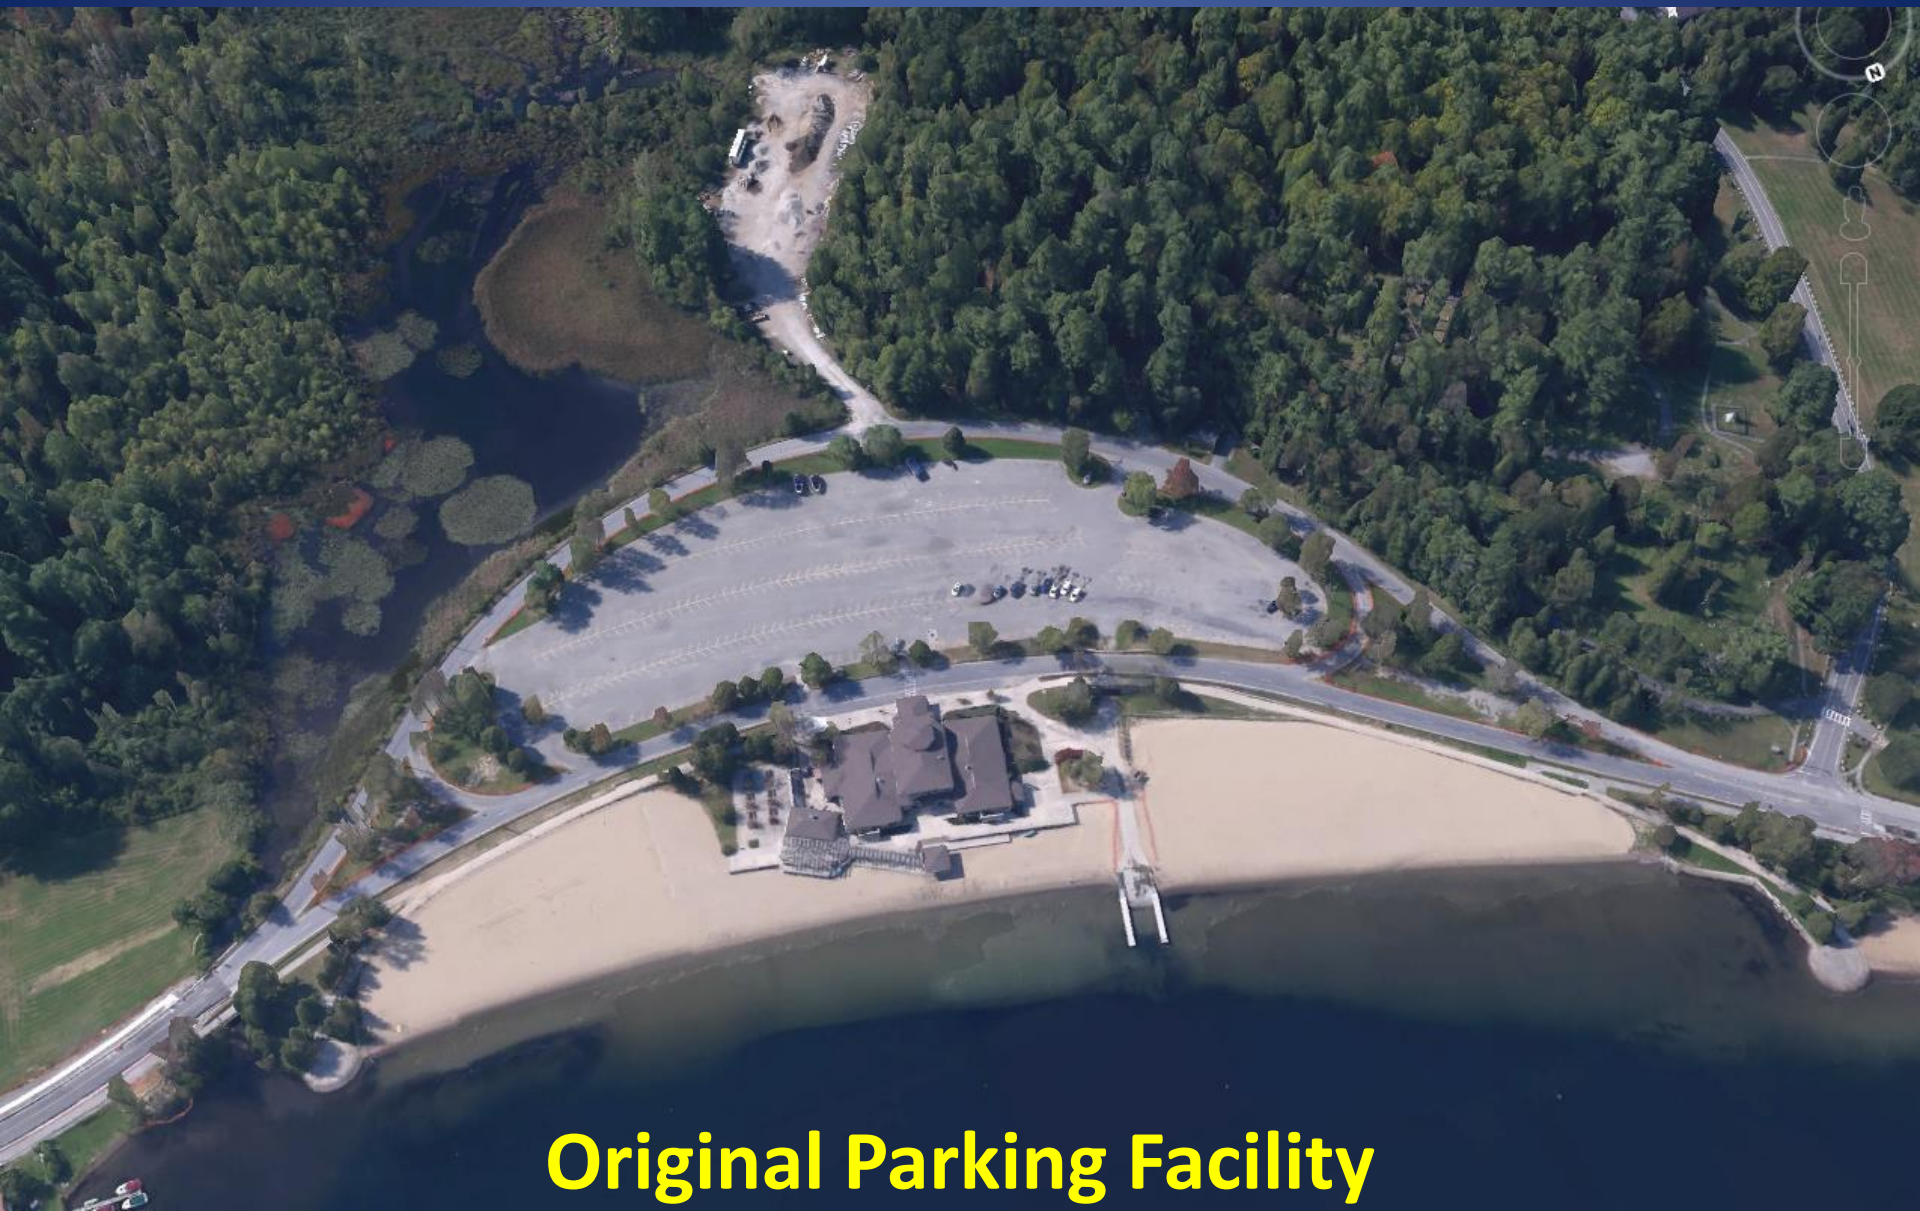
Original Parking Facility
94% Impervious

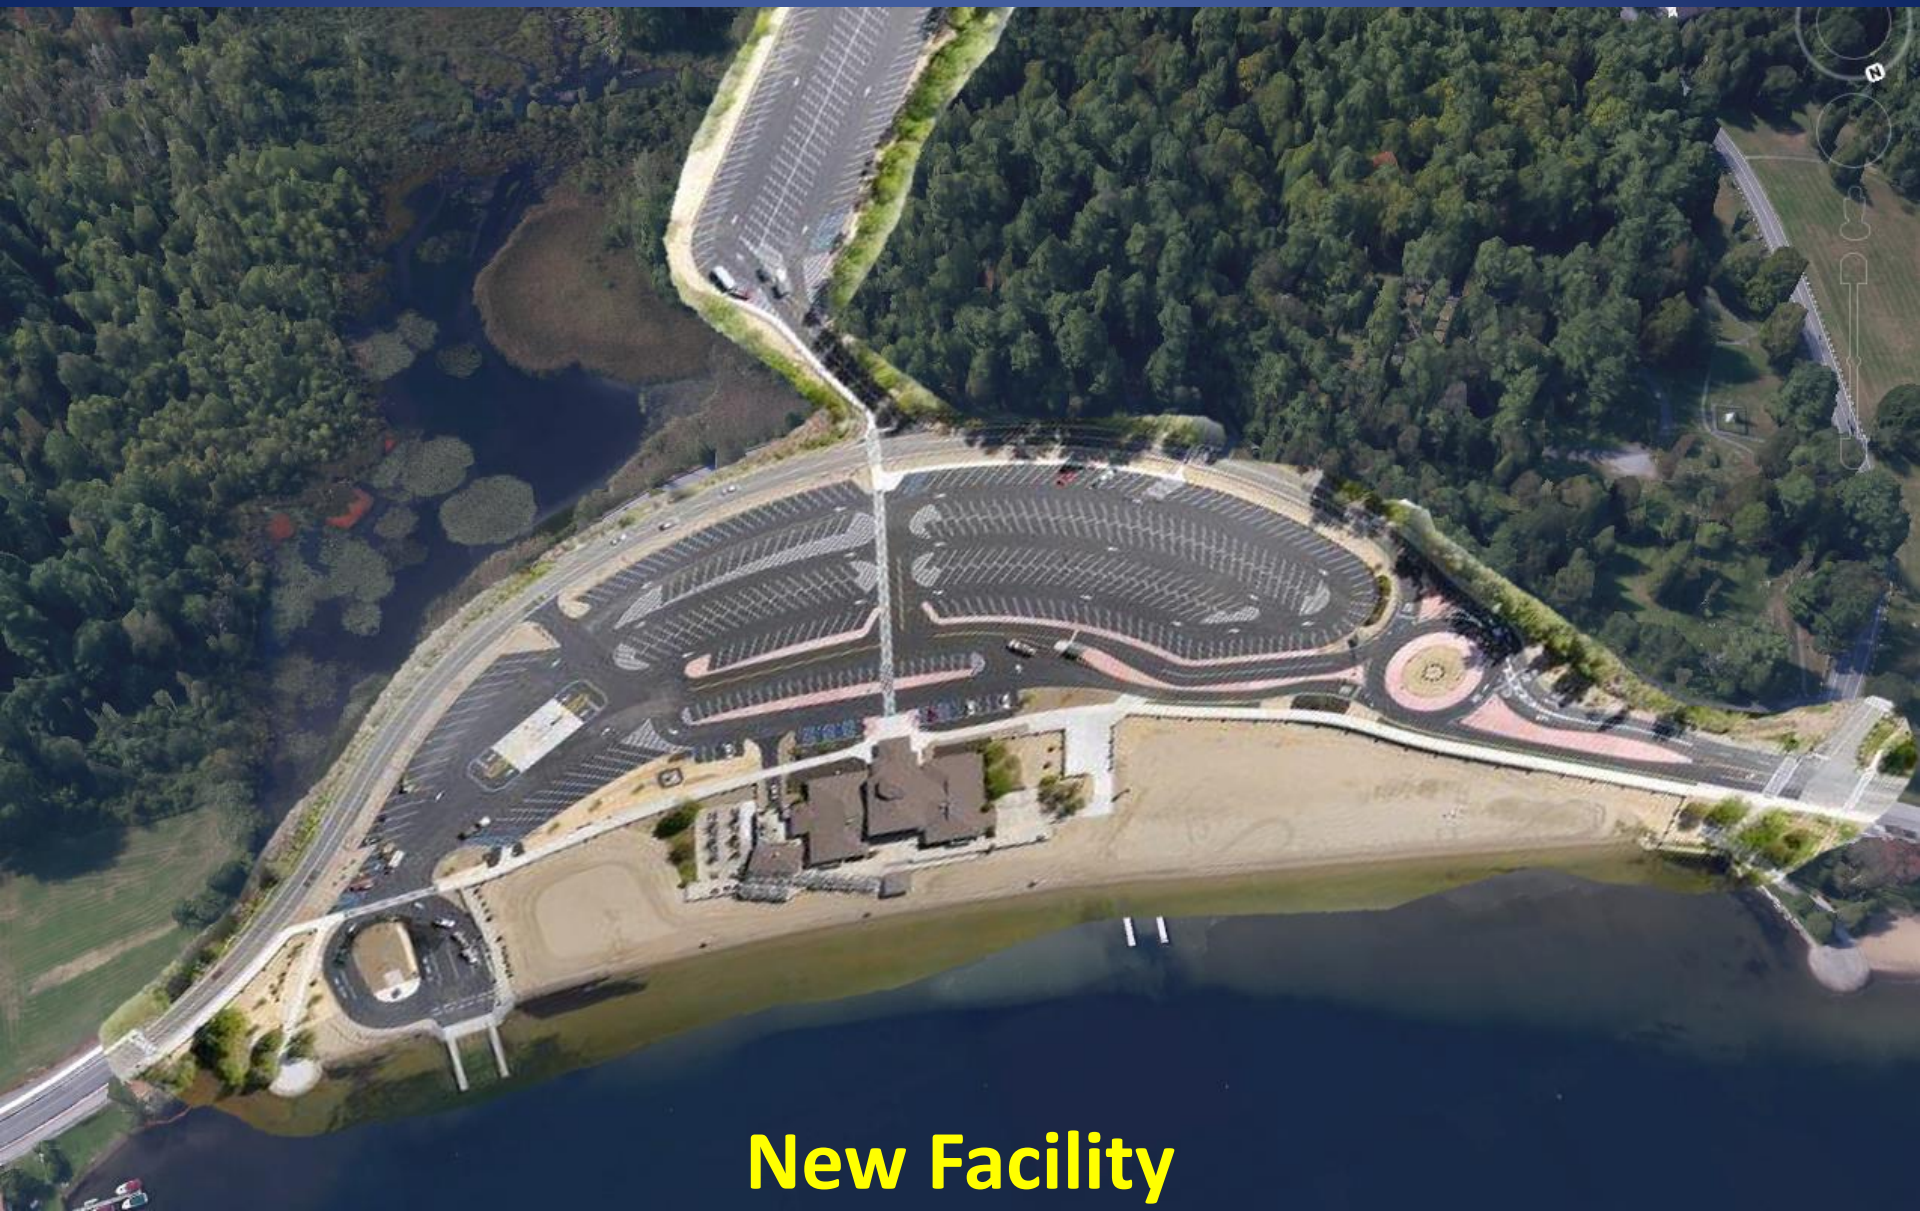
New Facility
50% Impervious

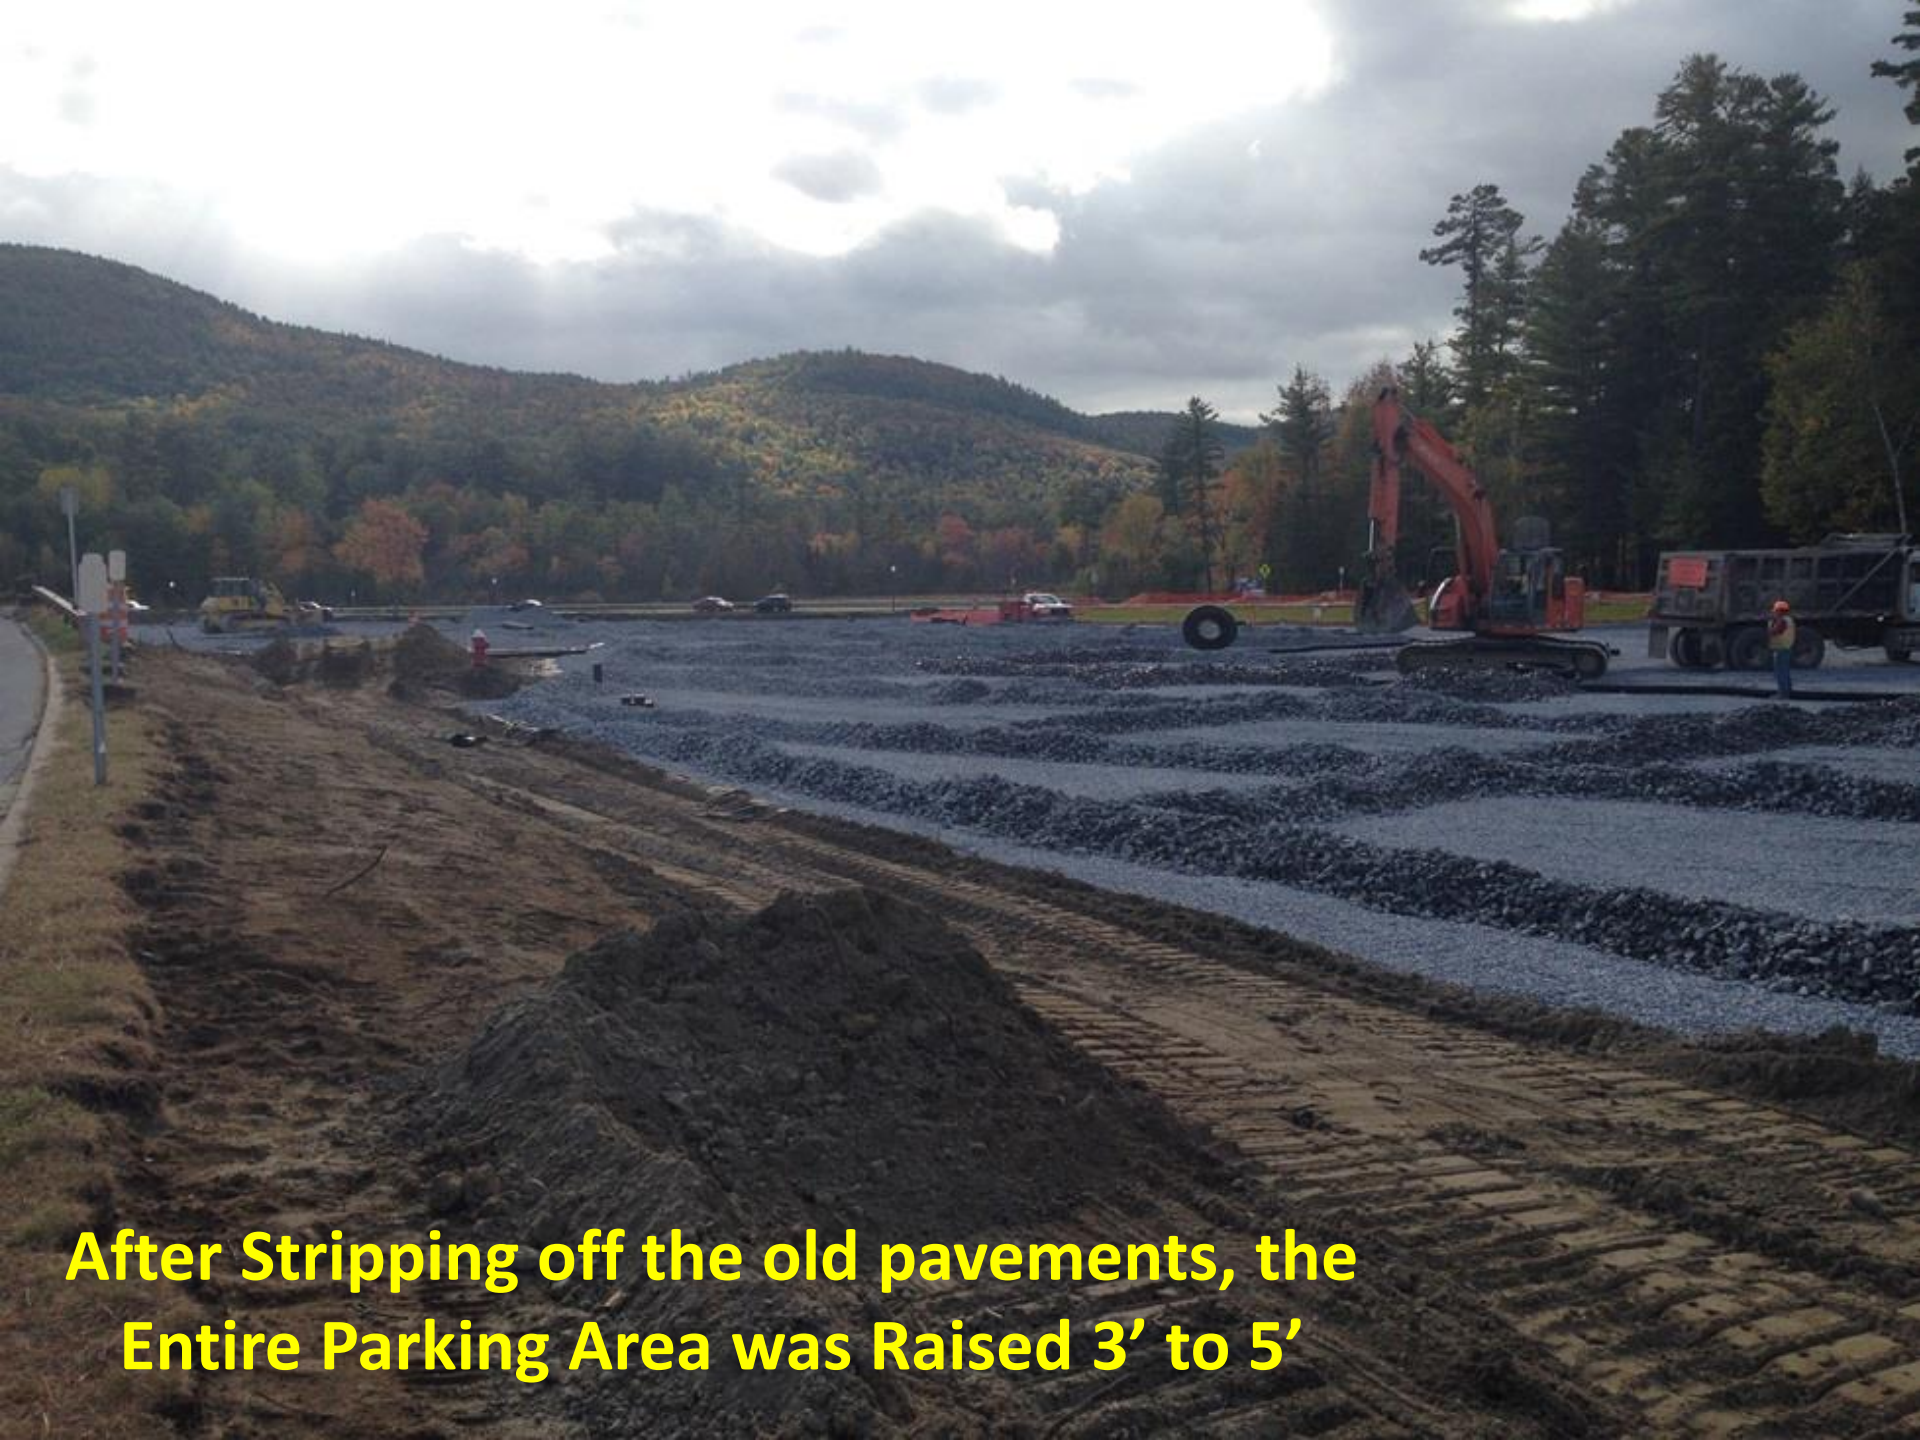
**After Stripping off the old pavements, the
Entire Parking Area was Raised 3' to 5'**

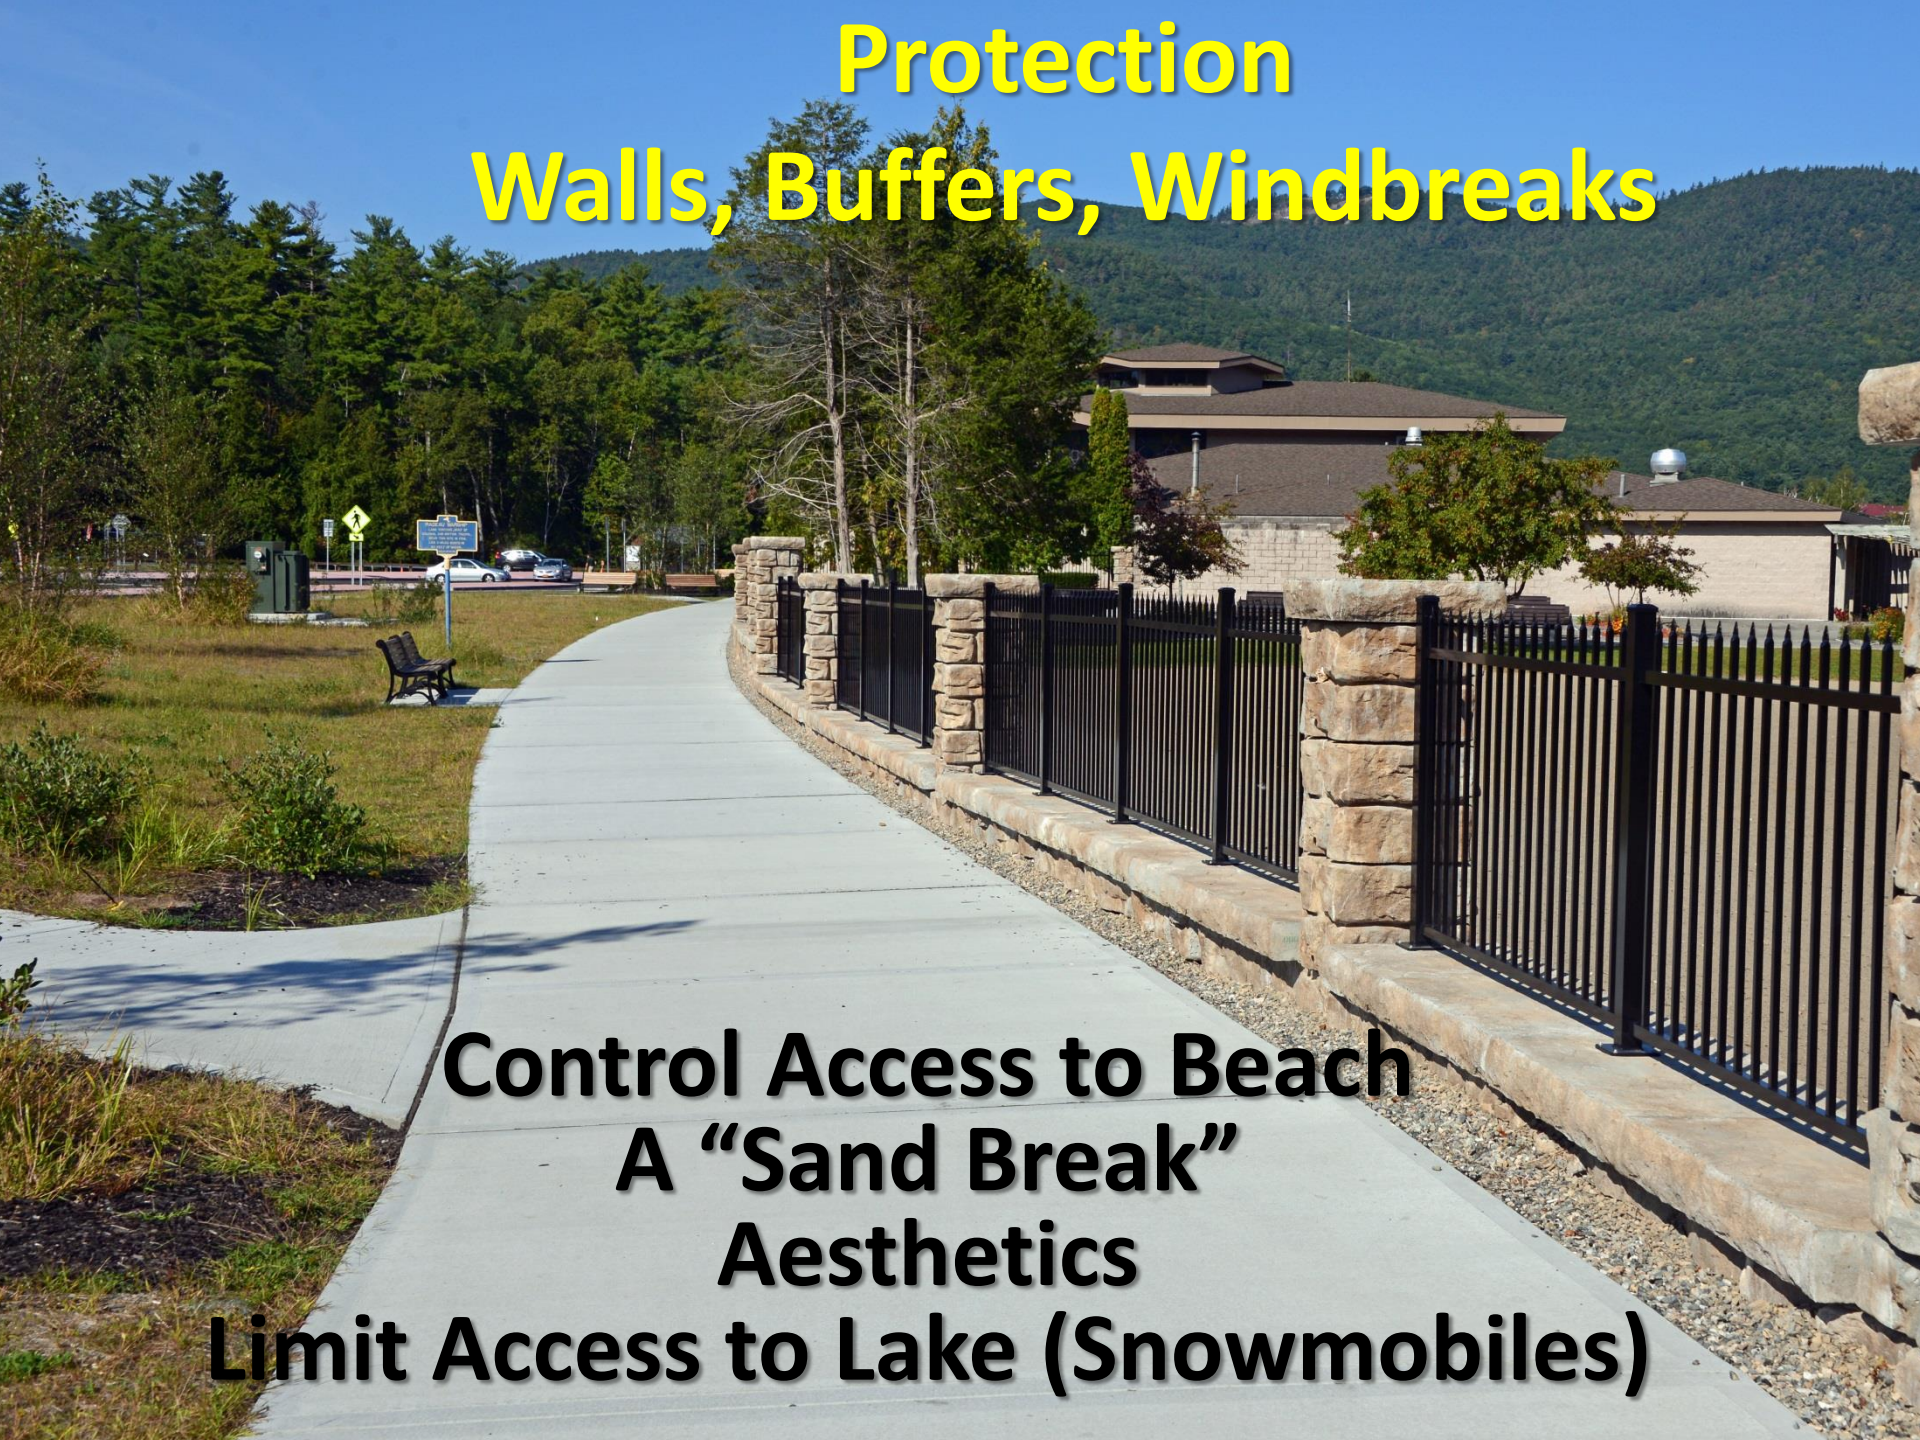
A photograph showing a concrete walkway that curves to the right. To the right of the walkway is a fence made of stone pillars and black metal pickets. In the background, there is a large, multi-story building with a brown roof, surrounded by trees and a forested hill under a clear blue sky. A bench is visible on the left side of the walkway.

Control Access to Beach
A “Sand Break”
Aesthetics
Limit Access to Lake (Snowmobiles)

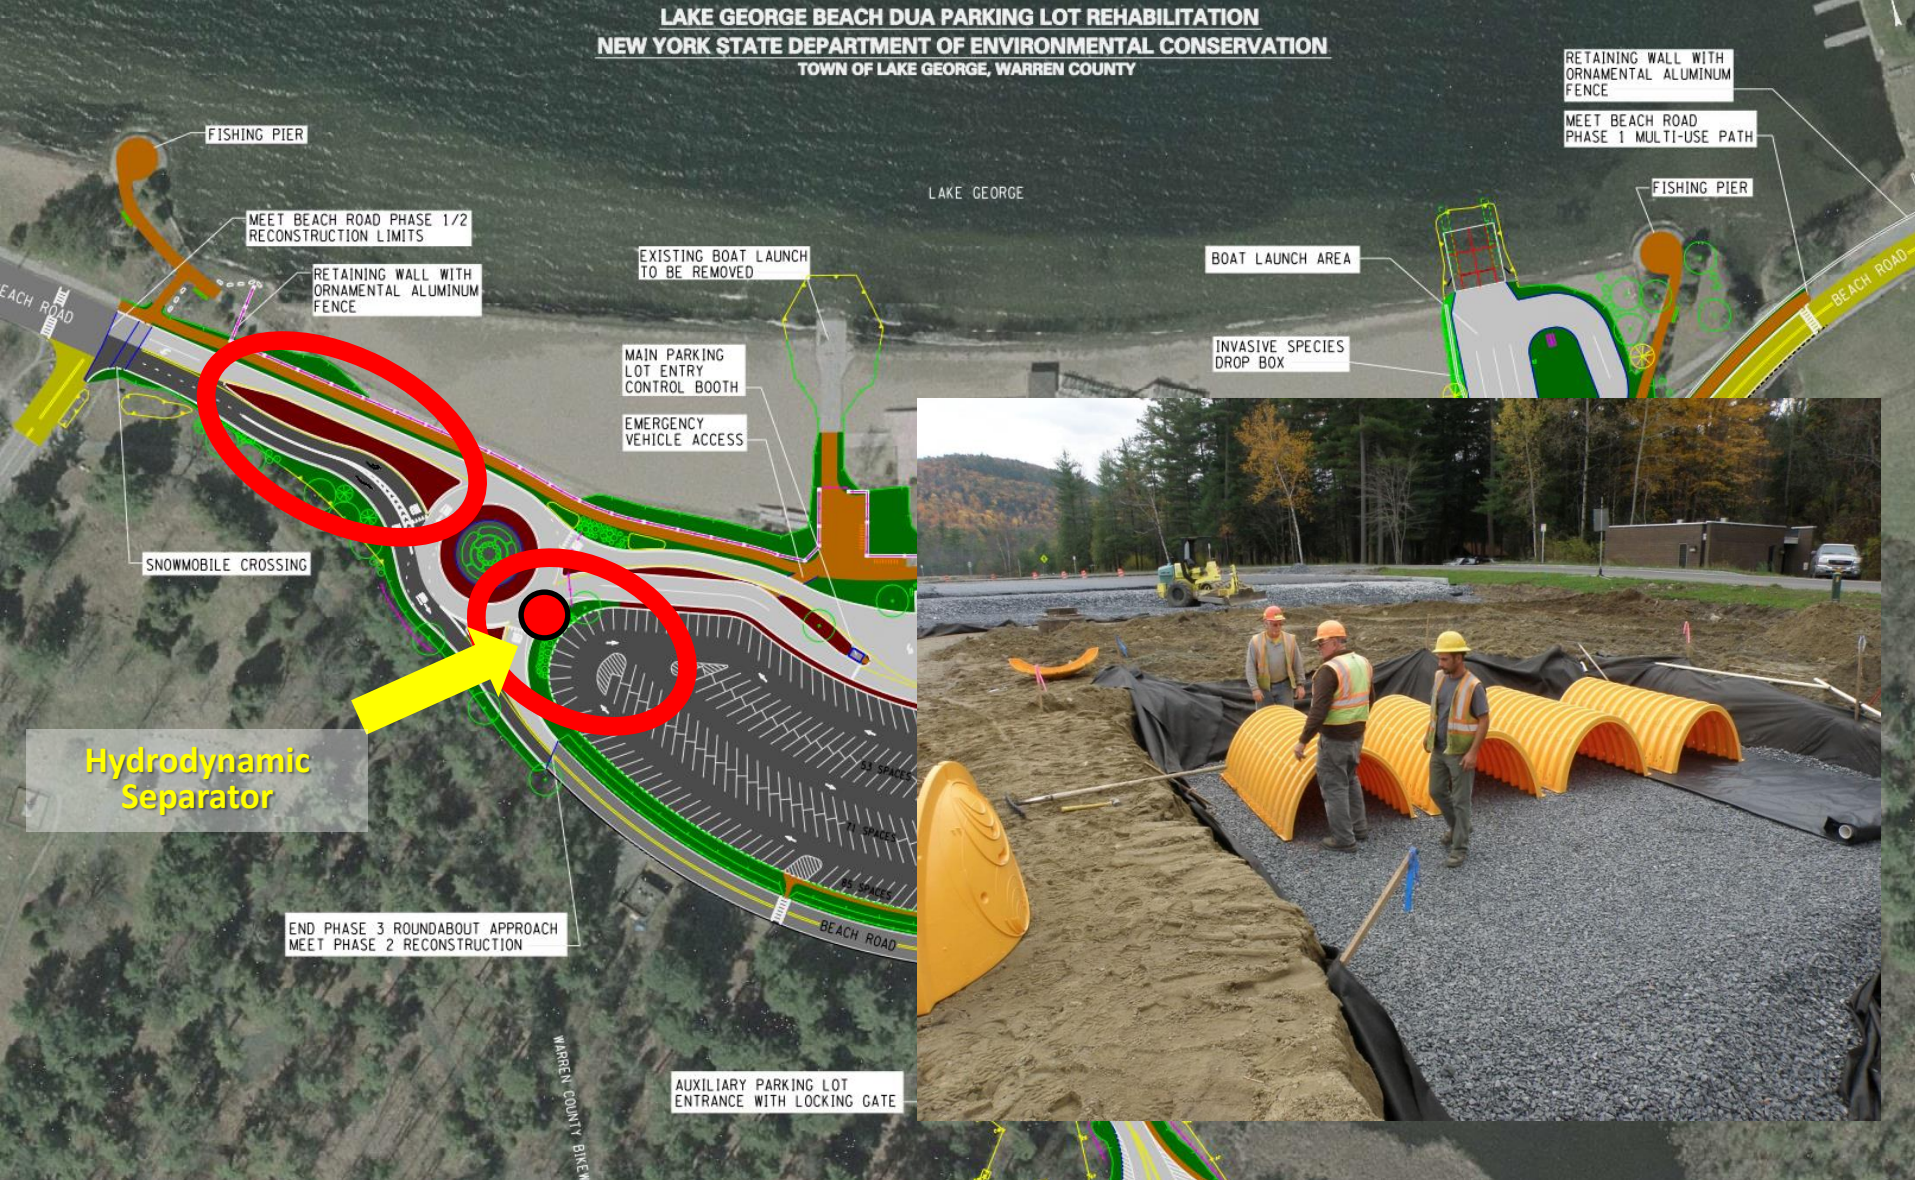
**Primary Treatment to
Underground Infiltration**

**Overflow goes to Reservoir
Layer Under Pavement**

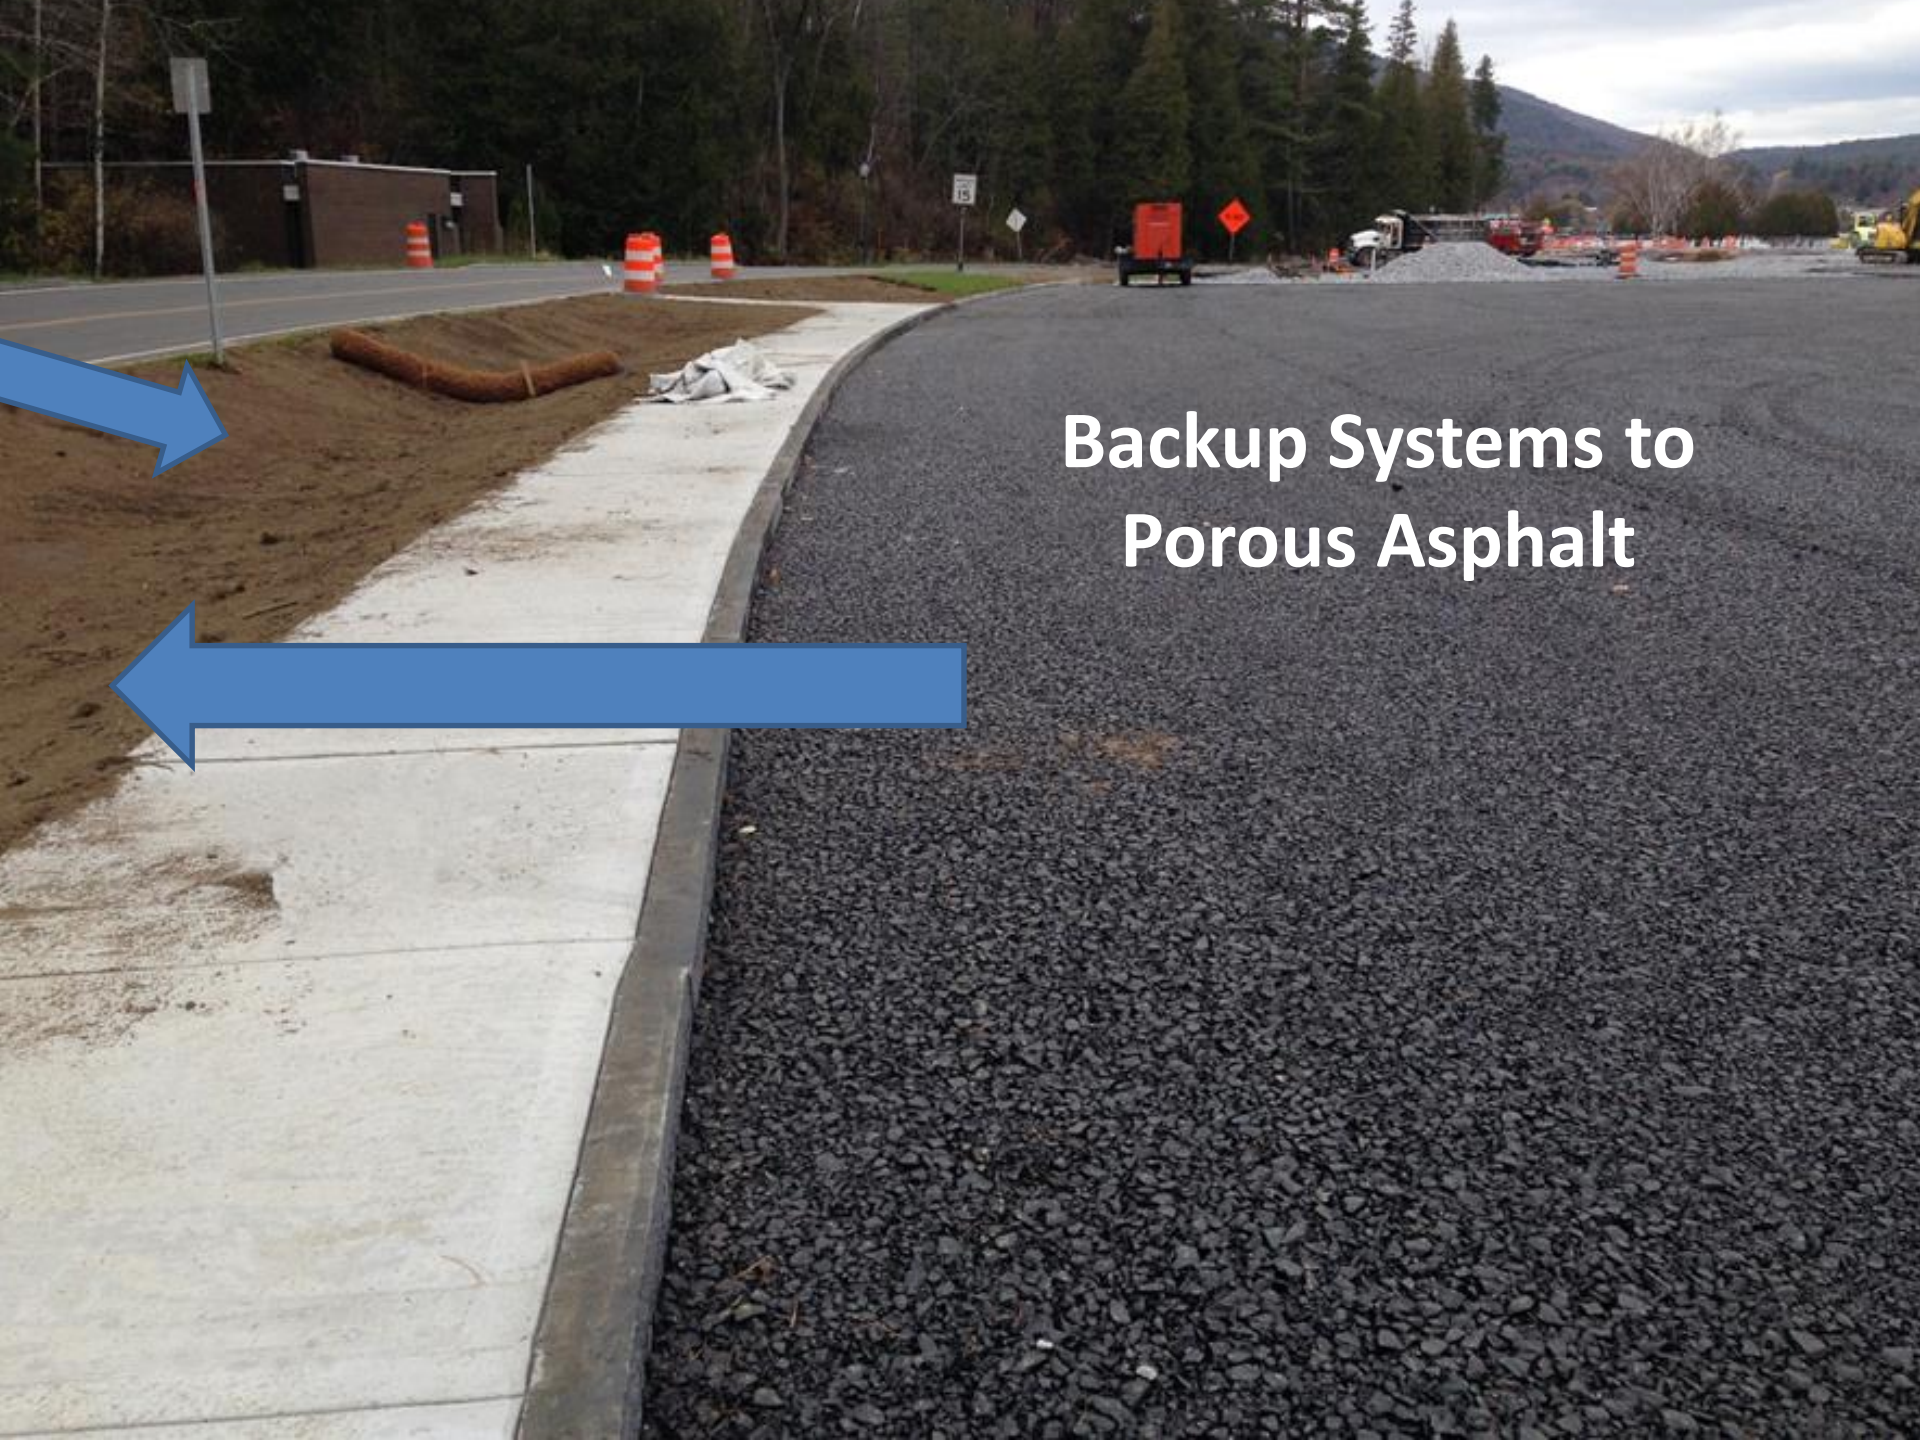
A photograph of a construction site for a road. In the foreground, there is a wide, dark grey porous asphalt surface. To the left of the asphalt is a concrete curb and a dirt shoulder. A blue arrow points from the dirt shoulder towards the asphalt. Another blue arrow points from the asphalt towards the dirt shoulder. In the background, there are orange traffic barrels, a red truck, and a road sign with the number 15. The sky is overcast.

Backup Systems to Porous Asphalt

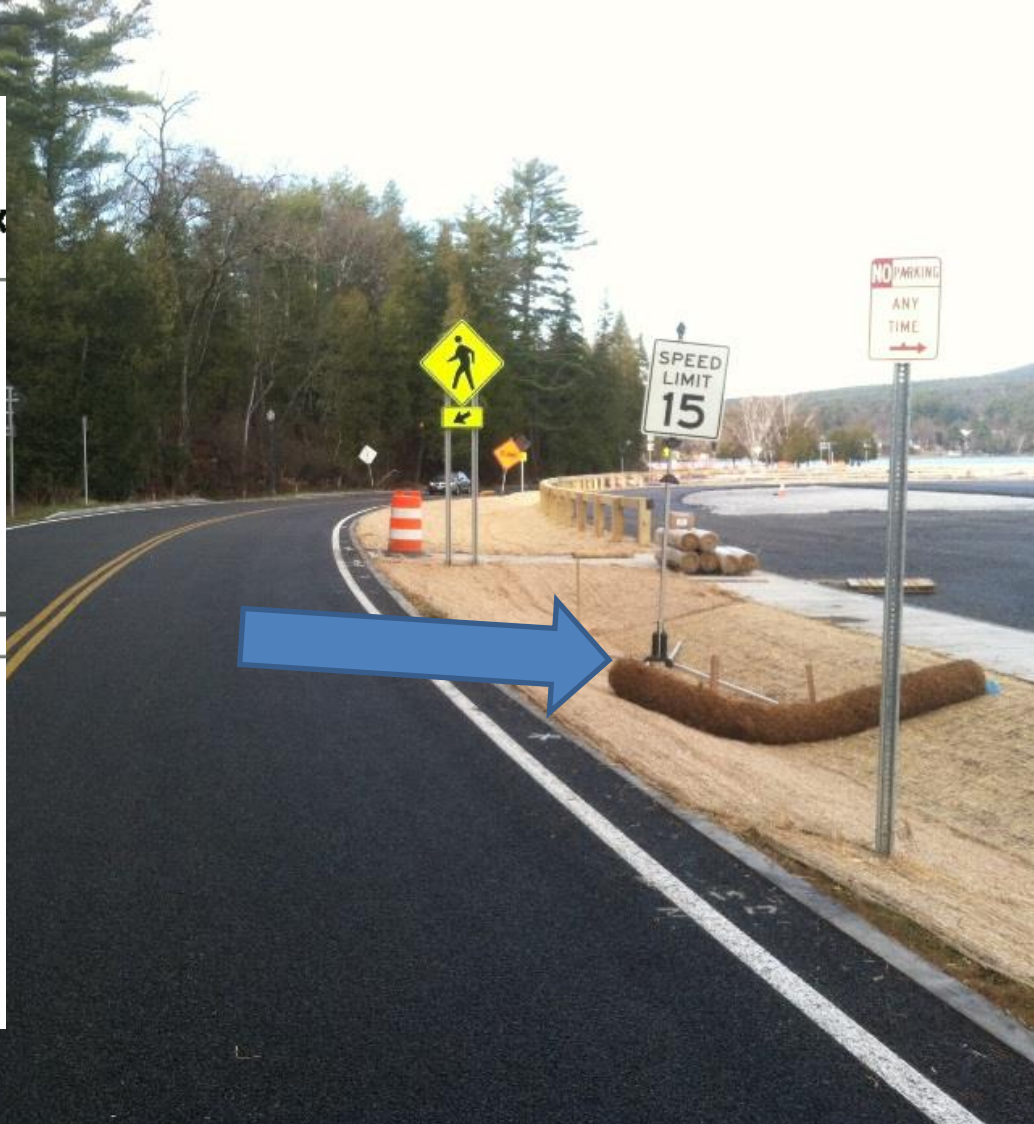
LAKE GEORGE BEACH DUA PARKING LOT REHABILITATION
NEW YORK STATE DEPARTMENT OF ENVIRONMENTAL CONSERVATION
TOWN OF LAKE GEORGE, WARREN COUNTY

Labels on the plan include:
 FISHING PIER
 MEET BEACH ROAD PHASE 1/2 RECONSTRUCTION LIMITS
 RETAINING WALL WITH ORNAMENTAL ALUMINUM FENCE
 SNOWMOBILE CROSSING
 MAIN PARKING LOT ENTRY CONTROL BOOTH
 EMERGENCY VEHICLE ACCESS
 EXISTING BOAT LAUNCH TO BE REMOVED
 LAKE GEORGE
 BOAT LAUNCH AREA
 INVASIVE SPECIES DROP BOX
 BUS DROP OFF LOCATION
 8 SPACES
 19 SPACES
 14 SPACES
 18-0"
 20 SPACES
 16 SPACES
 19-0"
 25 SPACES
 23 SPACES
 21 SPACES
 20 SPACES
 BEACH ROAD
 TOWN OF LAKE GEORGE
 WARREN COUNTY
 FISHING PIER
 RETAINING WALL WITH ORNAMENTAL ALUMINUM FENCE
 MEET BEACH ROAD PHASE 1 MULTI-USE PATH
 INVASIVE SPECIES BOAT WASHING STATION
 TRAILERS
 40'-0"
 SNUG HARBOR
 HYDRODYNAMIC SEPARATOR (highlighted with a red circle and yellow arrow)

Hydrodynamic Separator

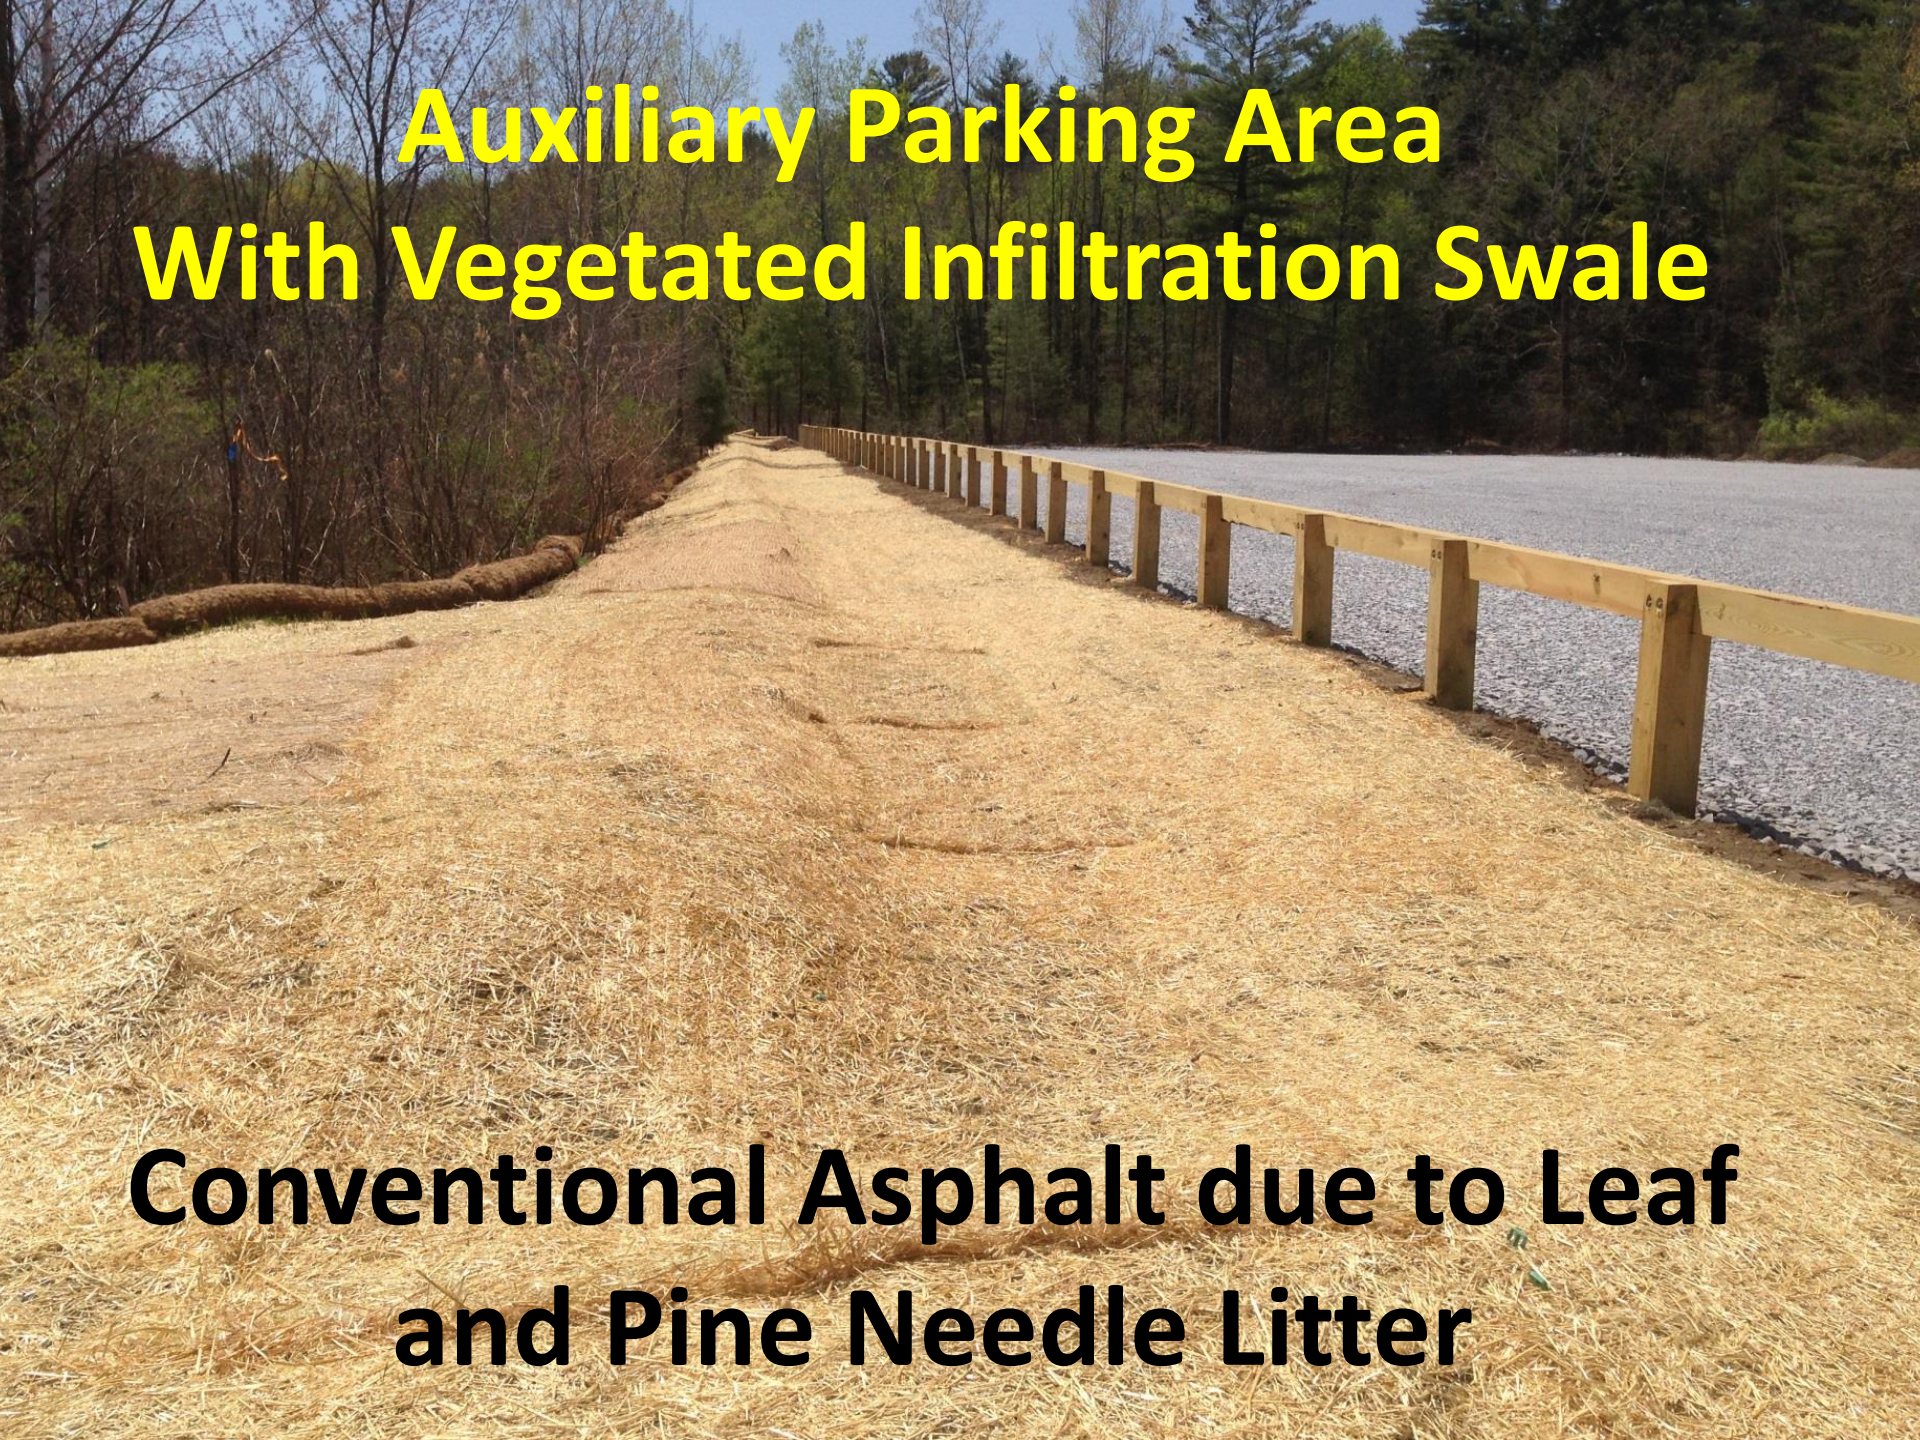
Auxiliary Parking Area With Vegetated Infiltration Swale

**Conventional Asphalt due to Leaf
and Pine Needle Litter**
