2018

STATE of the **LAKE** and **Ecosystem Indicators Report** for Lake Champlain

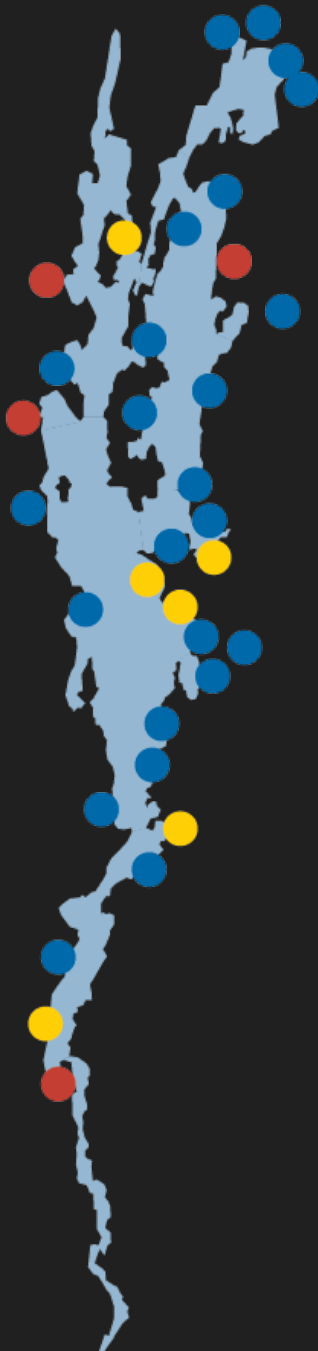
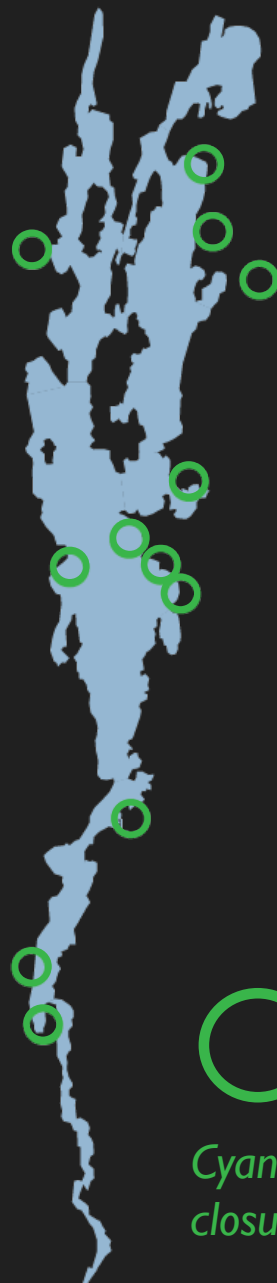
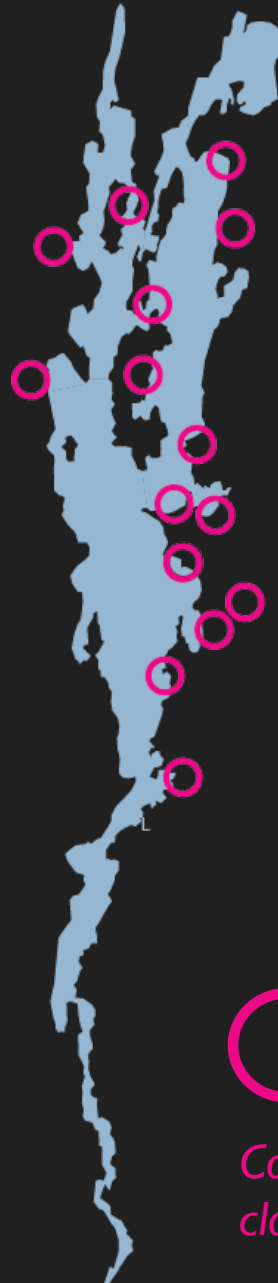
Public beach closures on Lake Champlain, 2015-2017

Closures between Memorial Day and Labor Day

Closed 0-5 days

Closed 6-19 days

Closed 20+ days

Cyanobacteria
closure

Coliform bacteria
closure

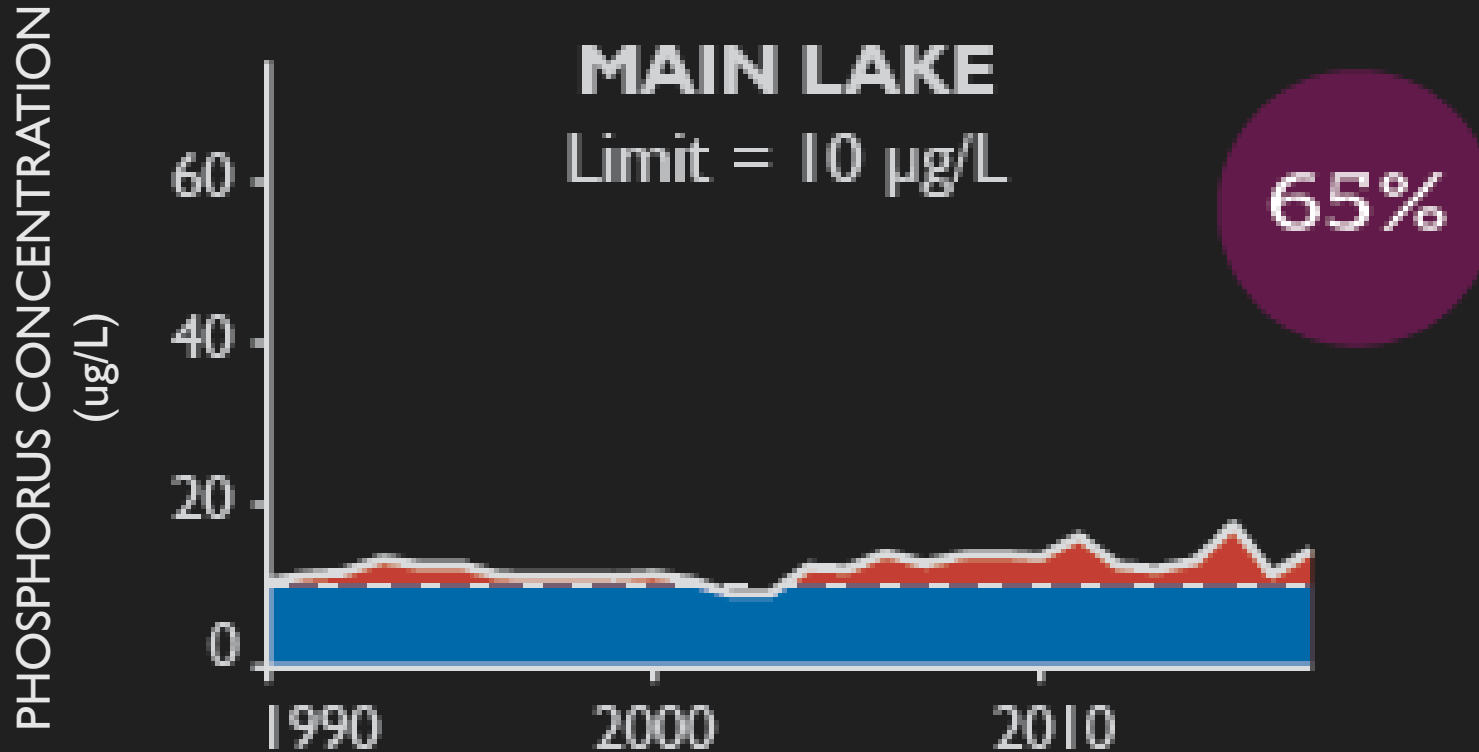
Annual mean phosphorus concentration, 1990-2017

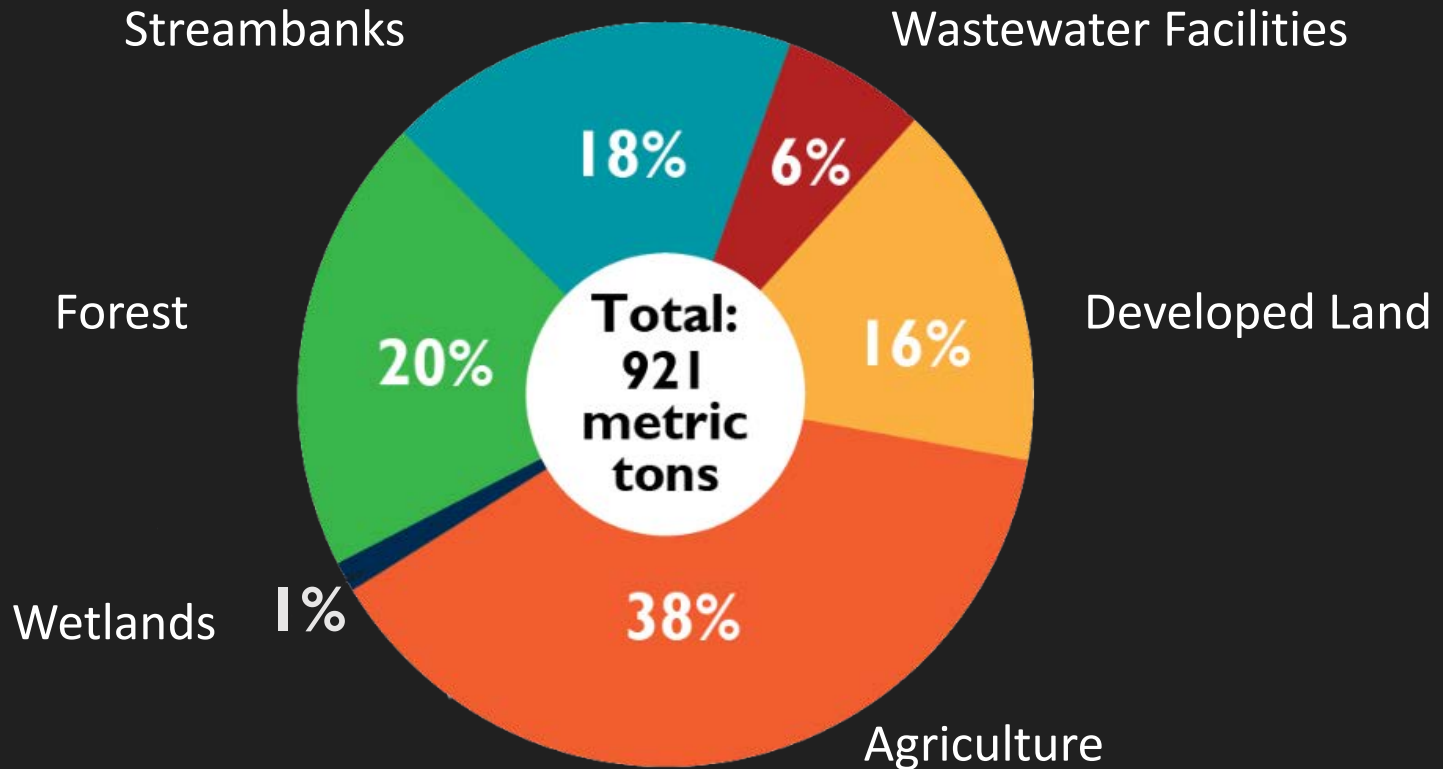
Annual phosphorus loading and land cover

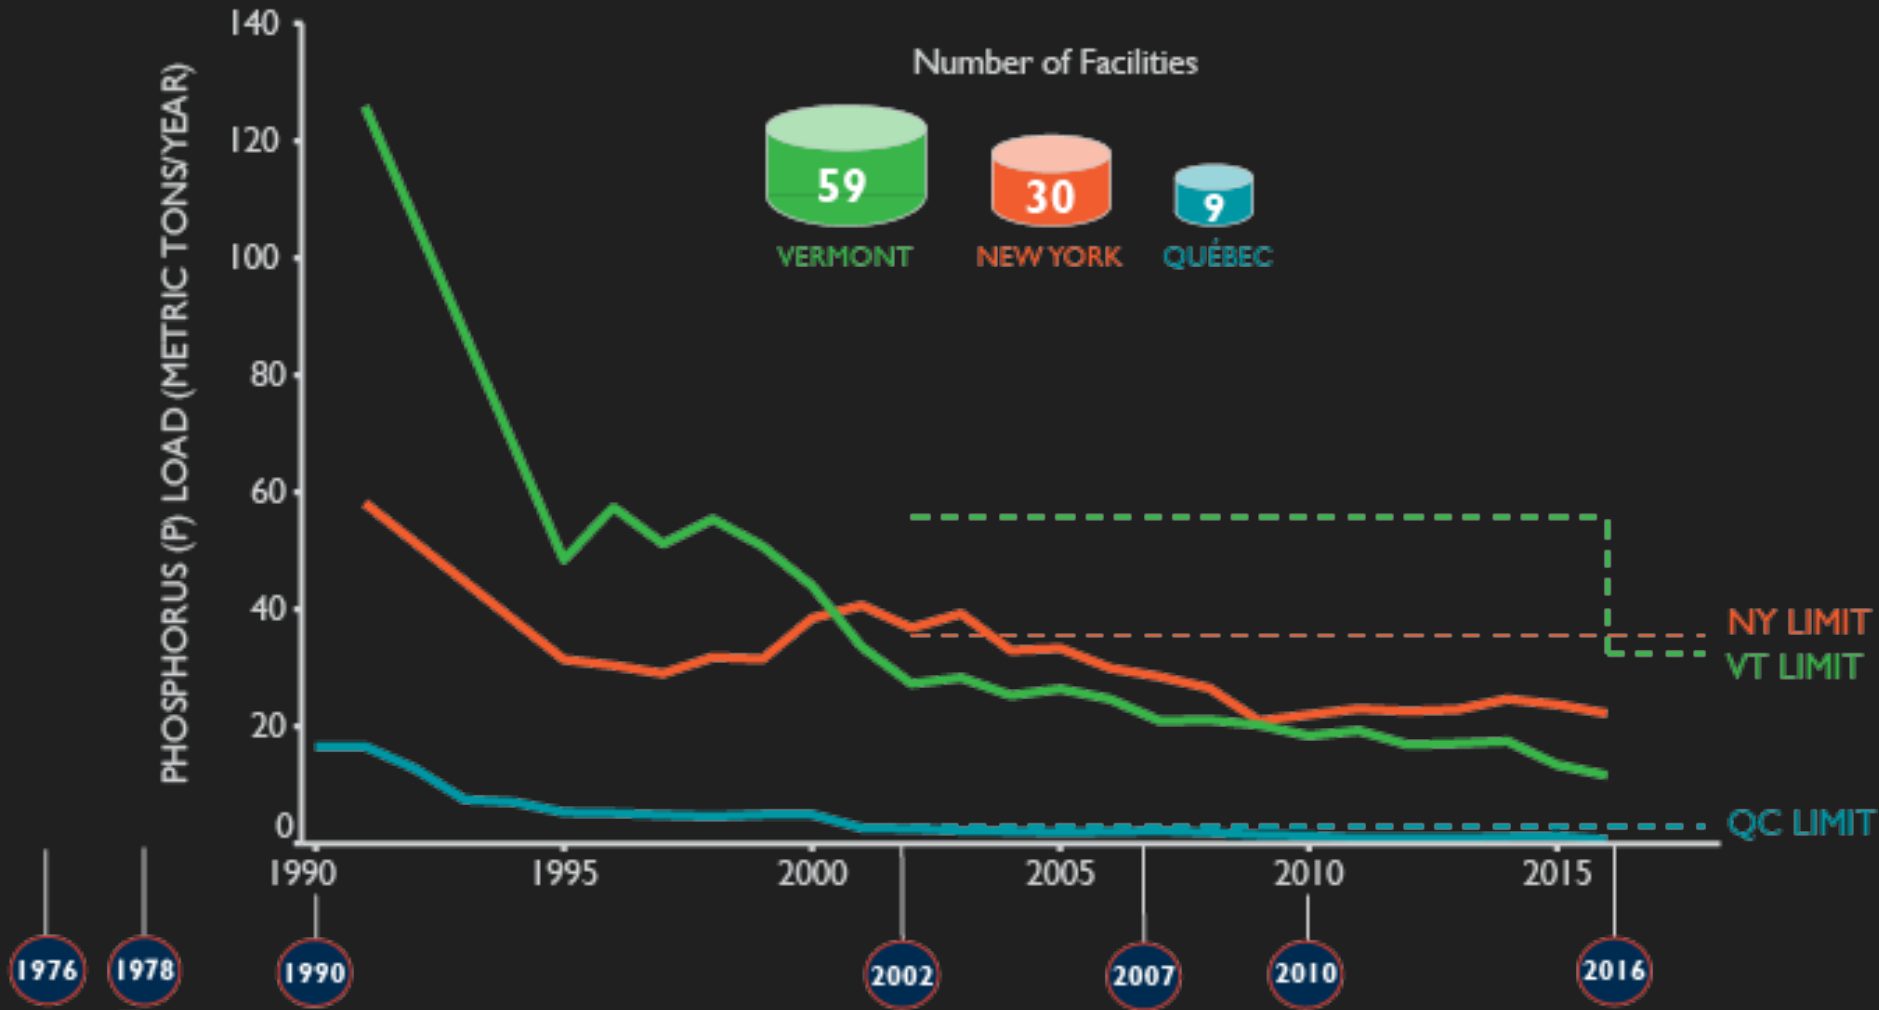
Phosphorus load from wastewater treatment facilities, 1990-2016

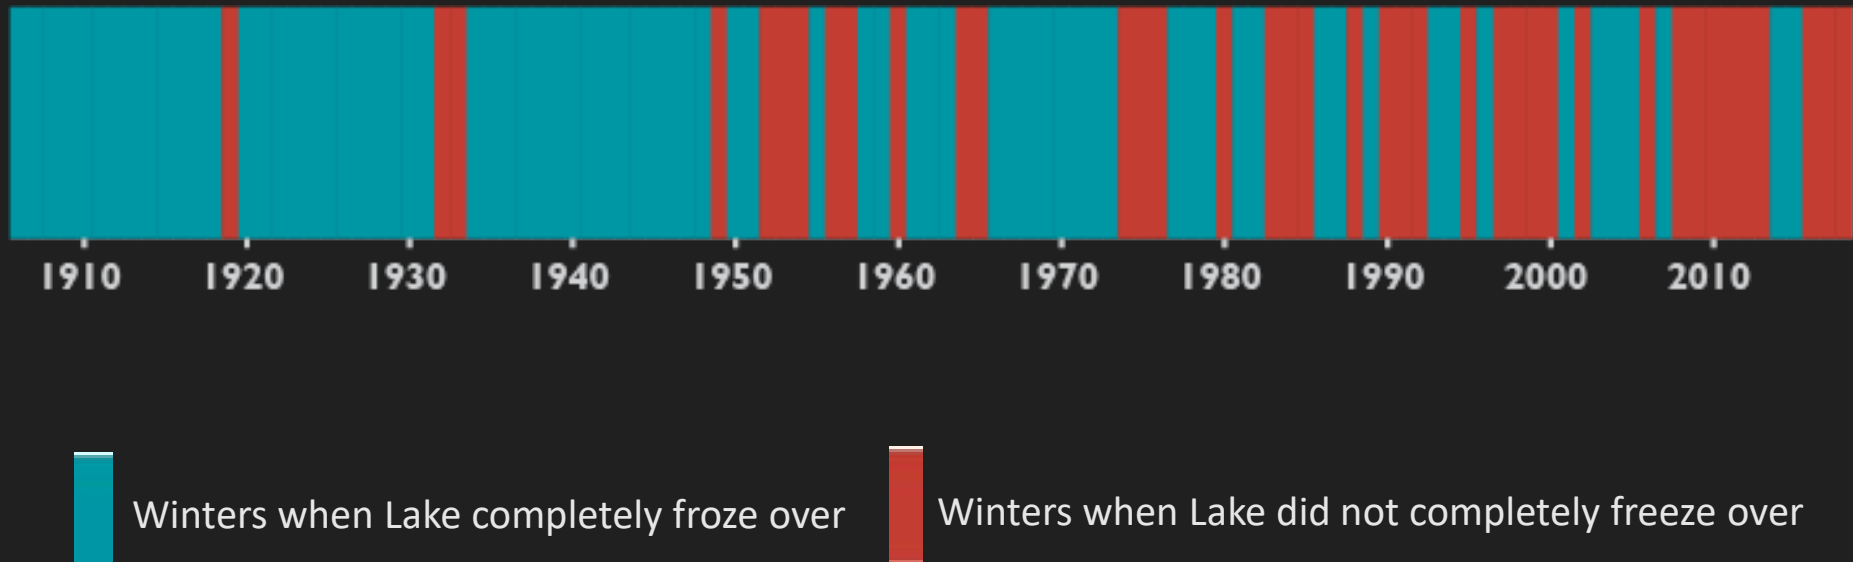
Freeze-over of Lake Champlain, 1906-2016

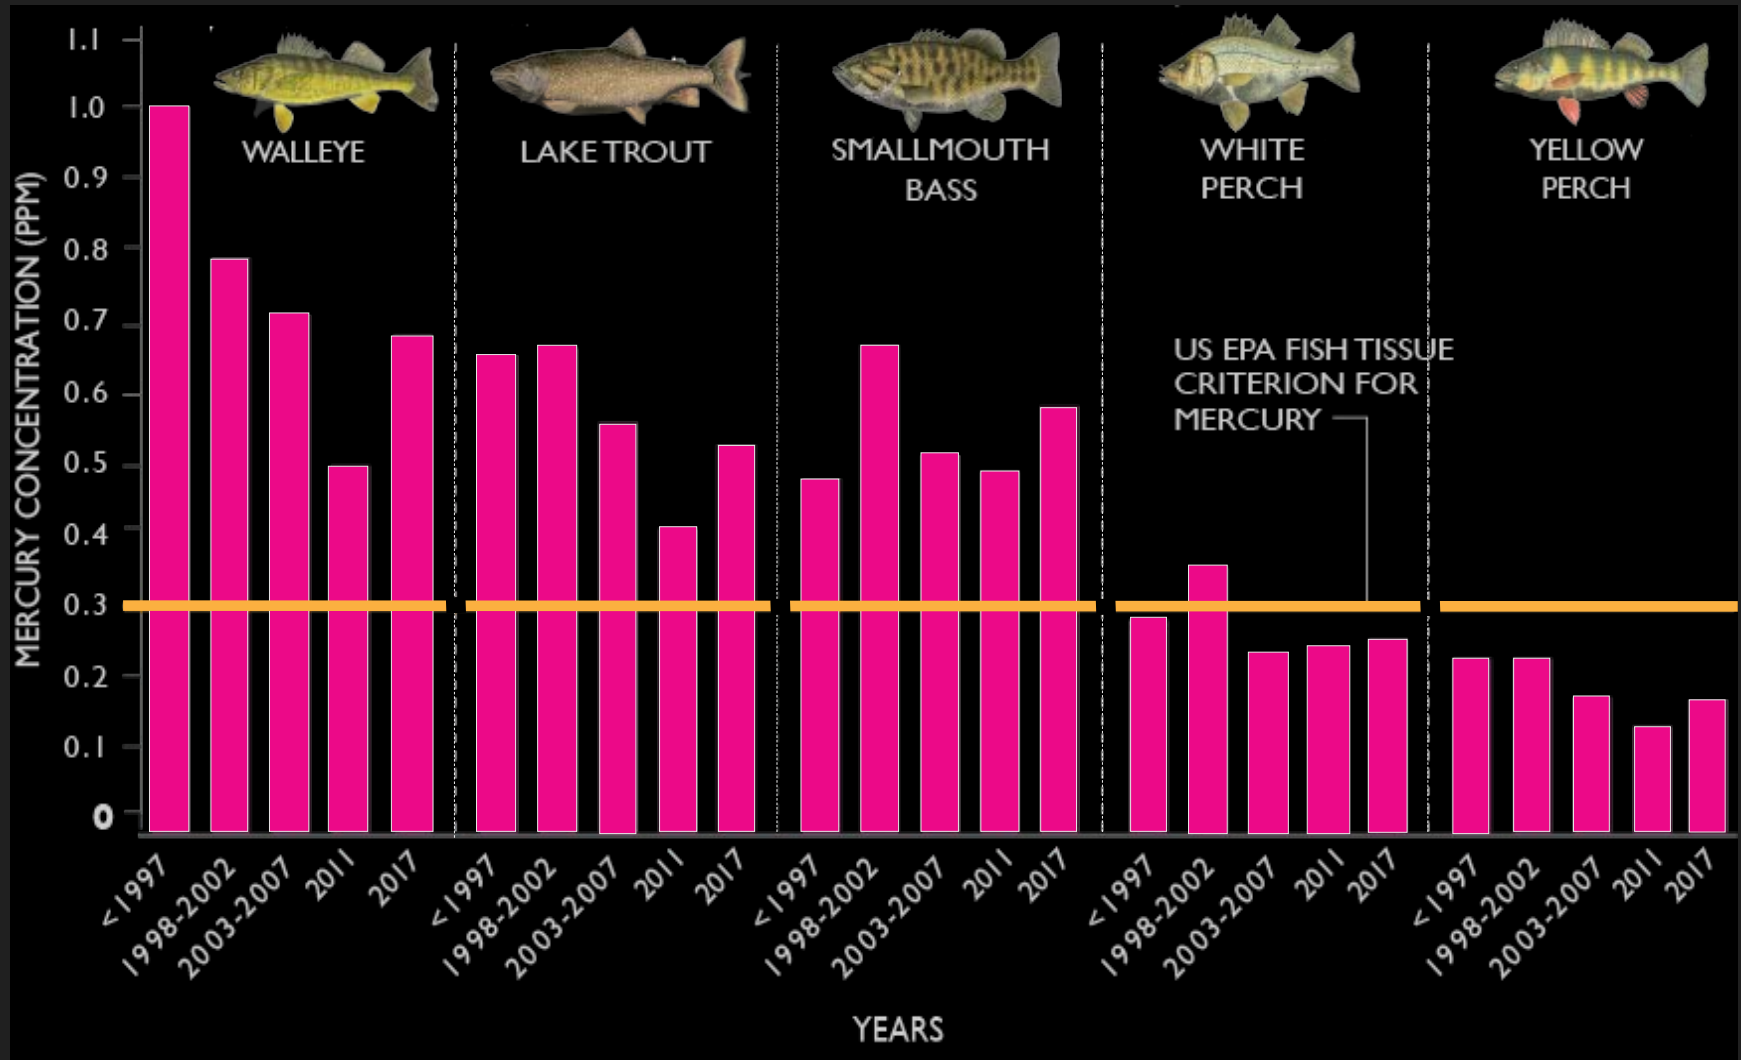
Mercury concentration in fish tissue

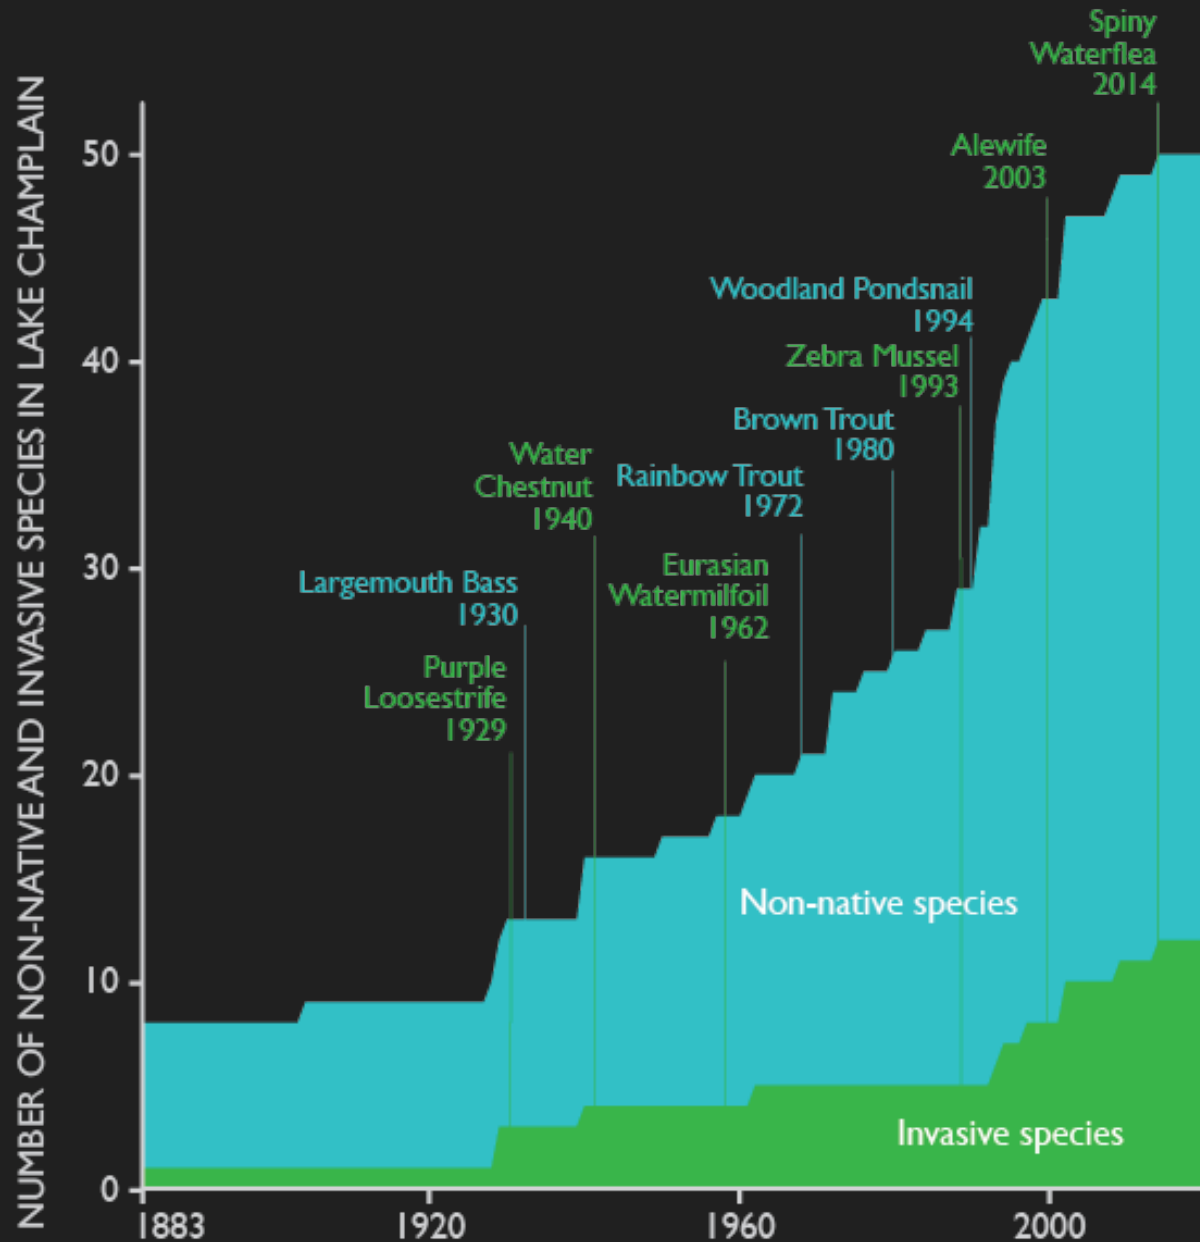
Aquatic non-native and invasive species, 1883-2018

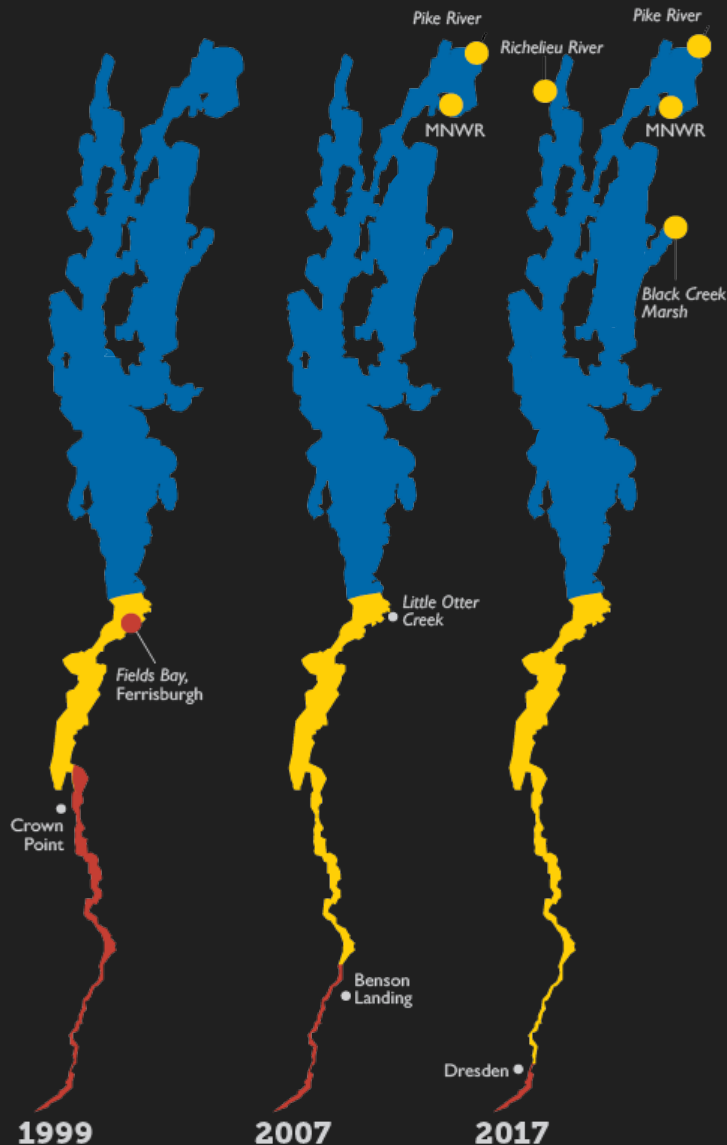
Extent of water chestnut coverage

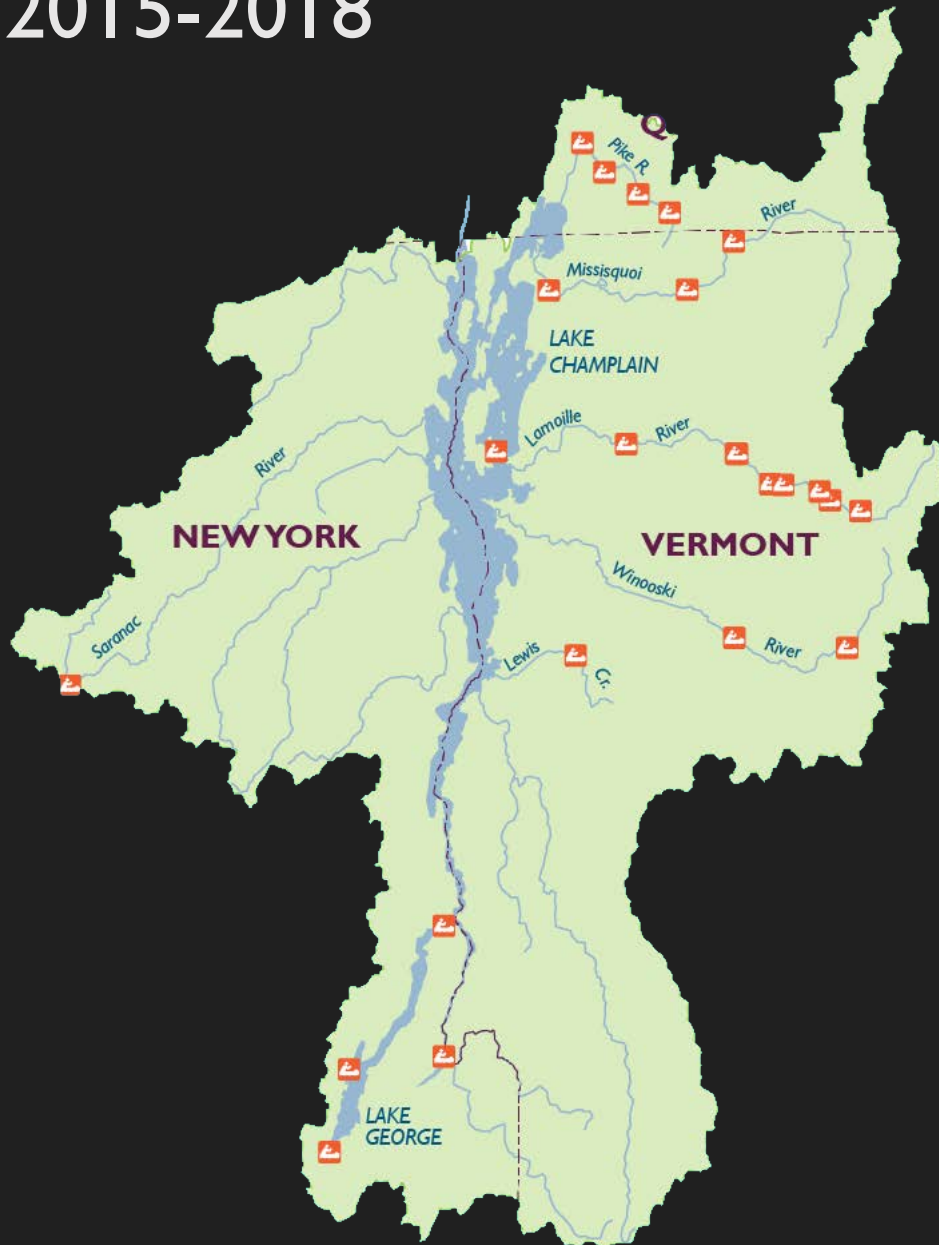
New and improved cartop boat access sites, 2015-2018
