Floating Treatment Wetlands – evaluation for pollutant removal improvement in cold climate stormwater ponds

Final Report

Becky Tharp and Tom Dipietro

Lake Champlain Sea Grant/ University of Vermont and City of South Burlington

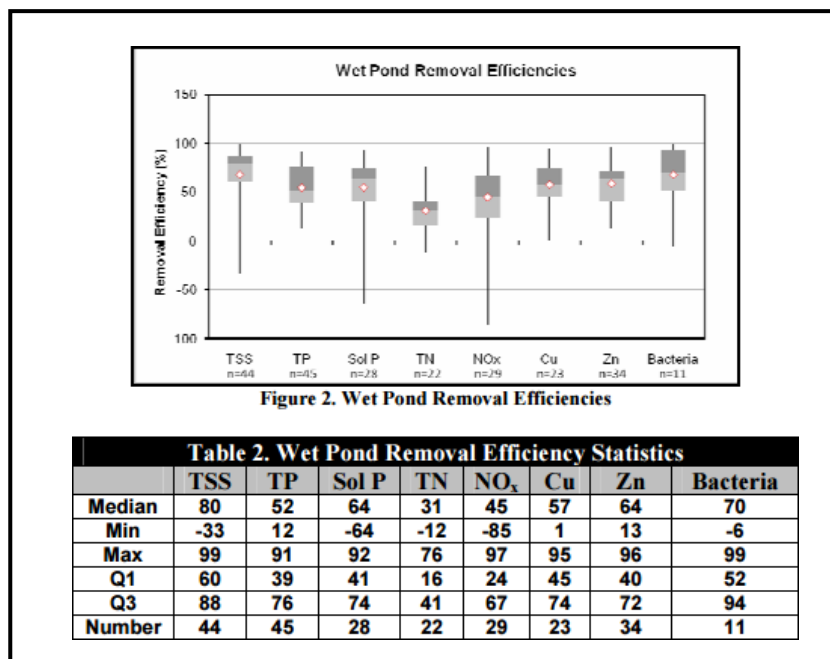
Figure 1: Wet pond removal efficiency from CWP 2007

While stormwater ponds are very effective at controlling peak flow, their nutrient removal capacity is limited. The Center for Watershed Protection's 2007 National Pollutant Removal Performance Database report collated data on removal rates from 46 wet pond studies (CWP, 2007). This report (and its predecessor from 2000) have been cited in dozens of state stormwater manuals establishing pollutant removal rates for a range of practices, including retention ponds. Focusing on the median removal efficiencies, it appears that total phosphorus (TP) and the total dissolved phosphorus (TDP) being captured by ponds are similar; 52% and 64% removal, respectively. However, the spread in these data is concerning. Figure 1 shows a minimum value for soluble P removal at -64% and a maximum at 92%. This means that in some of the studies that contributed to this dataset, 1.64 times more soluble P was being exported from the ponds than was coming in to them. Interestingly, the measure for TP never dips below 12% removal. This departure between the two measures of P forms indicates that while TP consistently measures at lower concentration in the effluent than the influent, the form of P (particulate versus dissolved) changes as it moves through the ponds, leading to a loading of the dissolved form even as the total measure is consistently reduced.

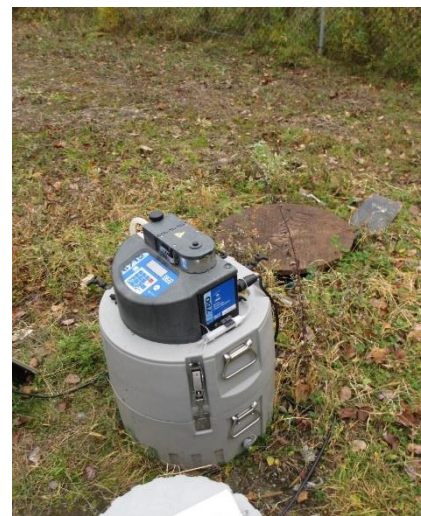
Figure 2: Automated sampler set up at the inlet structure

The stormwater retention pond for the Quarry Ridge townhouse development on Juniper Drive in South Burlington, Vermont, was evaluated for presence or absence of invasive species. A catalogue of macrophytes at the site was completed and submitted to LCBP. Automated sampling units (ISCO Automatic Water Samplers) were installed at the inlet and outlet structures of the pond in the spring of each study year (2015-2017). Level probes measured water level in the structures and converted level to flow rate. Samplers were programmed to sample based on flow throughout storm events, capturing a composite sample to represent each storm.

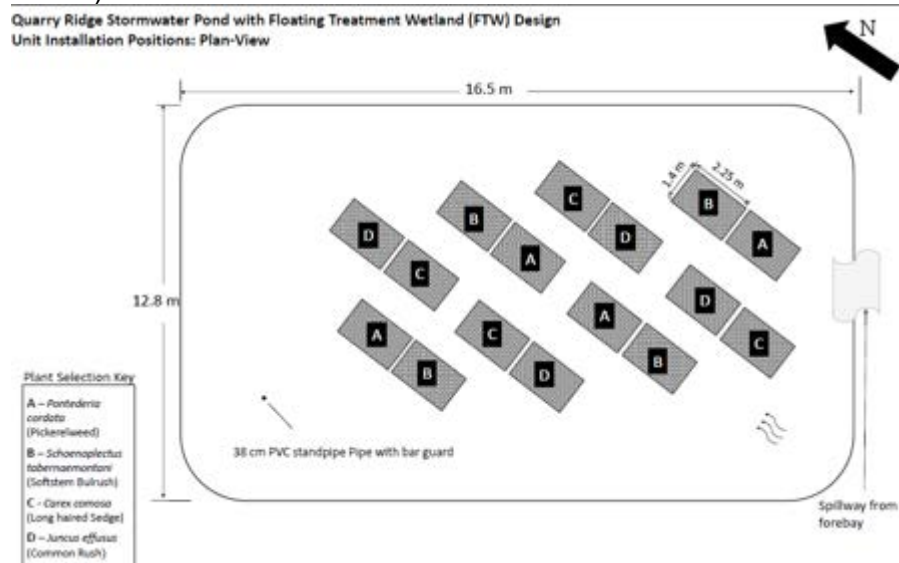
Figure 3: Plan view of FTW units in the Quarry Ridge pond

Floating Treatment Wetland Unit Layout: Plan-View

The results of chemical testing in the first year indicated that metals and hydrocarbons were not pollutants of significant concern in the pond. TSS was effectively managed but TP and TDP were more variable. As a result, a focused literature review on phosphorus removal as a target for FTWs informed plant species selection. Based on published literature, the project team determined that 25% pond surface area coverage was optimal to influence pollutant removal. Furthermore, species found to be successful in other FTW applications were selected for application in Vermont: *Pondetia cordata* (pickerelweed), *Schoenoplectus tabernaemontani* (Softstem Bulrush), *Carex comosa* (Long haired Sedge), *Juncus effusus* (Common Rush). (see design drawings included in Figures 3, 4 and 5).

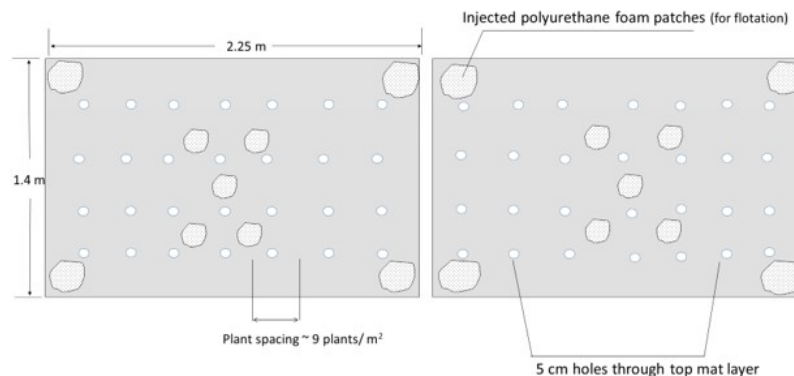
Figure 4: Plan view of a FTW raft pair with planting and floatation foam configuration

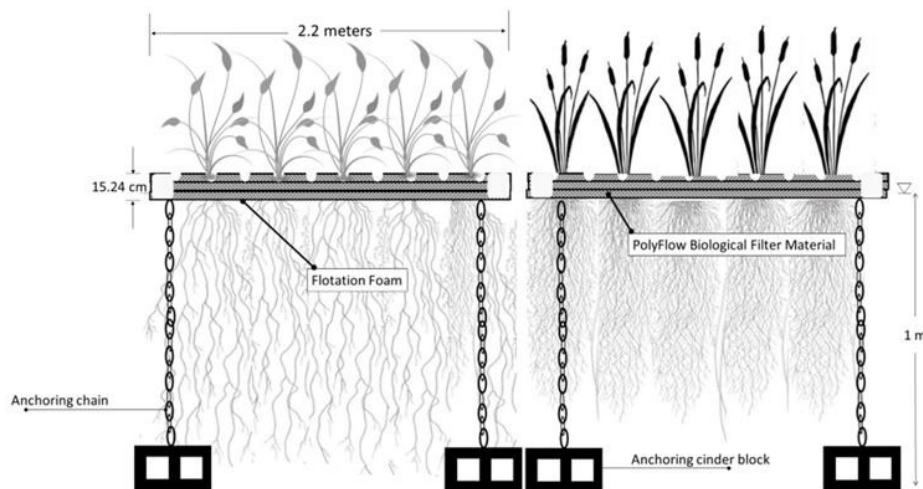
Figure 5: Cross section of a FTW unit pair as installed (showing anchoring mechanism)

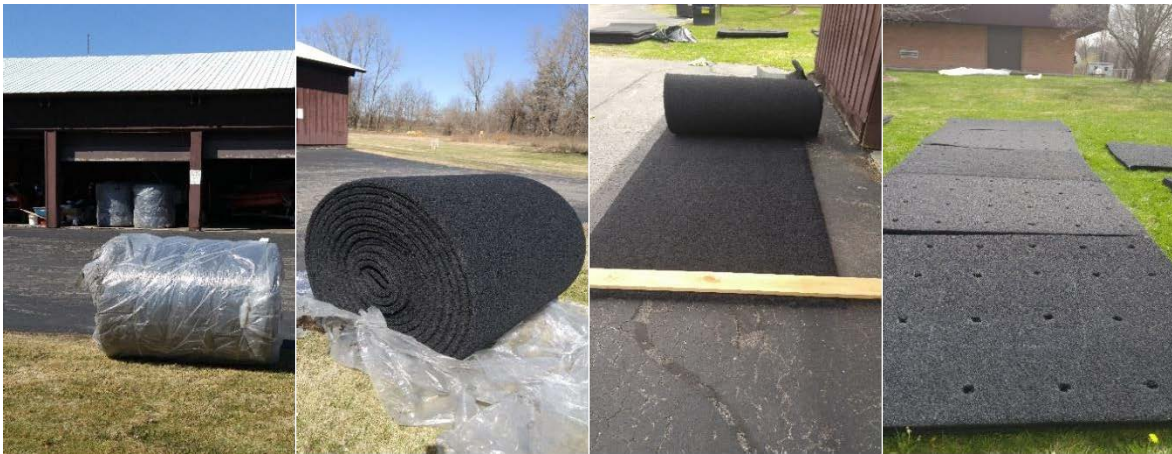
Figure 7: Rolls of Polyflow biological filter material being rolled and cut for installation preparation

The FTW units were constructed of three layers of biological filter material and a two-part marine foam for floatation. Holes were formed in the top two layers of the mats for plant plug installation and the bottom layer was left whole to provide a floor for the seedlings to establish (Figures 7 & 8).

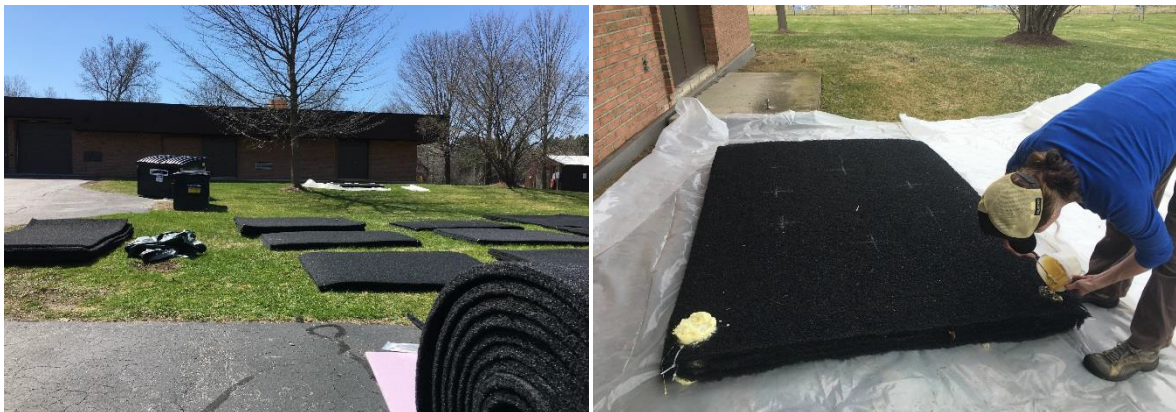
Figure 8: FTW mats are cut to size, stacked, and foam is poured for floatation

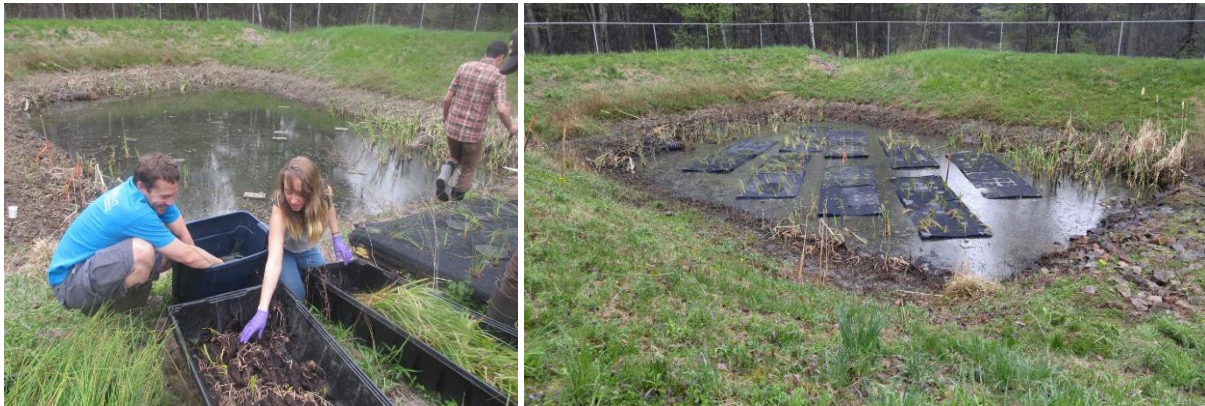
Figure 9: Project team inserts plugs and launches FTW rafts in Spring 2016

In the spring of 2016, the water in the stormwater pond was drawn down to allow easier movement within the basin. Plants were inserted into the built FTW mats and they were launched onto the surface of the pond. The outflow structure was then adjusted to return the water level to its standard ponding depth (Figure 9).

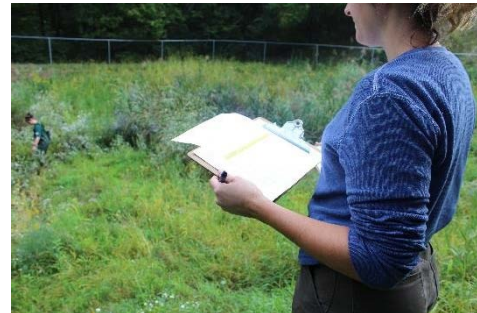
Figure 10: Project team counts and records individuals on mats in the fall of 2016

Mats and plants were evaluated for damage and survivability after the first winter (2016-2017). Species survivability was measured based on the number of individuals to sprout after winter after no modifications or management throughout the cold season (Figure 10).

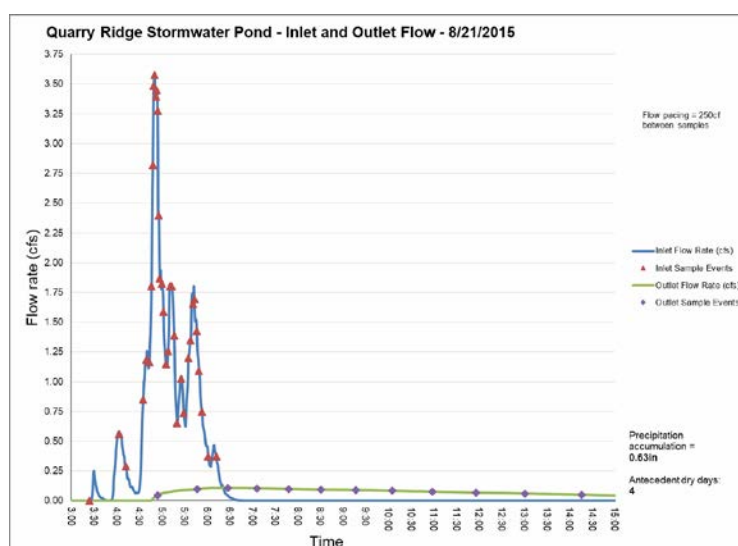
Figure 11: Example of hydrographs of the inflow (blue line) and outflow (green line) from the test pond.

Hydraulic performance of the pond was measured at the inflow and outflow structures using automated sampling equipment (ISCO 6712 auto sampling units). ISCO 720 submerged probe flow modules (Lincoln, NE, USA) were installed in the inflow and outflow structures of the pond. These sensors measure differential pressure of the overlying water column to determine level and the attached automated sampling units (ISCO 6712) convert the level measurement to flow using Manning's equation with programmed values of pipe diameter, material, and slope (Manning, 1891). Levels at the inflow and outflow structures of the pond were converted to flow and the data were downloaded from the samplers after each captured rain event. The downloaded tabular data was converted to flow graphs using Microsoft Excel 16 to display influent and effluent flow rates over time as well as the timing of sample collection along each hydrograph (as seen in Figure 11 below).

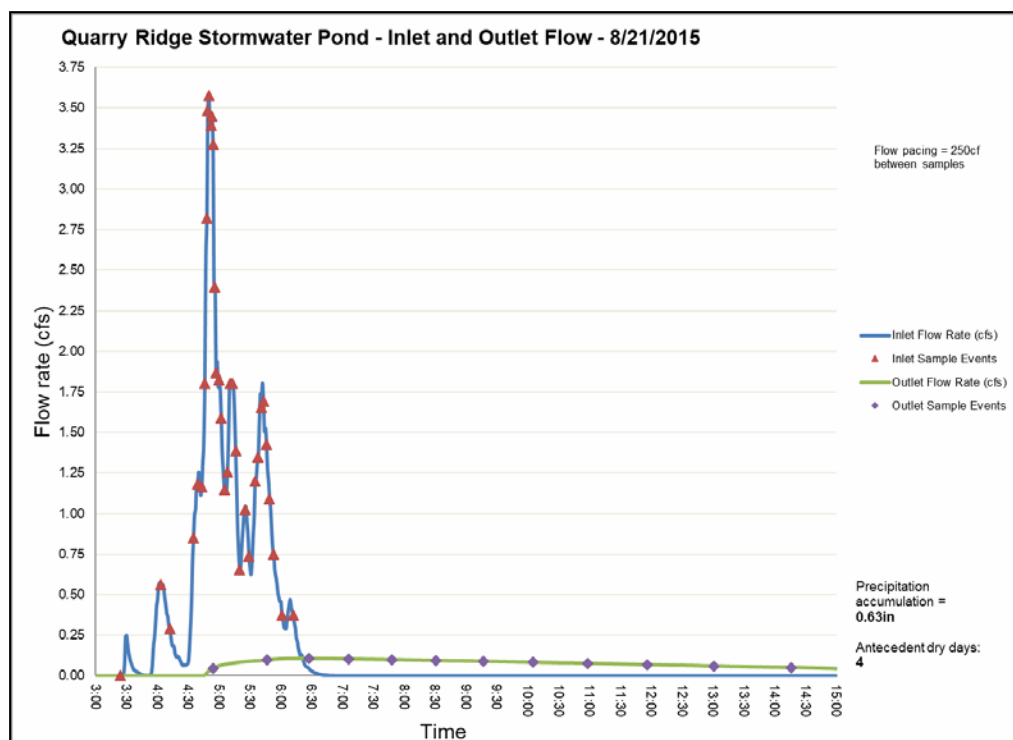
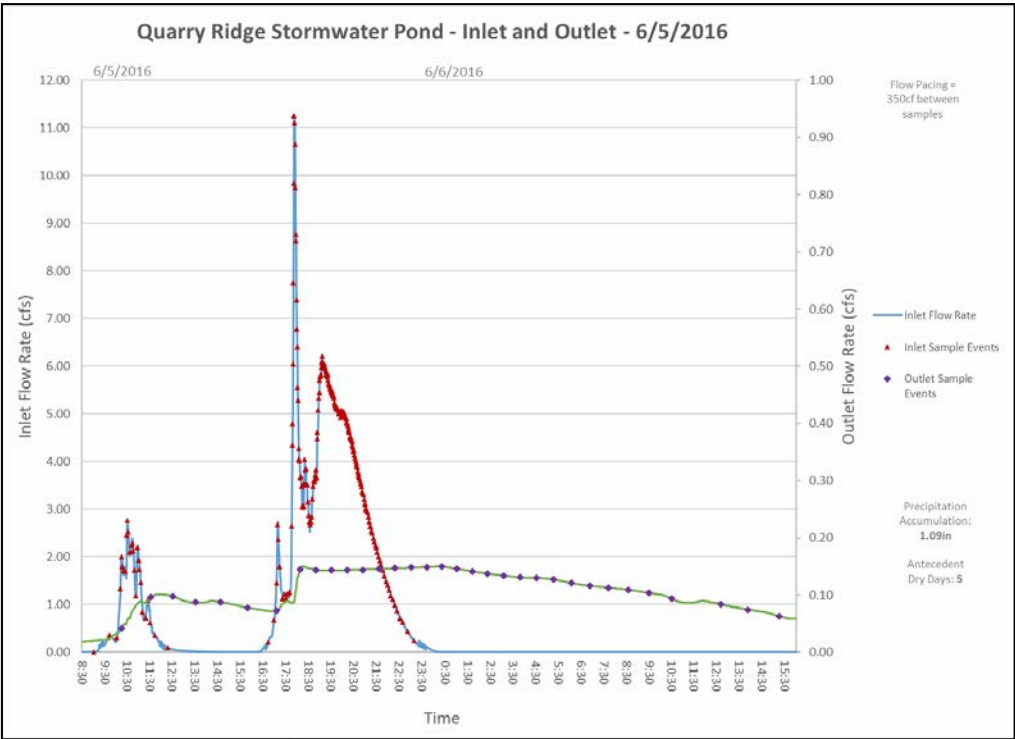
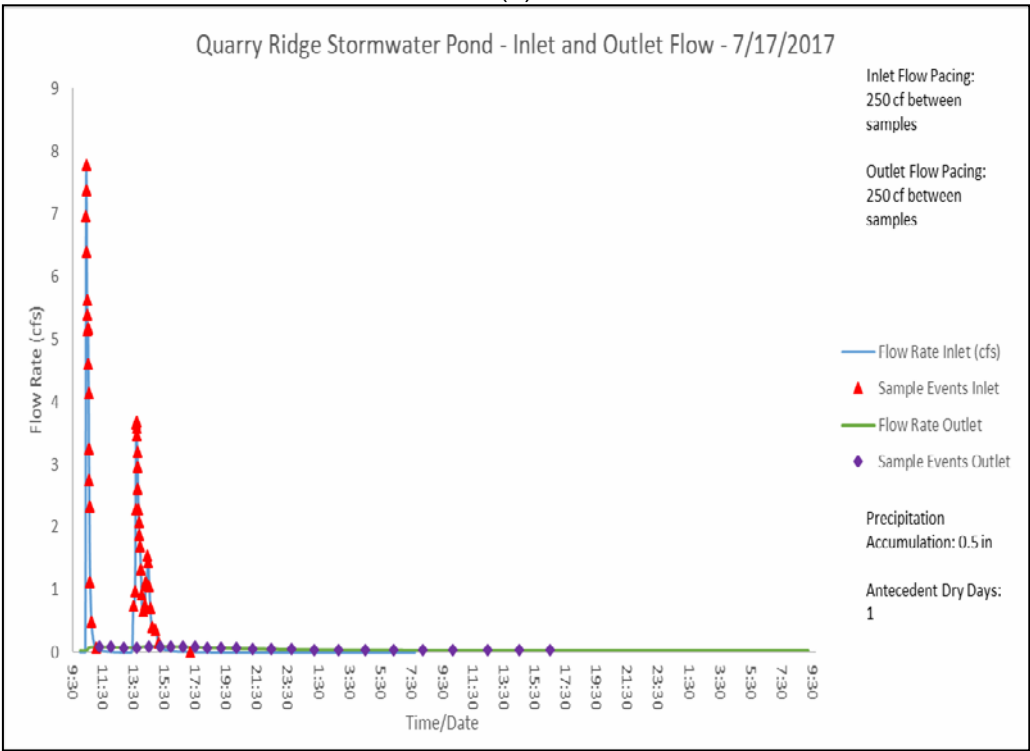
Figure 12: Example hydrographs from storms in each study year: a.) 2015, b.) 2016, c.) 2017

The Quarry Ridge pond is a wet extended detention pond. As such, its primary design objective is peak flow attenuation. The pond is highly successful at achieving this goal – irrespective of FTW installation. Hydrographs from storms in each year are illustrated in Figure 12 a-c.

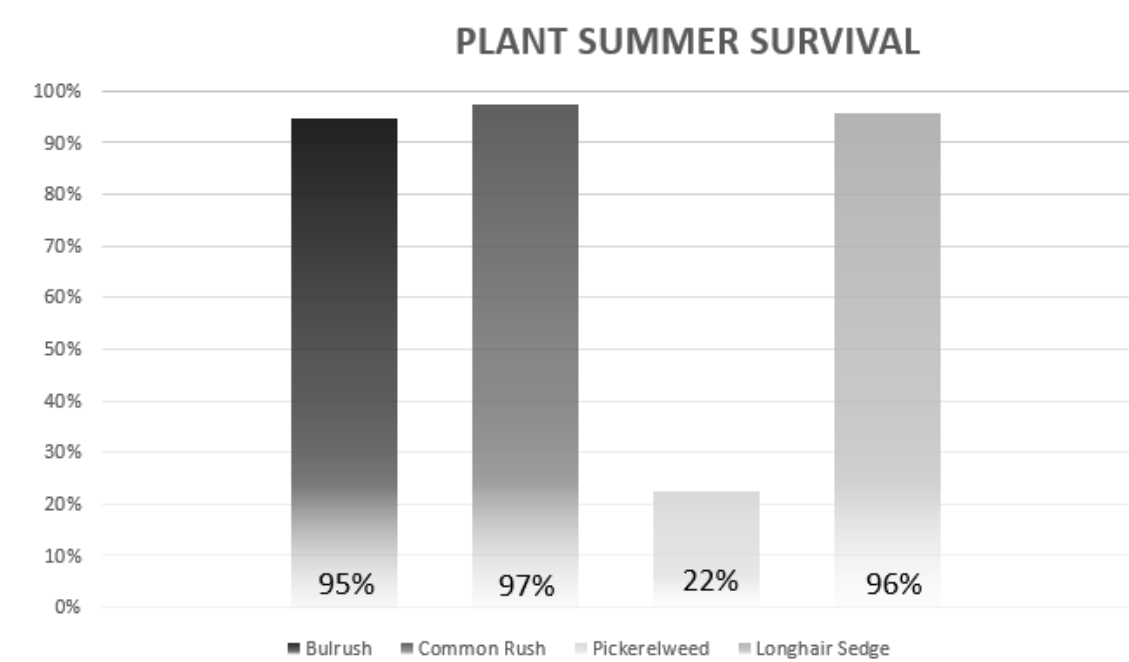
Figure 13: Plant species survival after first growth season. Data were collected by counting surviving individuals on each mat and averaging percent survival by species (mats/ species = 4). Data indicate that all species survived summer conditions well except Pickerelweed which suffered significant die off.

Evaluation of plant survival over a growing season indicates a plant's suitability for life in the conditions of a FTW on a stormwater pond in Vermont. After the first growing season, surviving plants were counted by species and mat location and compared to the total number planted at the beginning of the season. No effect of mat location (in relation to inlet or outlet) was noted to impact survivability. While pickerelweed suffered significant losses (78%) other plants lost modest numbers that are in keeping with expected fatalities from establishment (Figure 13).

Pickerelweed's losses could be attributed to establishment of the plugs early in the season (May) for a species that typically emerge from a tuber later in the year in Vermont. The cold conditions coupled with plug installation in submerged conditions lacking the insulating properties of wetland soils (which this species prefers) may have contributed to its failure. Other species survived summer conditions on the pond well, with losses ranging from 3-5%.

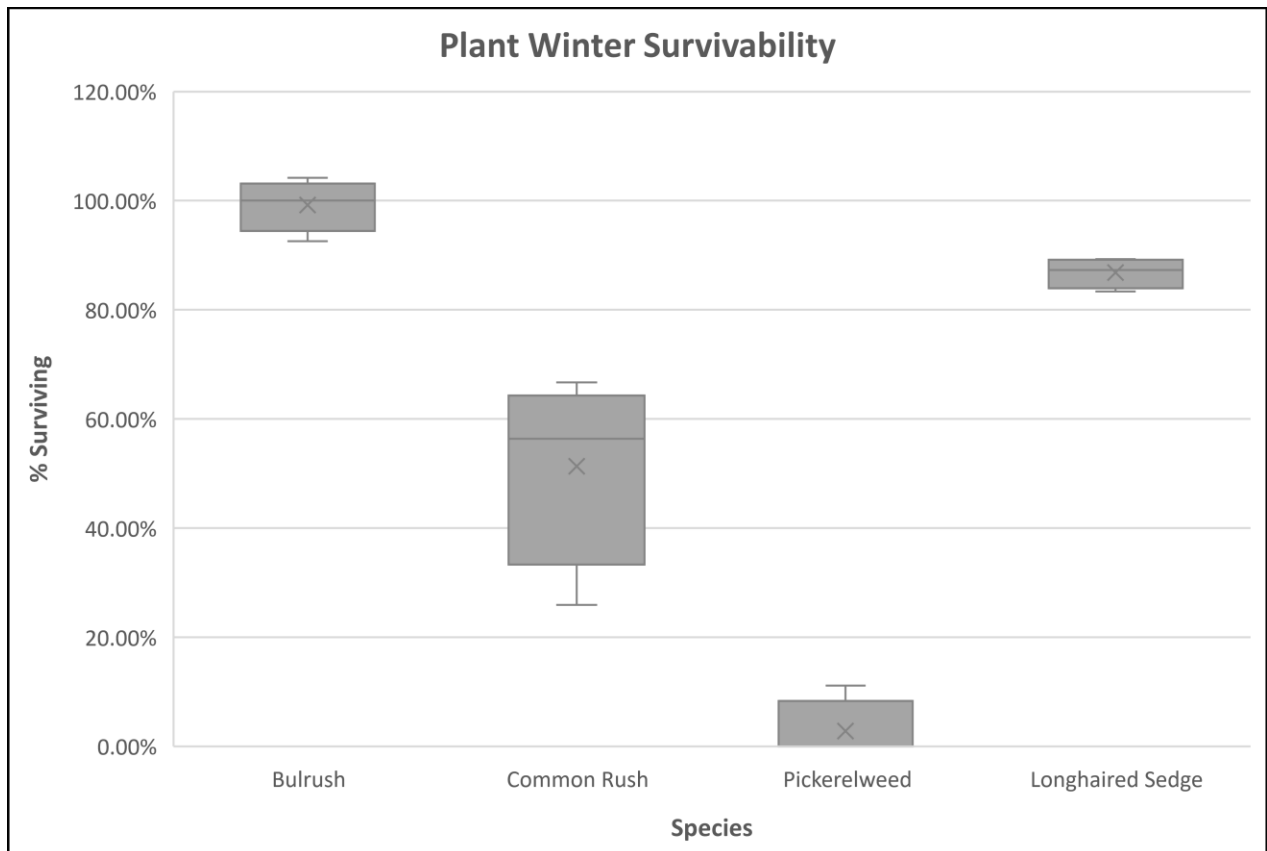
Figure 14: Percentage of plant individuals that survived the winter on each mat by species (4 mats/species). Data were analyzed for differences using Kruskal Wallis followed by Mann Whitney U test. Results indicate Pickerelweed's performance differed from the other species over wintering ($p < 0.05$).

After the winter of 2016-2017, plants were counted again based on spring emergence and compared to the number of living individuals prior to winter dormancy. The results from that analysis are below (Figure 14).

Winter survival analysis indicates a near complete loss of the few pickerelweed individuals that remained at the beginning of the winter season. There was a complete resurgence of the bulrush species and no individual plants were lost. Note that the bulrush data found a greater than 100% winter survival. The research team is unsure if this is a result of a counting error in the fall of 2016 that may have failed to include a plant in the analysis or the regrowth of an individual that had not been visible after the previous growth season. In either case, bulrush and longhair sedge were the most robust plant species in terms of winter survival.

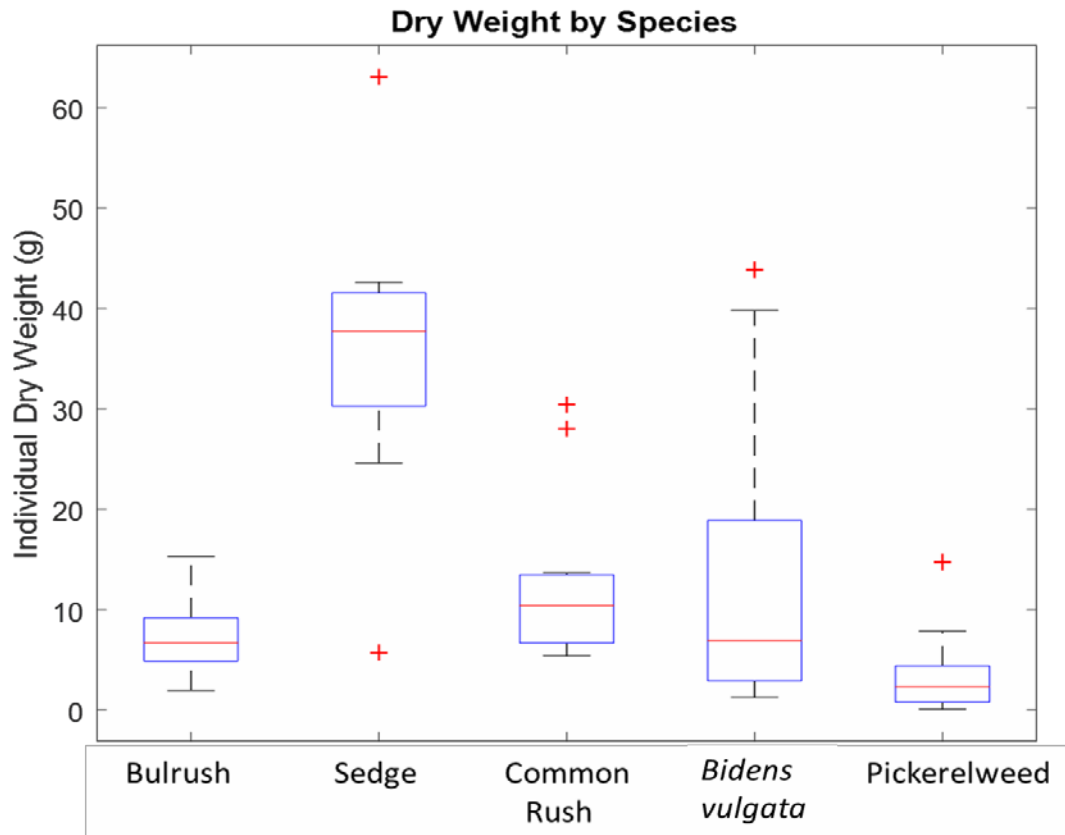
Figure 15: Biomass production by species' individuals ($n=12$ for planted species and $n=28$). Kruskal Wallis followed by Mann Whitney u-test with indicates significant difference between sedge and all other species ($p<0.001$). Pickerelweed was found to result in the lowest biomass production compared to all others ($p<0.01$). *Bidens vulgata* is a weed species that grew on most mats without being planted. It was harvested and analyzed to indicate its potential role as a vegetation choice on FTW in the Northeast. Collected samples indicate a large range of weight between individuals, likely due to the variable age and size because of germination from seed on the mats.

An assessment of biomass production by species gives information regarding which plant type grows the most above-mat biomass and is therefore likely to be more robust to environmental stressors, take up more nutrients, and potentially grow larger root zones. Larger root zones are typically associated with improved particle entrapment and filtration. During the sampling event, a volunteer species was found present in significant numbers on most mats. *Bidens vulgata* is a native species in the daisy family, grows tall woody stems, and multiple small flowers. Seeds germinated and took root on the mats and grew to significant size. As a result of their robust growth, they were included in the biomass analysis in order to characterize the potential significance of their presence and suitability for use in FTW installations. The results of the biomass assessment are below (Figure 15).

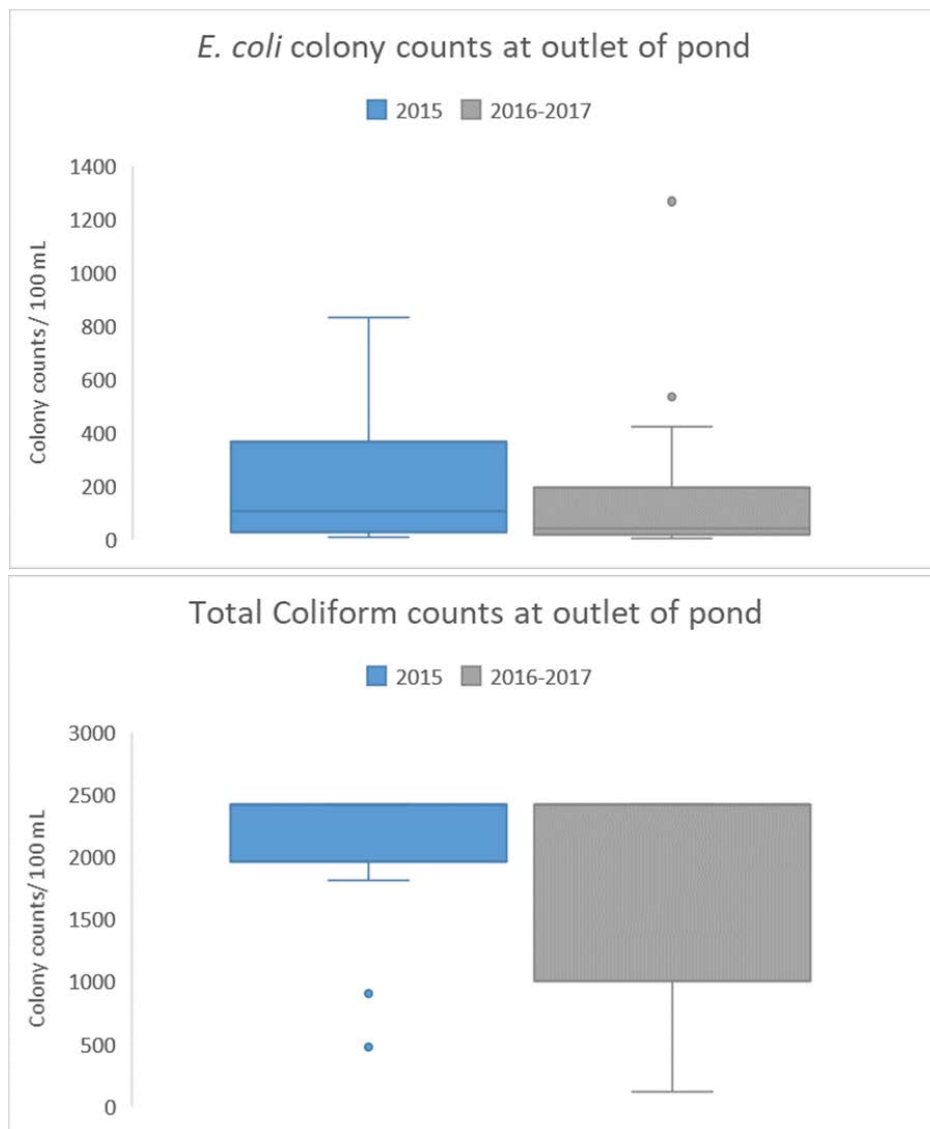
Figure 16: Comparison of *e. coli* and total coliform counts at pond outlet before and after FTW installation. n=12 for 2015, n=17 for 2016-2017. The box indicates the interquartile range. The line within the box indicates the median of the dataset. Coliform graphs are skewed so that the median is at the top of the box (2419.6 colonies/ 100 mL).

The bacterial data resulted in no difference between pre- and post-FTW years for *e. coli* or total coliform counts (though the range of total coliform counts at the outlet trended towards fewer colonies after FTW installation.) The influence of temperature, solar intensity, and number and size of storm events could be major factors influencing bacteria entering the pond. Concurrent sampling of side-by-side basins with and without FTW could clarify if the FTW had no influence on this metric or if this effect was impossible to see due to weather condition differences between years (Figure 16).

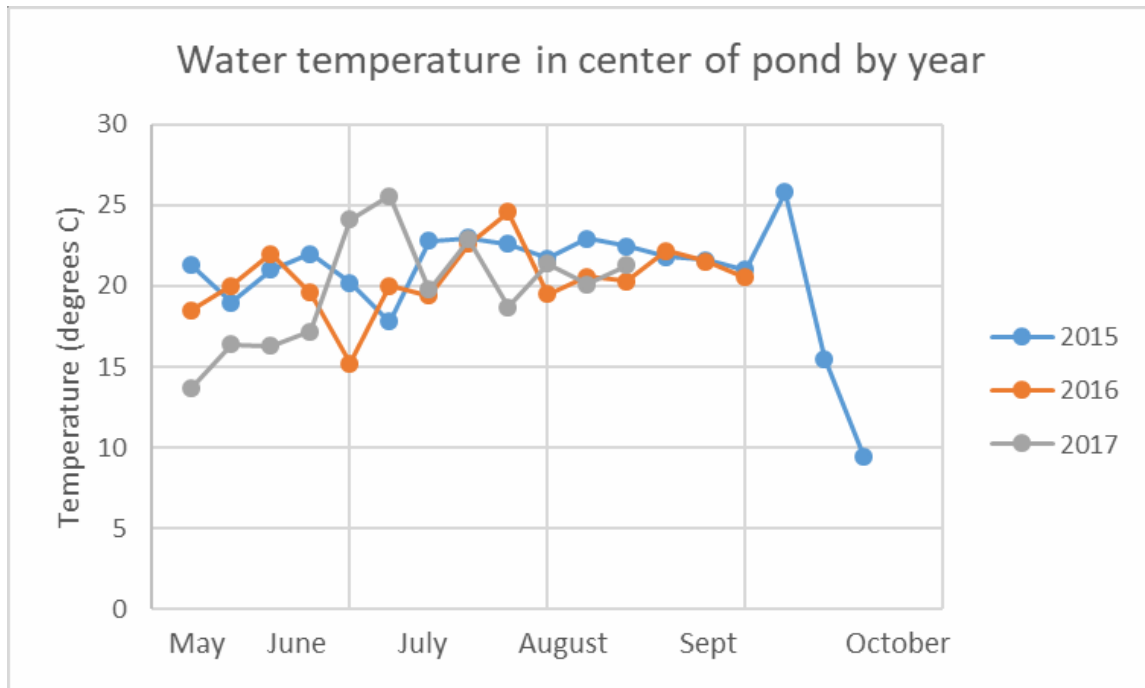
Figure 17: Water temperature at the center of the Quarry Ridge stormwater pond in each year of the study.

No differences in water temperature at the center of the pond were detected between years. To definitively determine an influence by FTW on pond water temperature, concurrent side-by-side analysis of basins with and without FTWs is necessary as there are confounding factors at play over the course of a multi-year study that are impossible to control for (Figure 17).

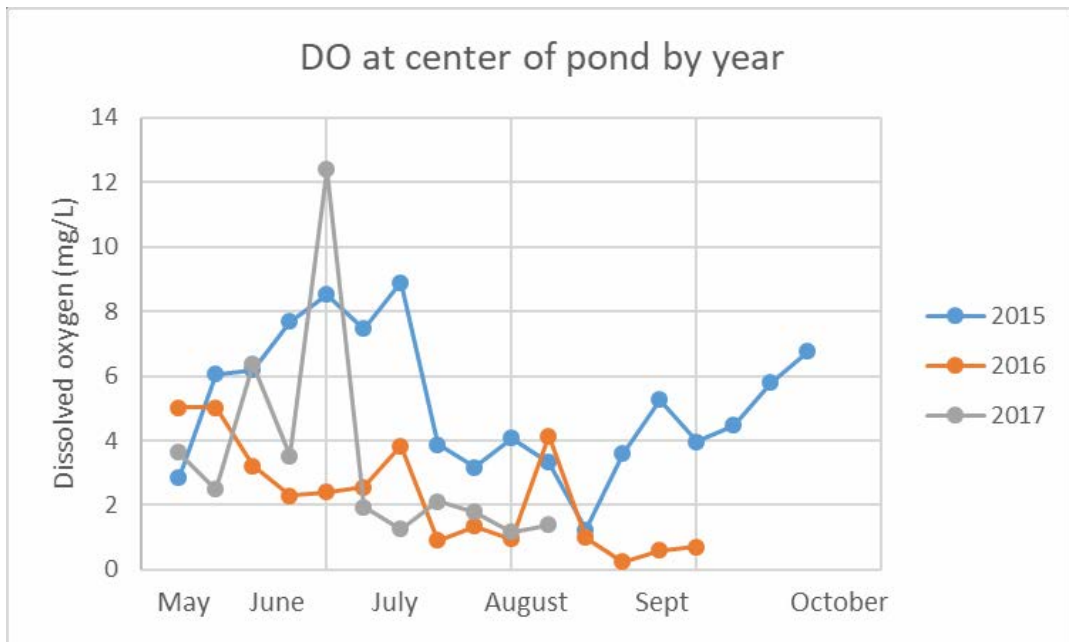
Figure 18: Dissolved oxygen in the center of pond by year of study (2015 is pre-FTW and 2016 and 2017 are post-FTW)

Dissolved oxygen was measured in the pond to track the potential for depressed levels as a result of FTW mats reducing fetch and reducing turnover of water in the water column (Lane et al., 2016). Our data show many instances of lower dissolved oxygen levels in the post FTW years as compared to pre-FTW installation. Overall, DO levels in the pond were lower in the post-FTW period than prior to FTW installation (2015) ($p=0.027$). This is a concerning trend as the presence of oxygen influence microbial respiration and the behavior of species bound to redox-sensitive compounds (ie. Fe) (Figure 18).

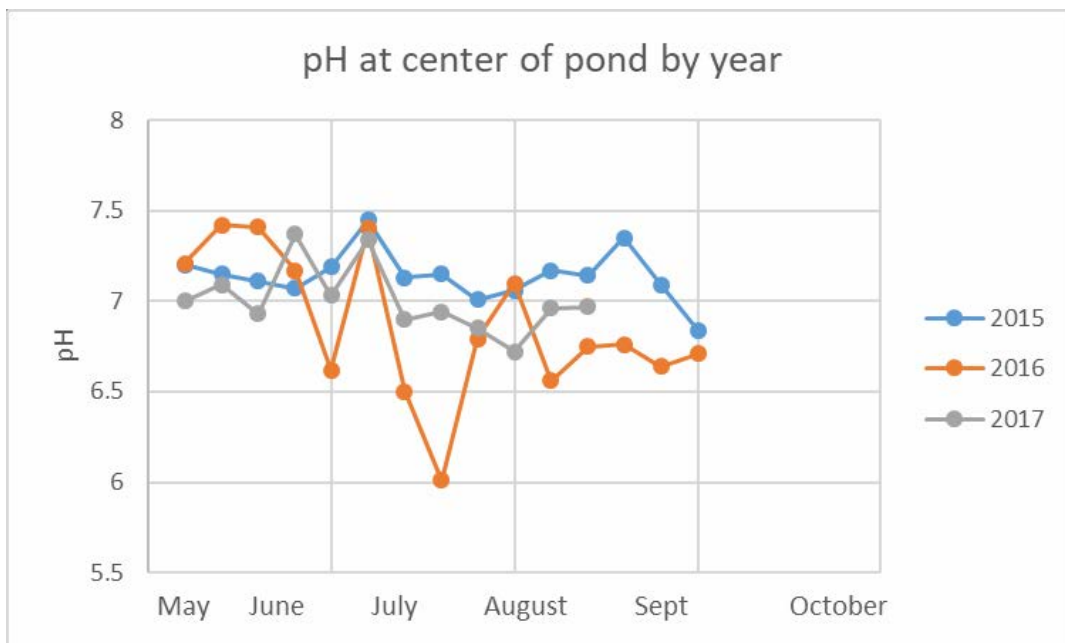
Figure 19: pH at center of pond in each study year (with and without FTW present)

The pH at the center of the pond fluctuated throughout the year and is slightly lower overall in the years with the FTW installed (Figure 19). The direction of the pH change is surprising, as the addition of plants, which take up CO_2 from the water and respire O_2 , is associated with a slight increase in pH of water. This opposite effect may be a result of the FTW replacing floating submerged aquatic plant species that were shaded and could not compete. Chara, a type observed in abundance throughout the Quarry Ridge pond in 2015, is associated with calcium nodules in the plant cells. An abundance of this species in a pond may cause an increase in pH due to the calcium cation providing charge balance to buffer against increasing acidic conditions. Hence, where FTW displace a species that would otherwise be present, unexpected influences on pond water quality are possible.

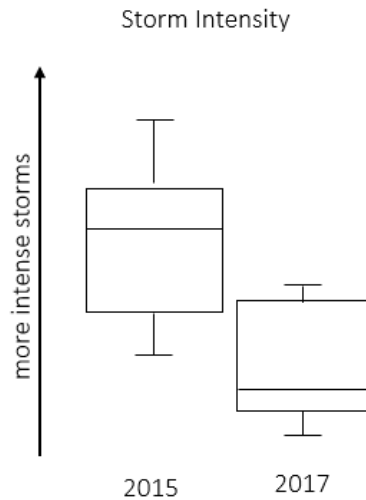
Figure 20: Captured storms were more intense in 2015 than 2017 ($p=0.008$) as determined by Mann Whitney U test.

Storm intensity did differ between 2015 and 2017 (Figure 20). Sampled storms in 2015 were less intense than in 2017 ($p=0.008$).

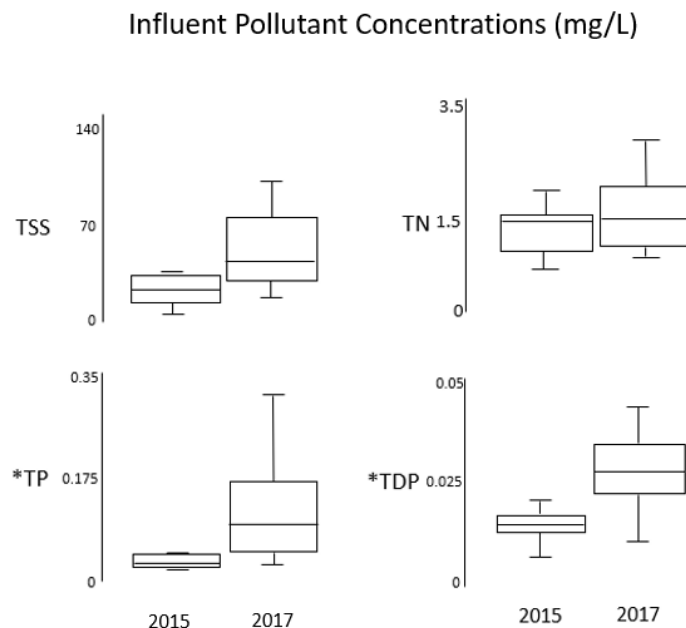
Figure 21: Influent pollutant values between pre- and post-FTW (units in y-axis are mg/L). While TSS influent concentration distributions are not statistically different, the graph indicates a greater spread in the influent TSS concentrations in the post-FTW year (2017) as compared to the pre-FTW period (2015). Influent TN values overlap much more and are not statistically different. Conversely, TP and TDP influent concentration values are different between pre- and post-FTW years. As a result, pond performance in the removal of those parameters are determined by % concentration difference between inlet and outlet.

Both TN and TSS influent concentration distributions were the same between years (as measured by Mann-Whitney U test). TP and TDP influent concentrations are non-normally distributed and differ between years (Figure 21). There was more TP and TDP coming in to the pond in 2017 than 2015 ($p=0.035$, 0.037 respectively).

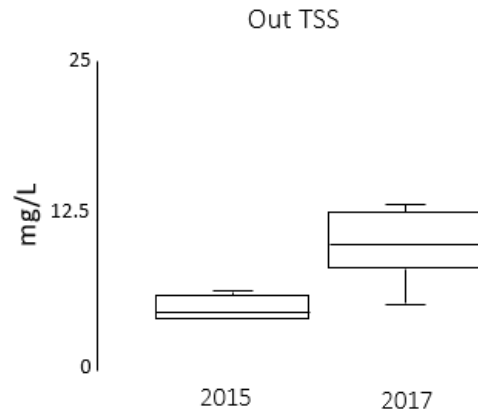
Figure 22: TSS concentration in the effluent of the pond by pre- and post-FTW period. 2015 was characterized by a lower concentration of TSS in the effluent while influent concentration distribution did not differ. The 2015 effluent concentration values were consistently low. The influent values that year also did not vary as much as the post-FTW period.

TN effluent values did not differ between pre- and post-FTW years. TSS effluent values did differ ($p=0.025$) between years with greater TSS concentration in the effluent in 2017 (post-FTW) than in the pre-FTW period (Figure 22).

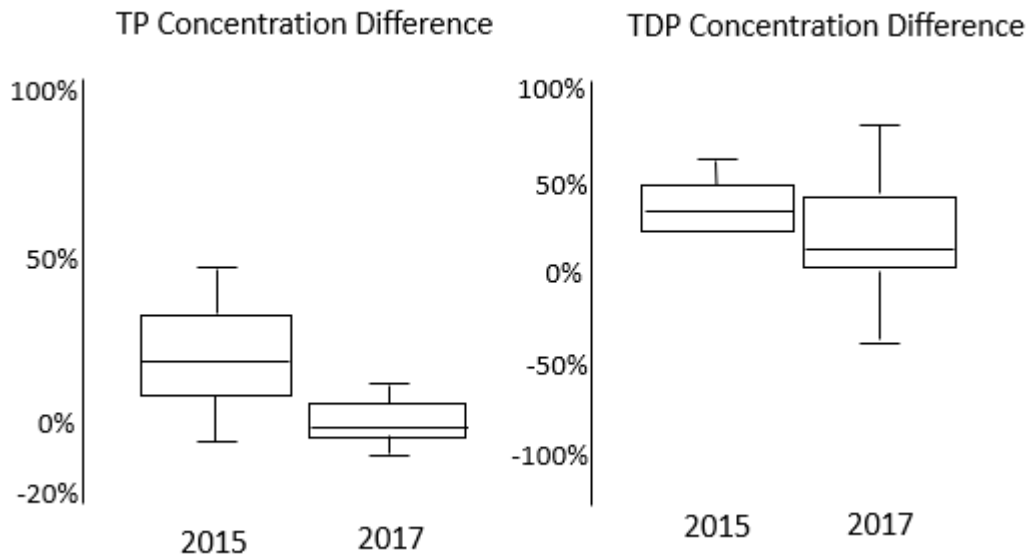
Figure 23: TP and TDP concentration difference between in and out by year. No difference is detected between years in percent concentration reduction pre- and post-FTW. Note that unlike the previous graphs, this figure represents pollutant removal performance where higher values denote greater removal of the pollutant (better performance).

Because TP and TDP influent concentrations differed between years, comparison of pond performance was determined as a ratio with influent and expressed as percent concentration difference between influent and effluent. Both TP and TDP concentration differences from influent to effluent did not vary between years (Figure 23.)
