AUSABLE RIVER ASSOCIATION (AsRA) UPDATES

Ausable River Association | April 22, 2024

New York Citizens Advisory Committee (NYCAC) on
Lake Champlain Management

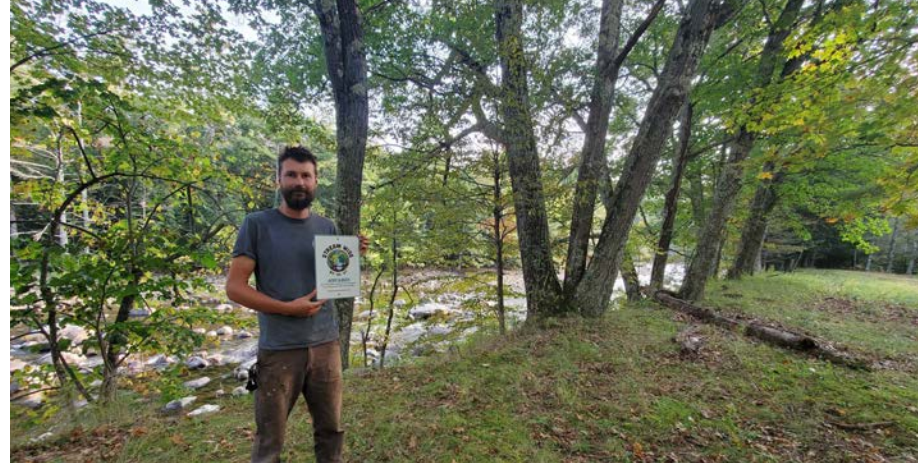
The current buffer meets all of the criteria provided by Stream Wise. All of these criteria are listed on **pages 9 and 10**. The buffer meets the minimum width though there is room for expansion on the house side of the river. The buffer contains a lot of native diversity though there are a few invasive species. All tiers and zones are present within the buffer. Dead and downed trees are left in the buffer to provide habitat and nutrients. Access paths are minimized and there is little to no disturbance (mowing, raking, cutting) within the buffer and none within the Streamside (15ft from the river) zone. No area of concentrated flows from overland runoff.

In the tree canopy and understory, we noted several native tree species, including Eastern hemlock, white pine, sugar maple, basswood, red oak, white ash, and elm. We identified a few different species of shrubs in the buffer including common ninebark, American witch-hazel, meadowsweet, serviceberry, and chokecherry. There were many wildflowers and grasses including New York aster and goldenrods and few ferns including ostrich fern.

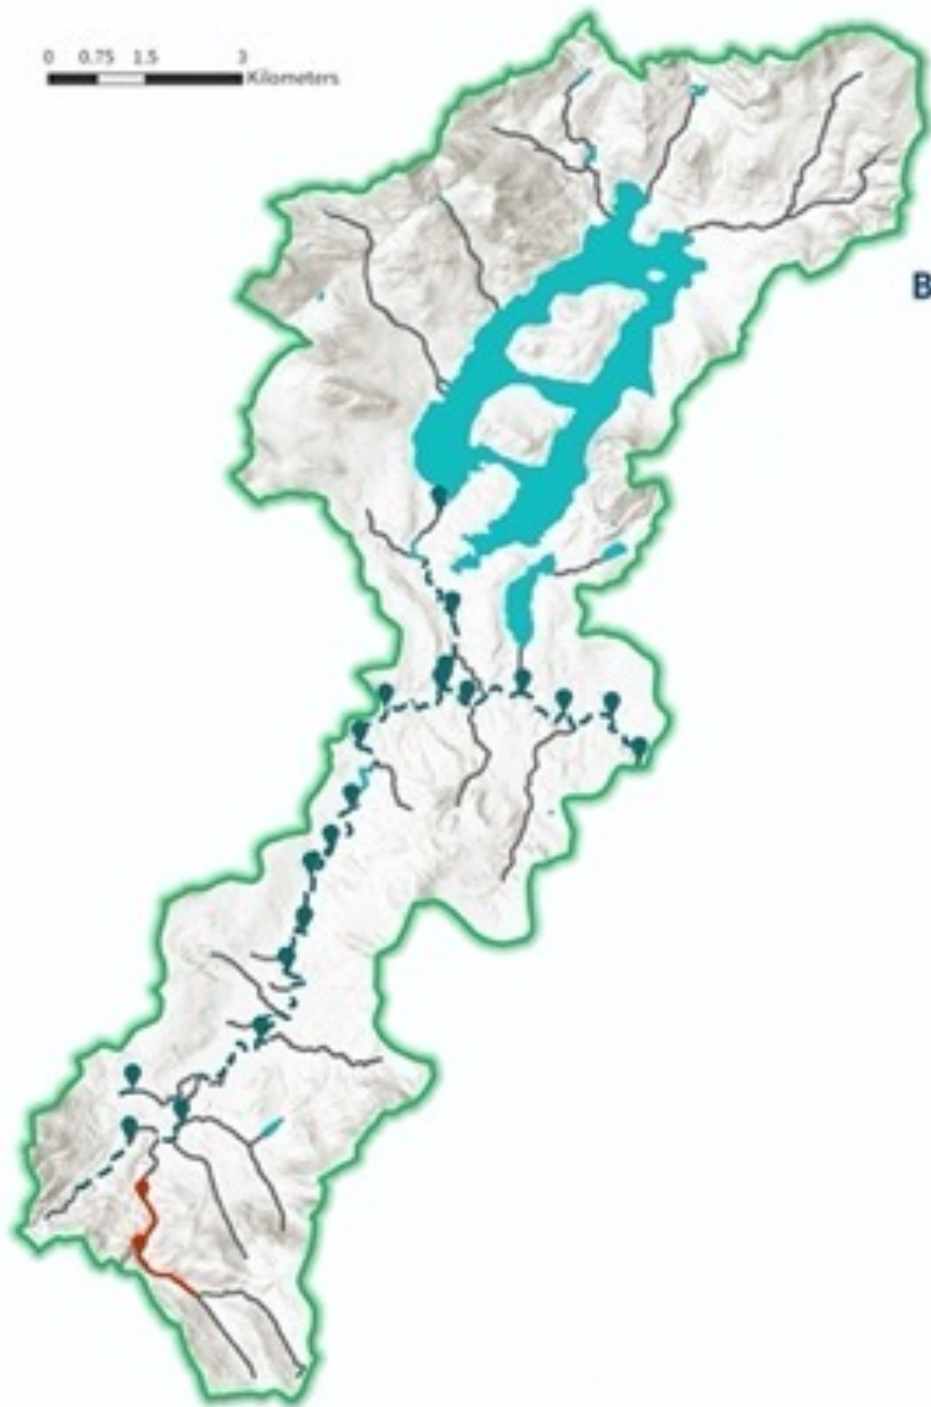
eDNA Detections
📍 **Brown Trout**
📍 **Rainbow Trout**
📍 **Both**
📍 **Neither**

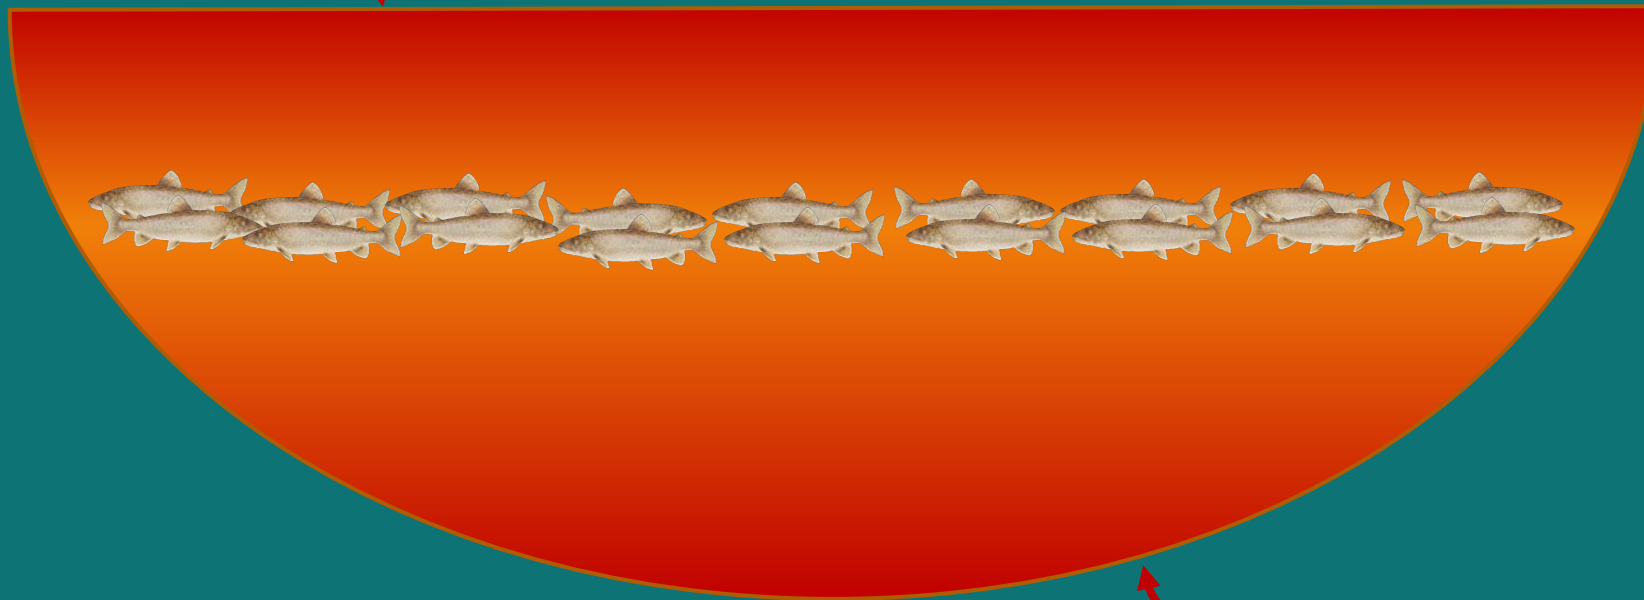
Late Summer

Too Warm

Low Dissolved Oxygen

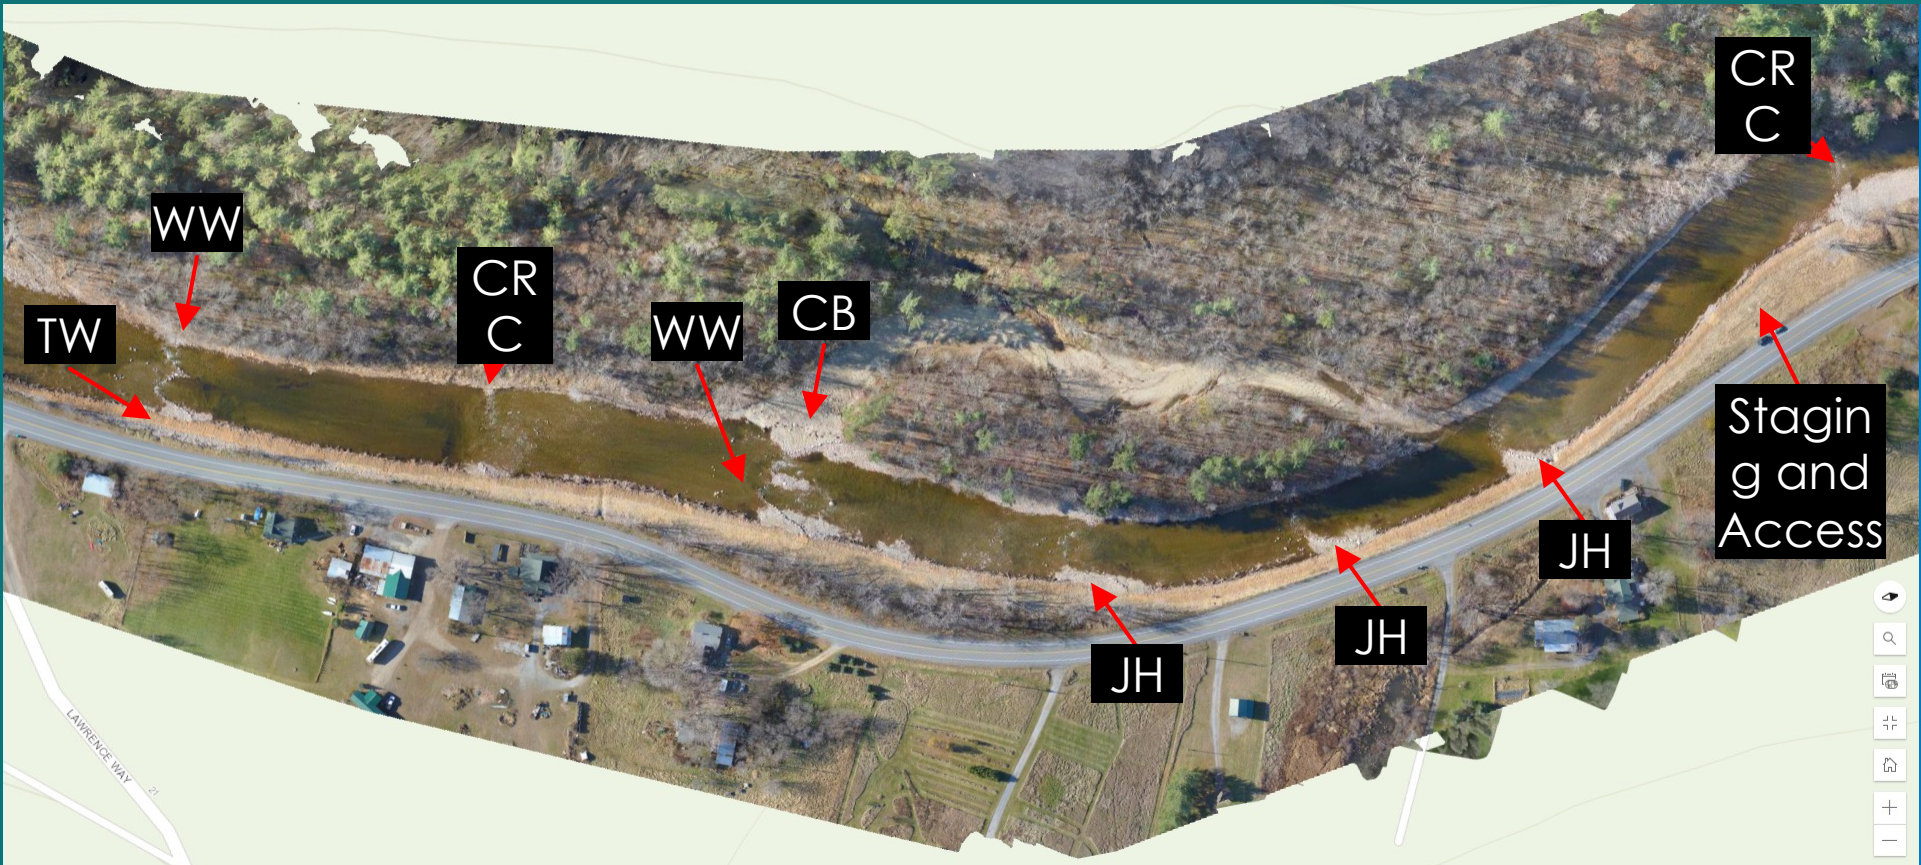
Project Area 2

WW – w-weir; TW – toe wood; CRC – converging rock cluster;
JH – j-hook; CB – channel block
