Tile Drain Base-flow Phosphorus Removal Using St. George Black

June 2025

Prepared by: Watershed Consulting Associates. LLC

The Lake Champlain Basin Program and NEIWPC

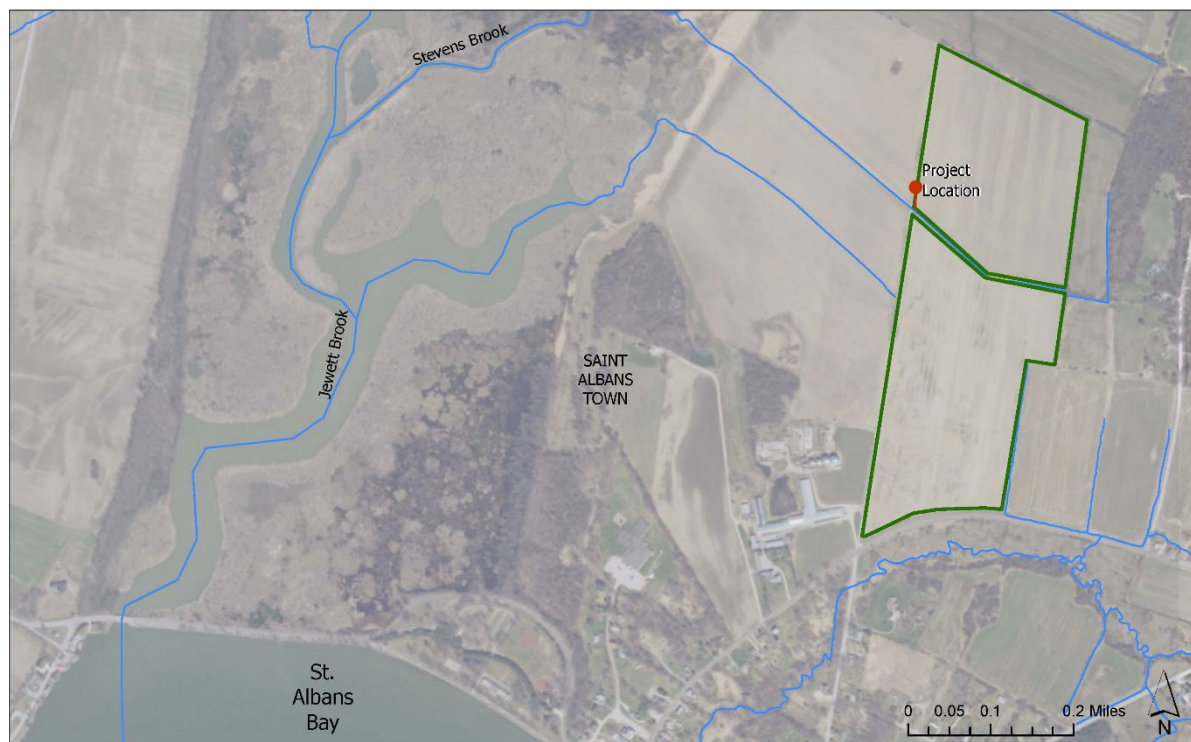
Figure 2. Project sampling location. Ditch collecting tile drain effluent from adjacent fields (outlined in green) where filter will be installed, marked with the red pin.

Samples were taken from the influent and effluent points of the ditch filter box at the approximate latitude and longitude: 44.818208, -73.132996 (Figure 2).

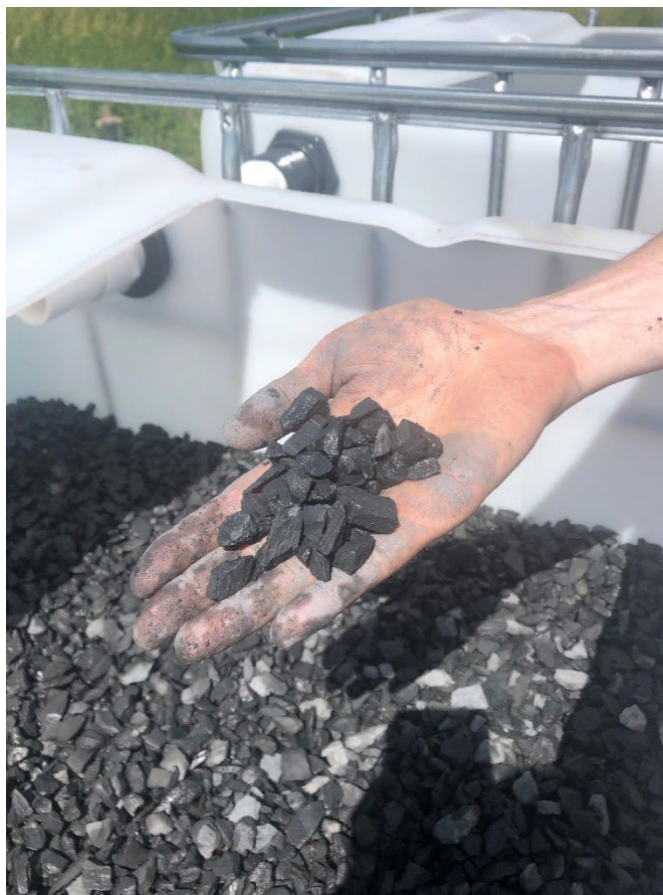
Figure 3. St. George Black media within the filter housing unit.

The SGB media was optimized to have a coarseness size of ¾" x ¼". This material was thoroughly washed to remove all fines that could potentially clog the treatment system. Based on this coarseness, the hydraulic conductivity of SGB appropriate for the filter was 0.86 cm/min (0.01 cm/sec). Two cubic yards of SGB was required to completely fill the filter units (Figure 3).

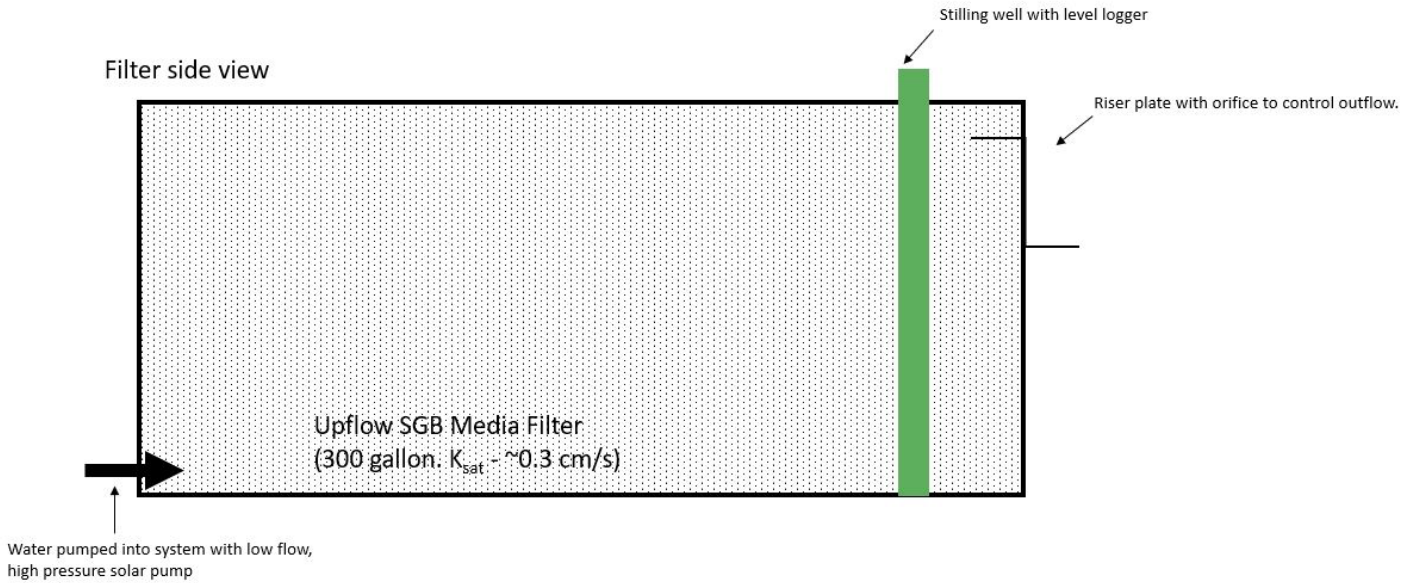
Figure 7. Side view of the proposed filter.

A tile drain filter study funded by LCBP in 2016/2017 resulted in recommendations for improvement that this filter design is taking advantage of. Notably, the 2017 report recommended high saturated hydraulic conductivity (>0.3 cm/s) and an up-flow filter design to avoid clogging (Braun, 2017b). The previous investigation also noted the challenge of housing the filter media in a closed, buried, concrete tank which lacked accessibility. The construction of such a system was costly and impractical on a working farm. In response to these recommendations, the proposed filter in this study had an up-flow filter design with a highly conductive material in a sufficiently

large housing unit to allow optimal contact time with the media (Figure 7). The filter housing was specified to be a prefabricated plastic tub commonly used on farms and easily purchased from local farm stores. This also gave the added benefit of ease of installation and removal at the end of the study period or potential replacement with a different media to test alternatives in a future study. Figure 5 through Figure 8 illustrate the existing conditions on the study site and the proposed location of the filter and sampling equipment.

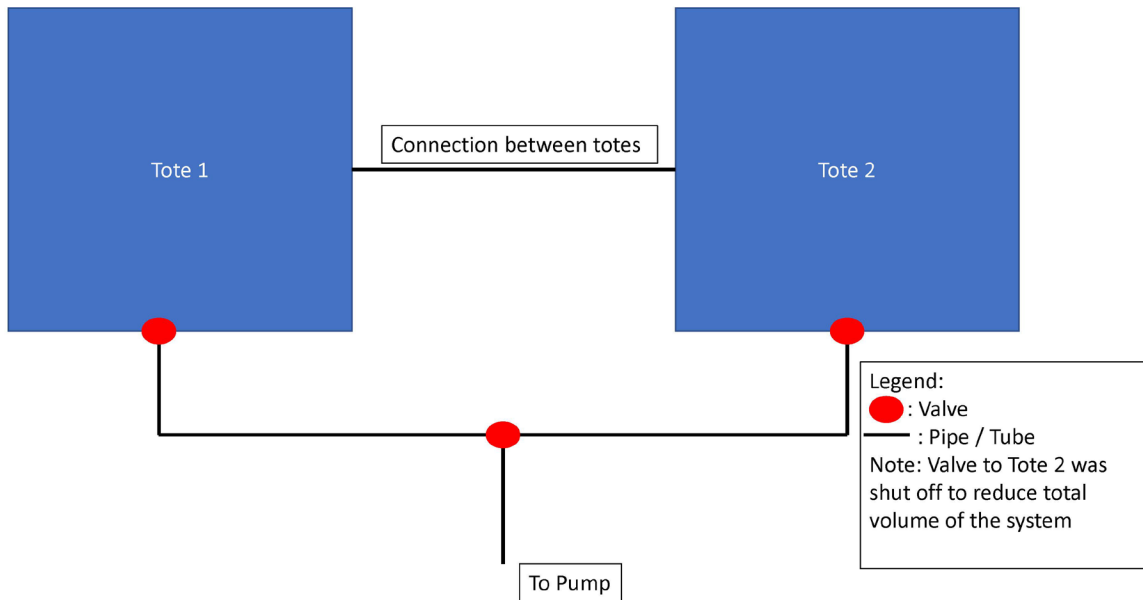
Figure 8. A schematic of the two filter housing units connected to each other and the pump.

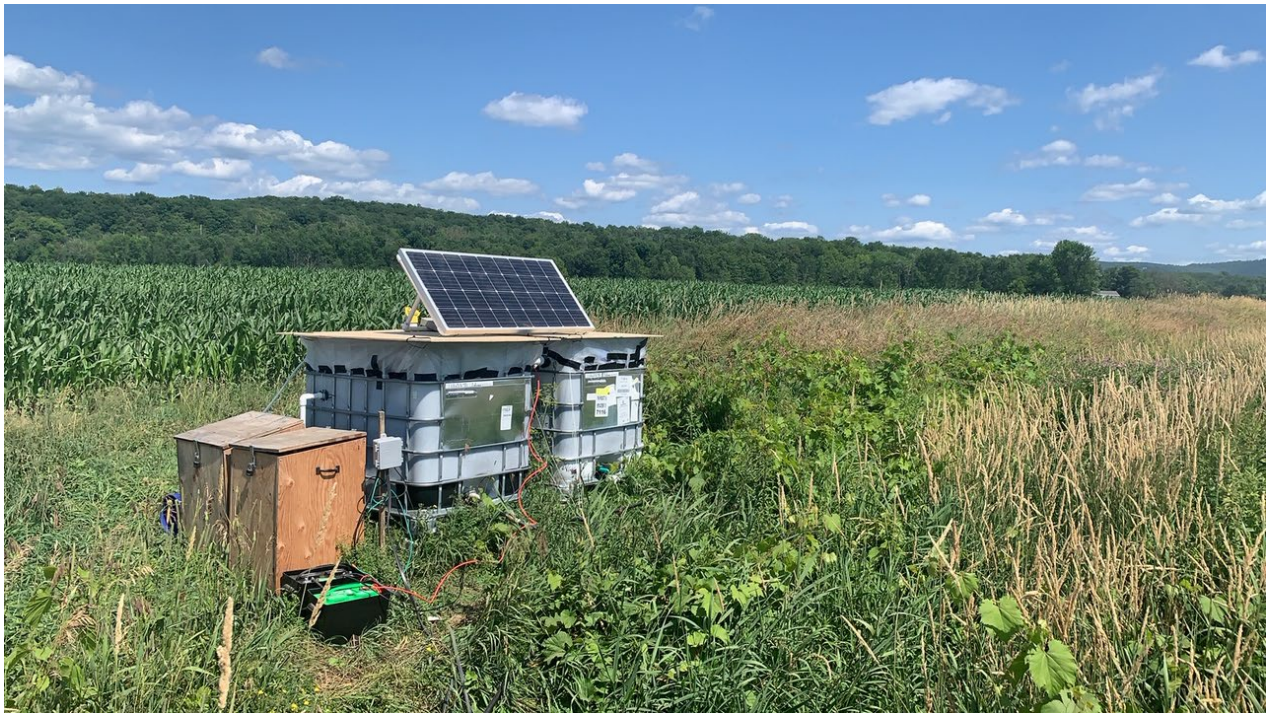
Figure 9. The original experimental design setup with the filter units, ISCO samplers, solar panel, batteries, sump, and the Sunpump.

The Spring 2019 conditions in the field were very wet, delaying the delivery date of the SGB and pushing back the first sampling events. Some challenges with pump activity were also encountered as the solar pump failed to operate when linked only to the 12-volt batteries. Additional electrical connectors were ordered to fix this issue. The filter units themselves were installed in the field to process tile water. The experimental design setup was finalized by May 2019 (Figure 9-Figure 12).

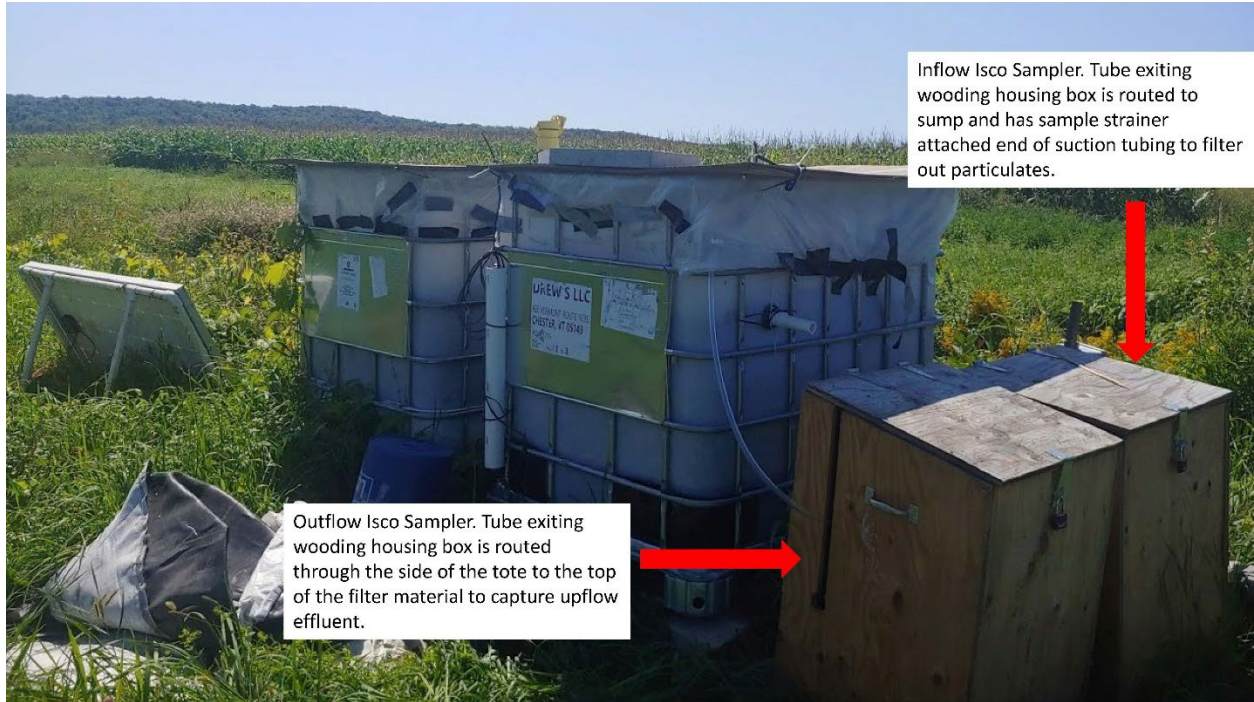
Figure 10. ISCO Sampler setup.

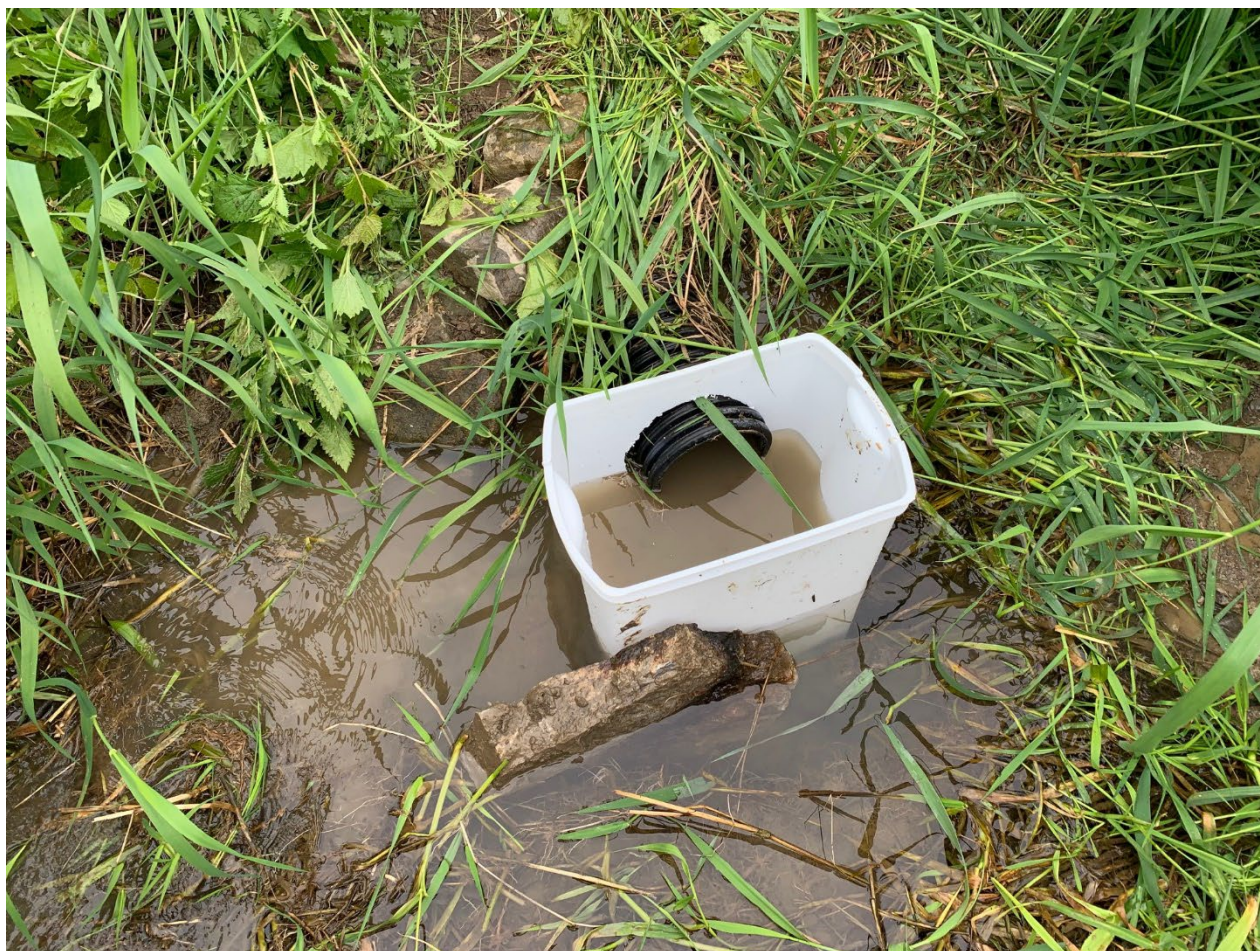
Figure 12. Close-up of sump collecting ditch flow.

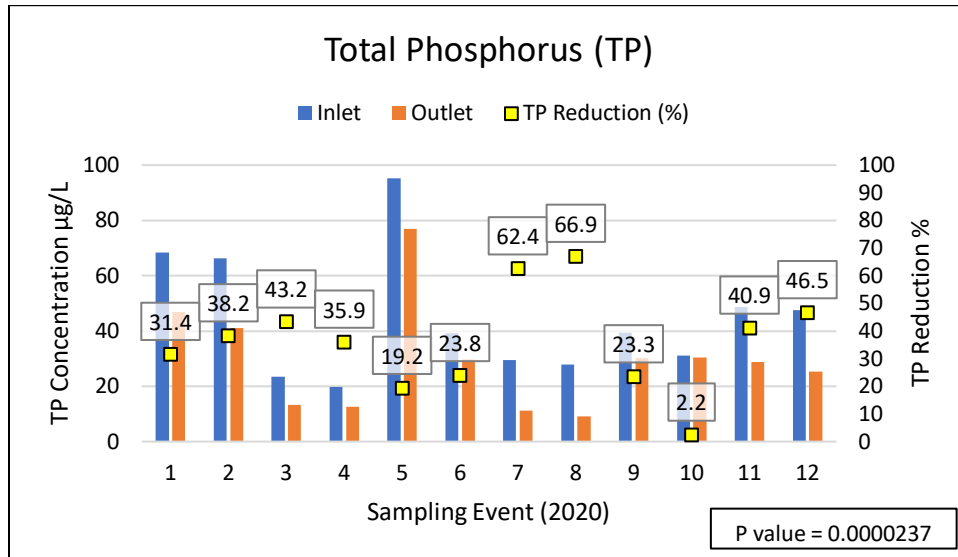
Figure 13. Total Phosphorus concentrations are shown for the inlet and outlet over 12 sampling events. A paired, normal distribution t-test was performed to determine significance. TP reduction is statistically significant as shown by the P-value. Note that vertical axis scale differs between the 2020 and 2021 plots.

A two-tailed, paired distribution t-test was performed on the TP, TDP, and SRP datasets to produce a P-value for each dataset. Results of this analysis show that outlet concentrations were significantly lower than inlet concentrations during events for TP ($p < 0.05$), TDP ($p < 0.05$) and SRP ($p < 0.05$).

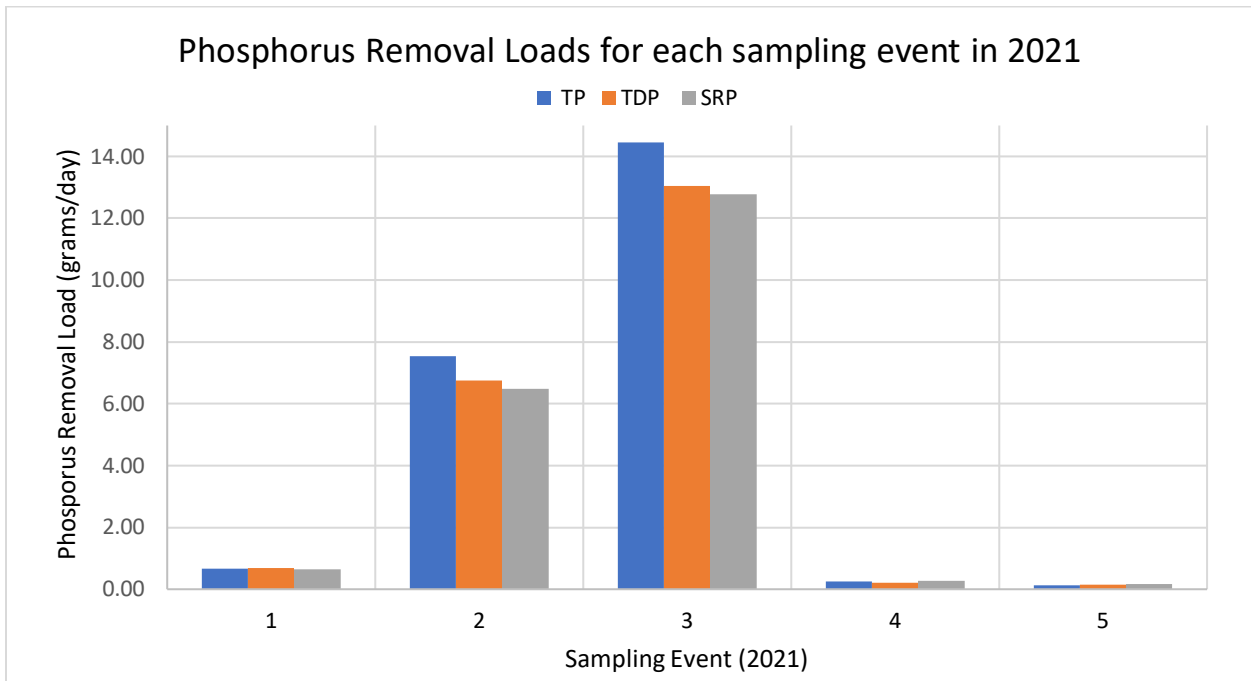
Figure 20. Phosphorus removal loads for each of the P forms for each sampling event in 2021. Note that each P form is displayed in its own-colored bar. Also note that the scale for the load in grams per day is different than the scale for the sampling events in 2020.

The average loading rate for each sampling event can be seen in the graphs below. The sampling events in 2021 has a wider range of loading rate, as displayed in a different scale as the graph for 2020. The loading rate for 2020 can be seen in Figure 19. The loading rates for each of the sampling events in 2021 can be seen in Figure 20.
