Port Henry Stream Study

A multi-year investigation of Mill, McKenzie, and Stony Brooks

Aims and Objectives

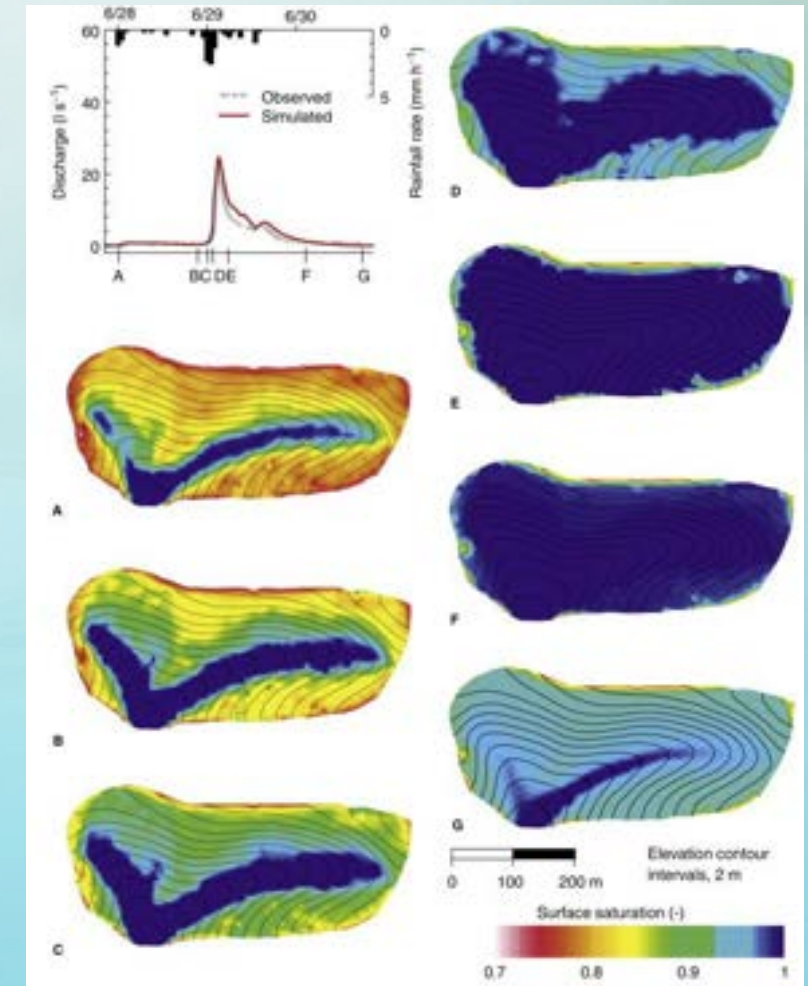
Example of post-rain event time of concentration saturation within a watershed

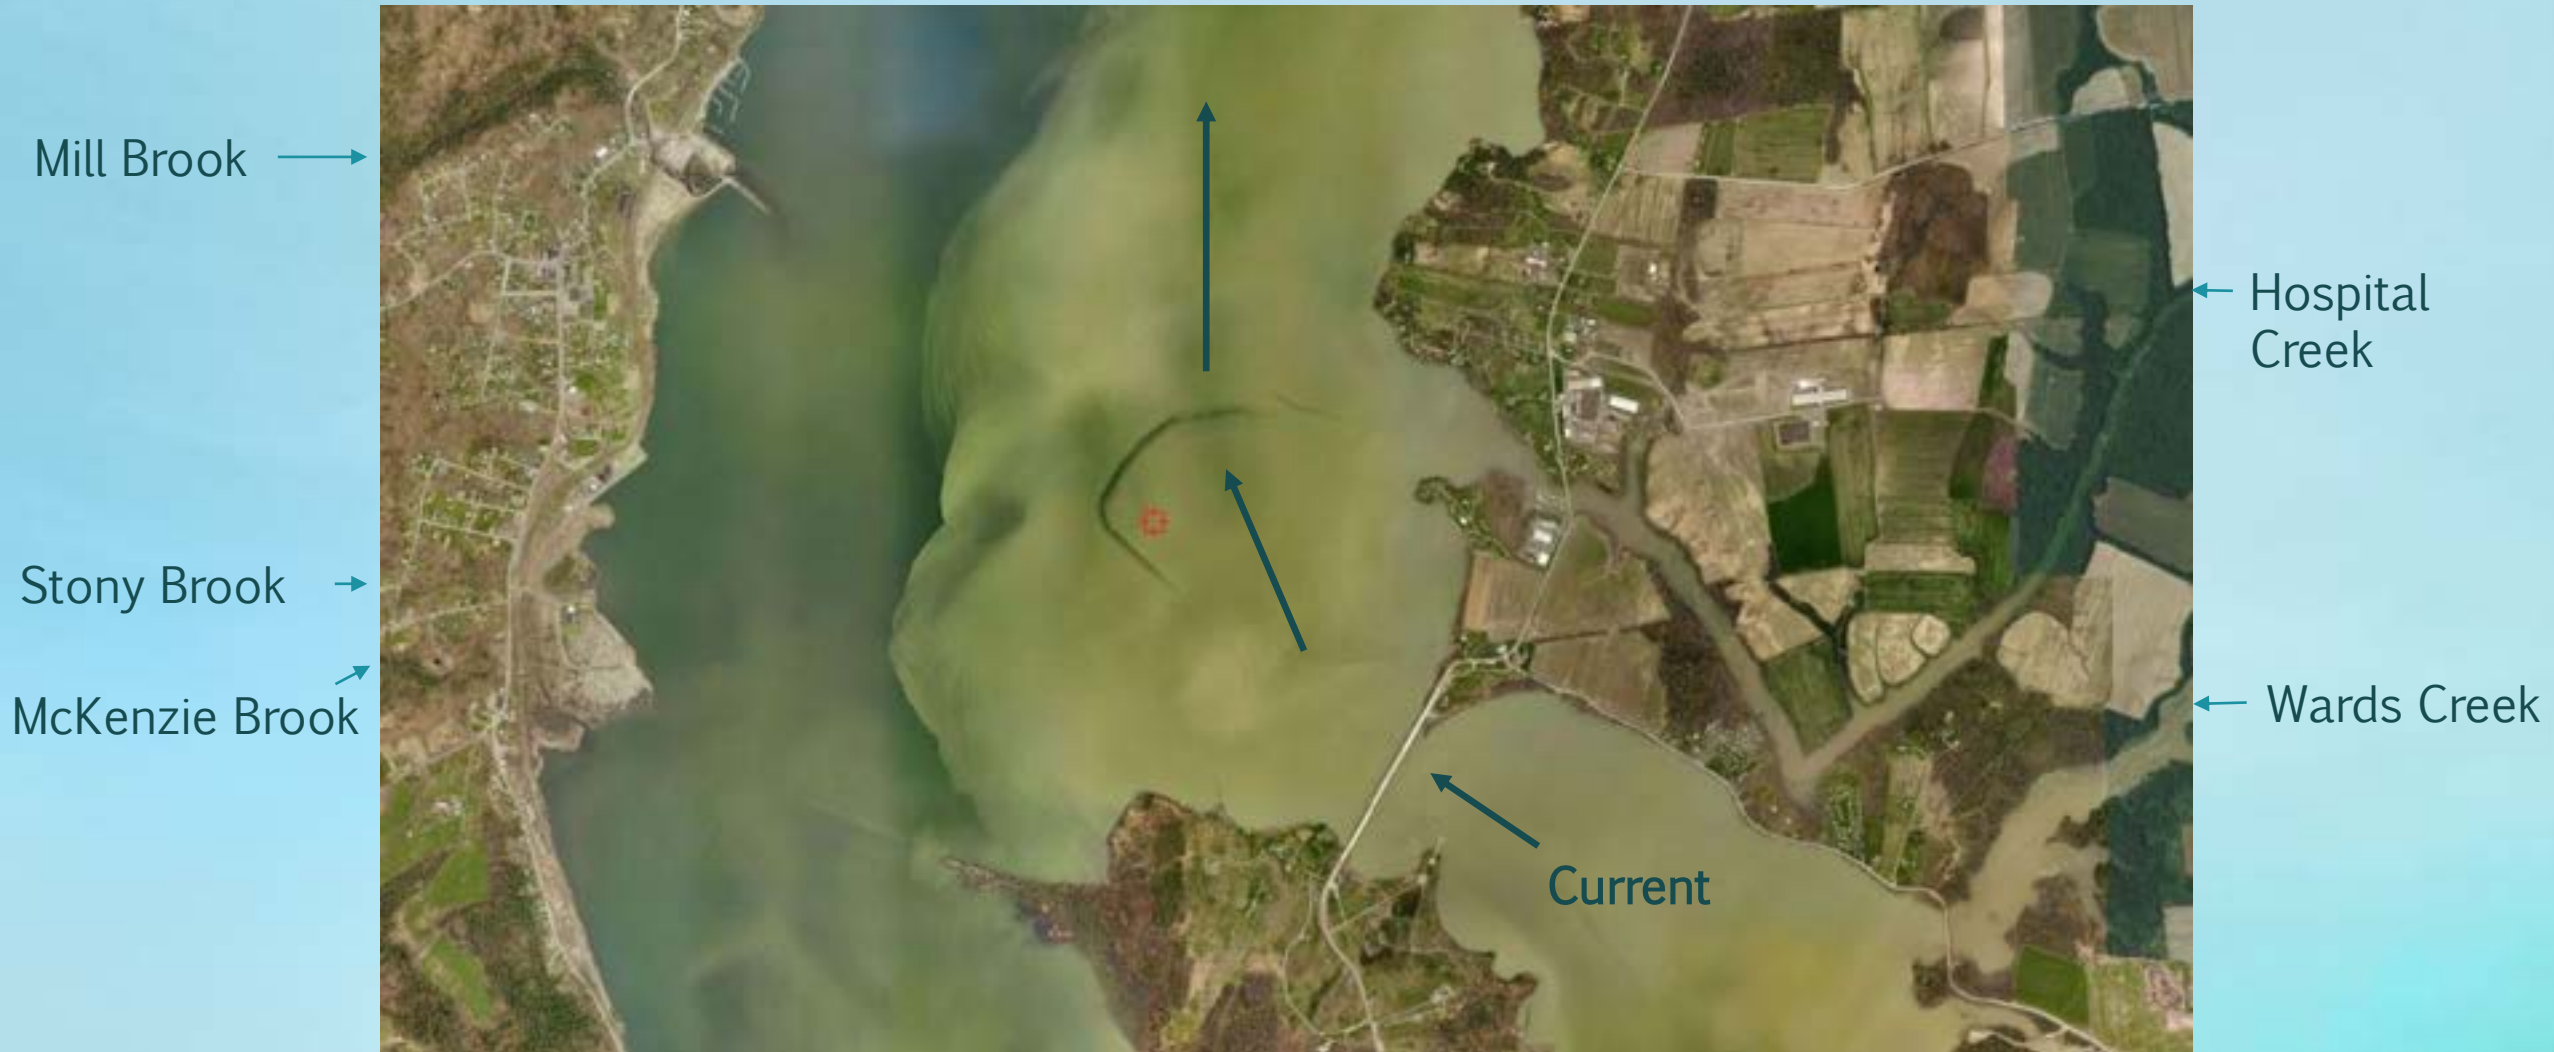
Post Rain Event Sedimentation and Turbidity

- These pictures were taken on the same day, 4 miles apart after a rain event
- Some streams are affected more than others by runoff
- Land use, riparian buffers, and marsh filtration make a difference

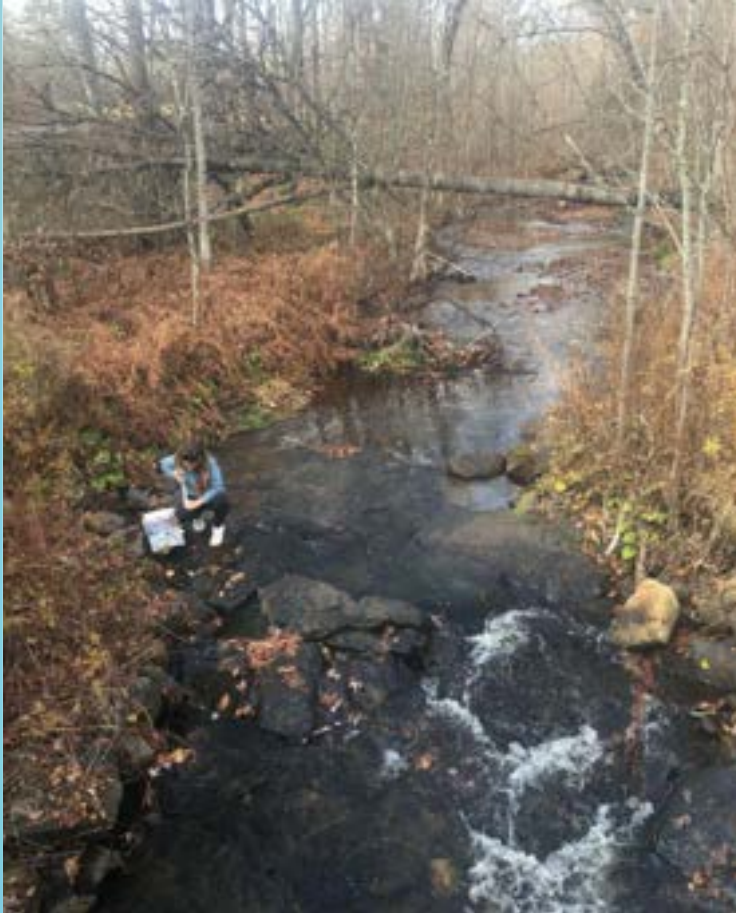
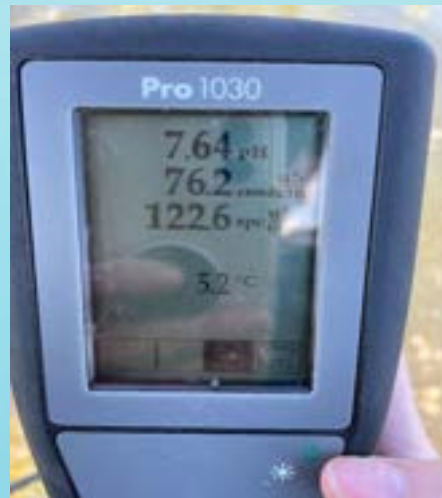
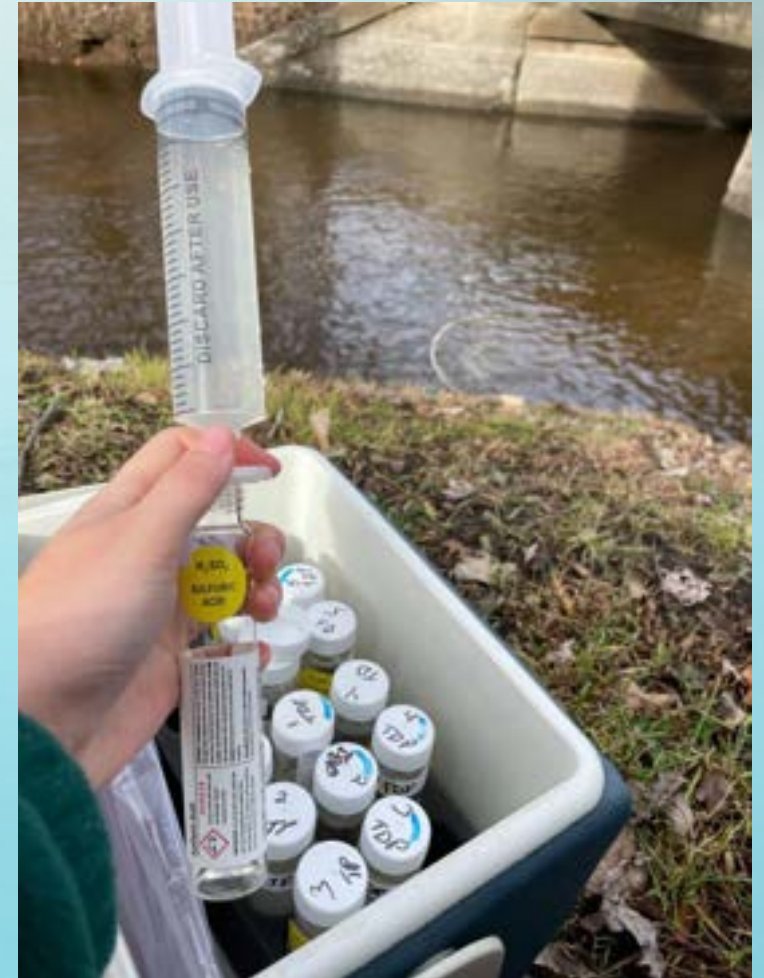
Field data collection:

1. YSI Pro 1030 Probe
2. Water samples to Endyne
3. Endyne data then sent to LaBella Labs for analysis

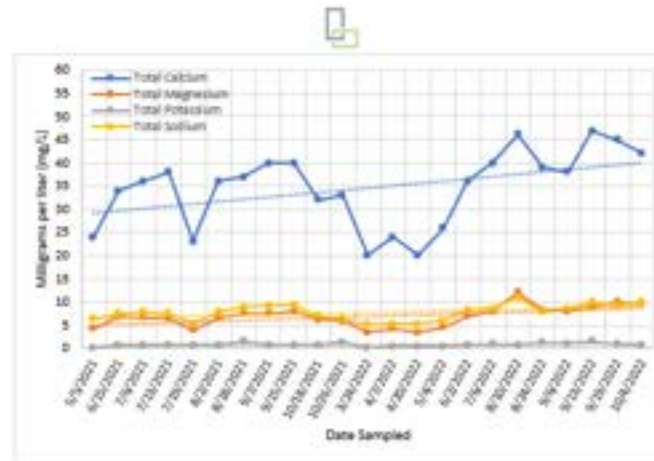
Figure 1.3.1h: Total calcium, total magnesium, total potassium, and total sodium milligrams per liter (mg/L) concentrations from seasonal water quality sampling dates for McKenzie Brook downstream.

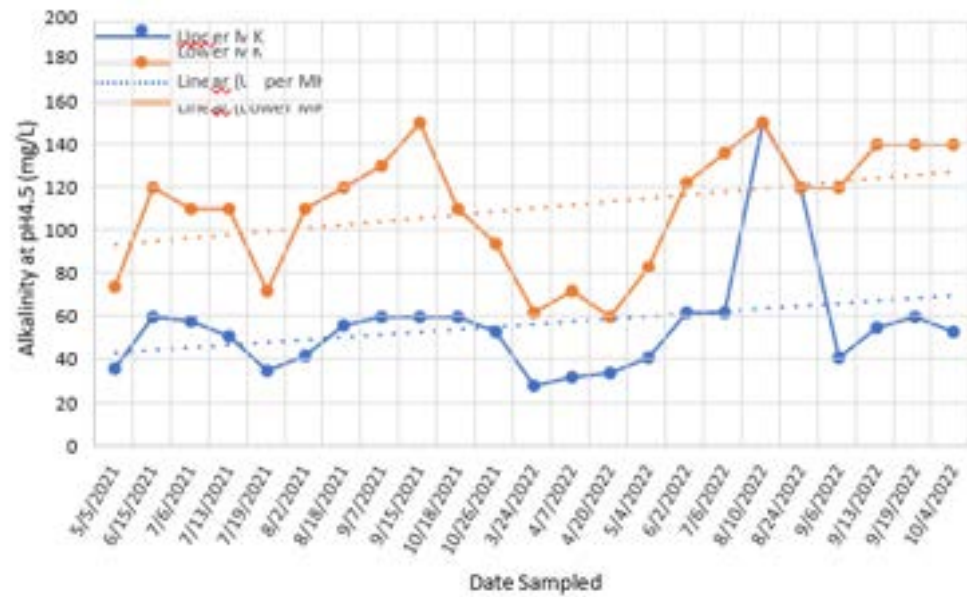
Figure 1.3.1a: Alkalinity at pH 4.5 (mg/L) concentrations from seasonal water quality sampling dates for McKenzie Brook.

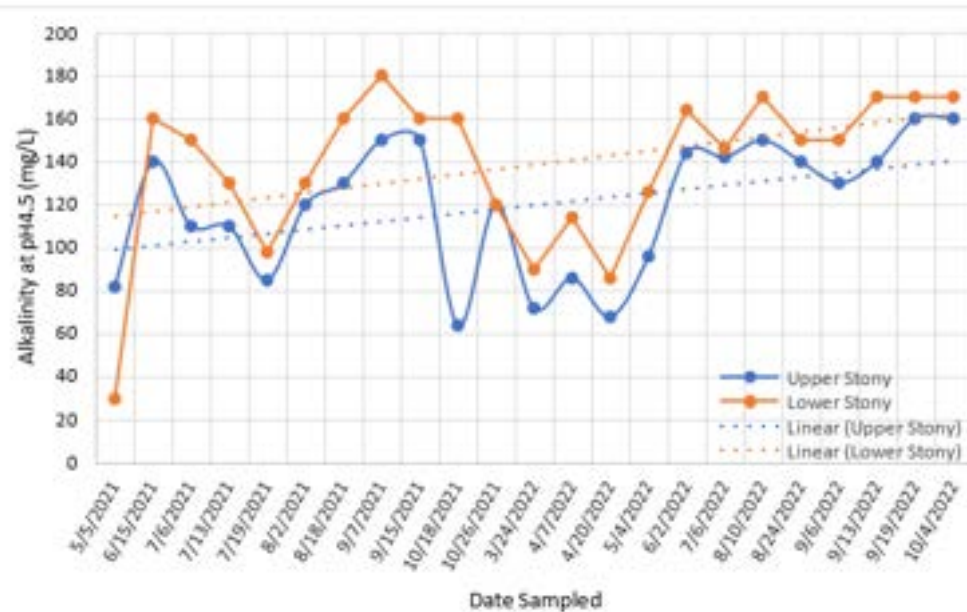
Figure 1.3.1b: Alkalinity at pH 4.5 (mg/L) concentrations from seasonal water quality sampling dates for Stony Brook.

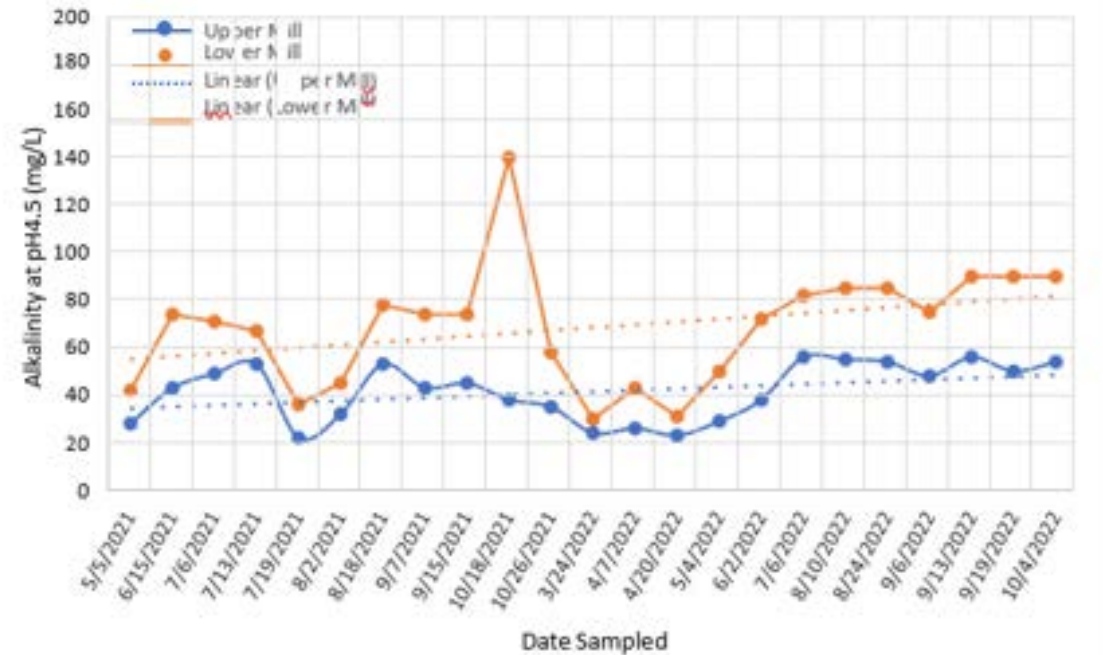
Figure 1.3.1c: Alkalinity at pH 4.5 (mg/L) concentrations from seasonal water quality sampling dates for Mill Brook.

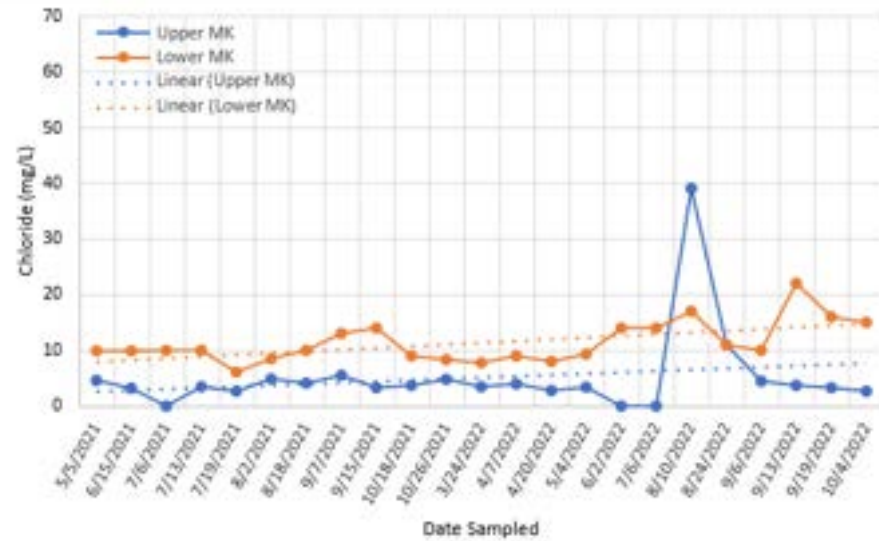
Figure 1.3.1d: Chloride (mg/L) concentrations from seasonal water quality sampling dates for McKenzie Brook.

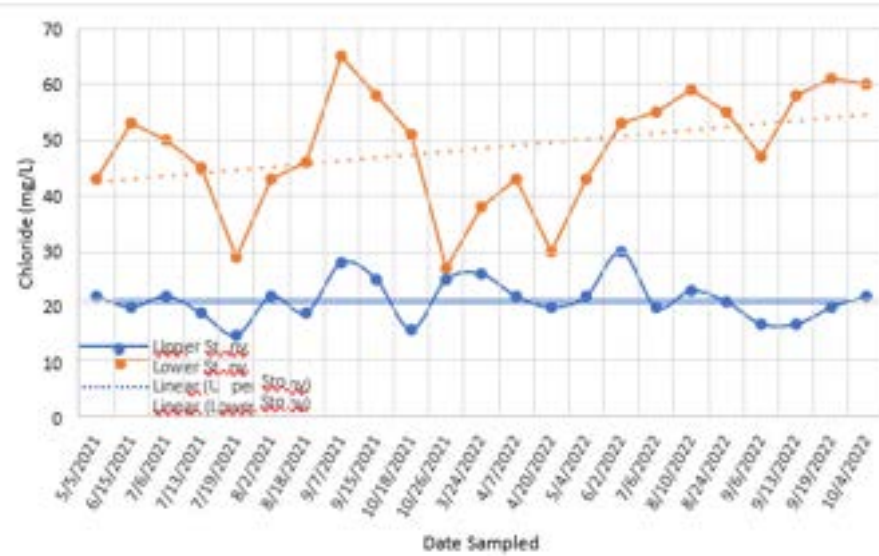
Figure 1.3.1e: Chloride (mg/L) concentrations from seasonal water quality sampling dates for Story Brook.

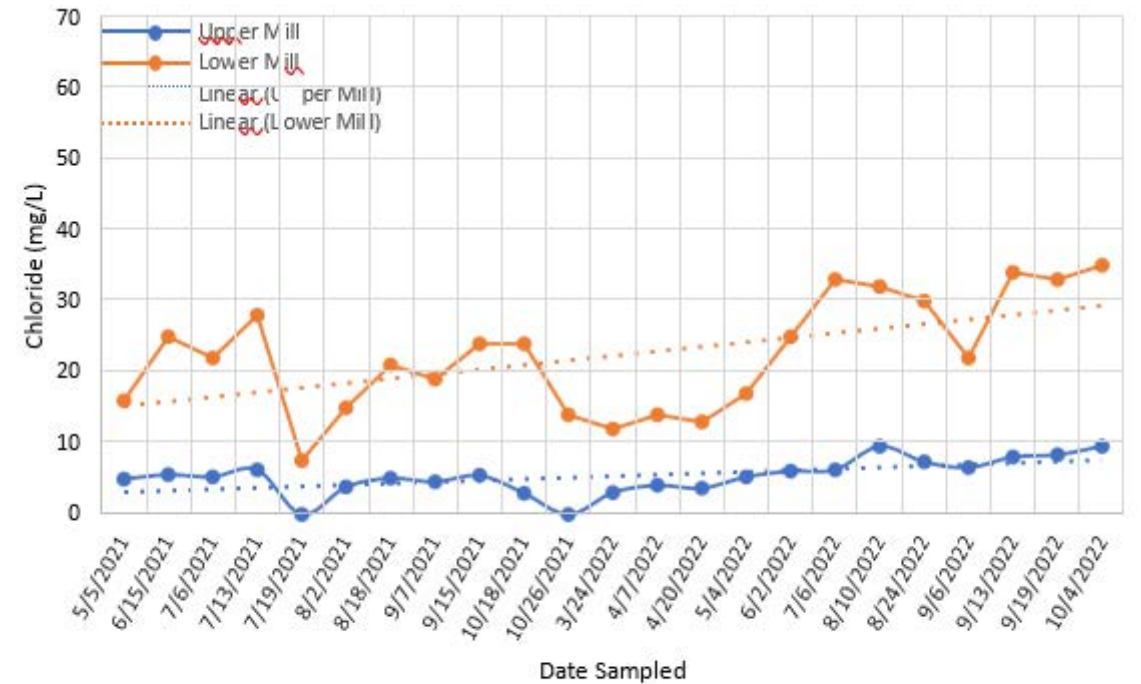
Figure 1.3.1f: Chloride (mg/L) concentrations from seasonal water quality sampling dates for Mill Brook.

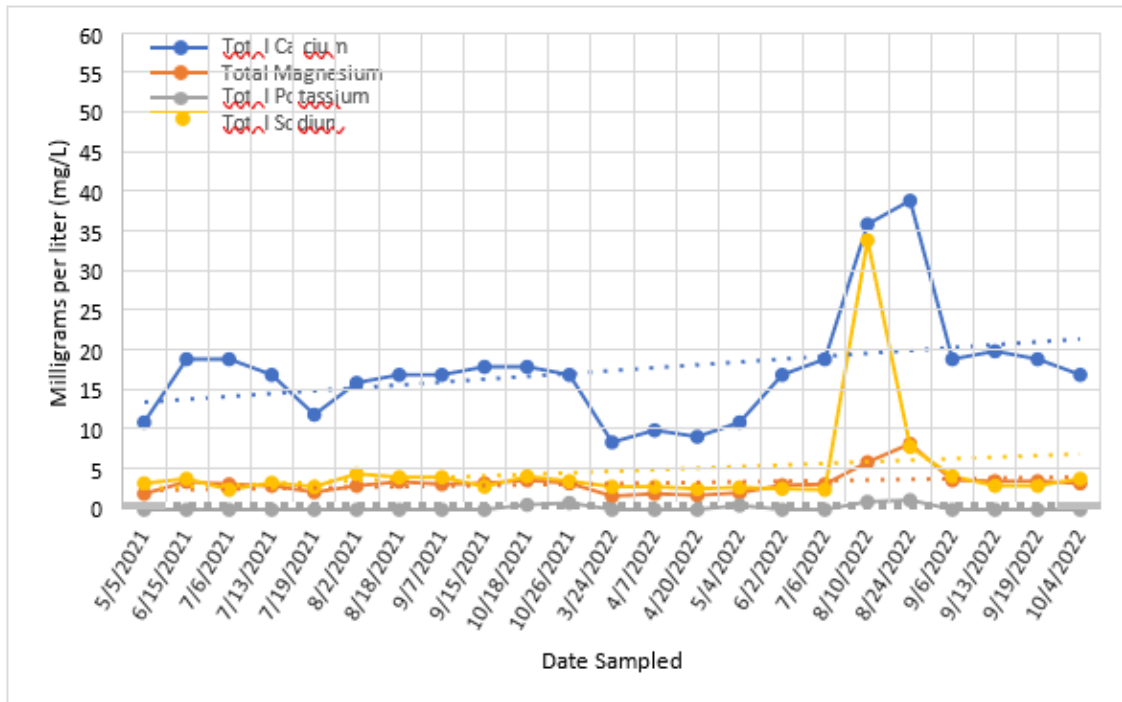
McKenzie Brook Upstream

Figure 1.3.1g: Total calcium, total magnesium, total potassium, and total sodium milligrams per liter (mg/L) concentrations from seasonal water quality sampling dates for McKenzie Brook upstream.

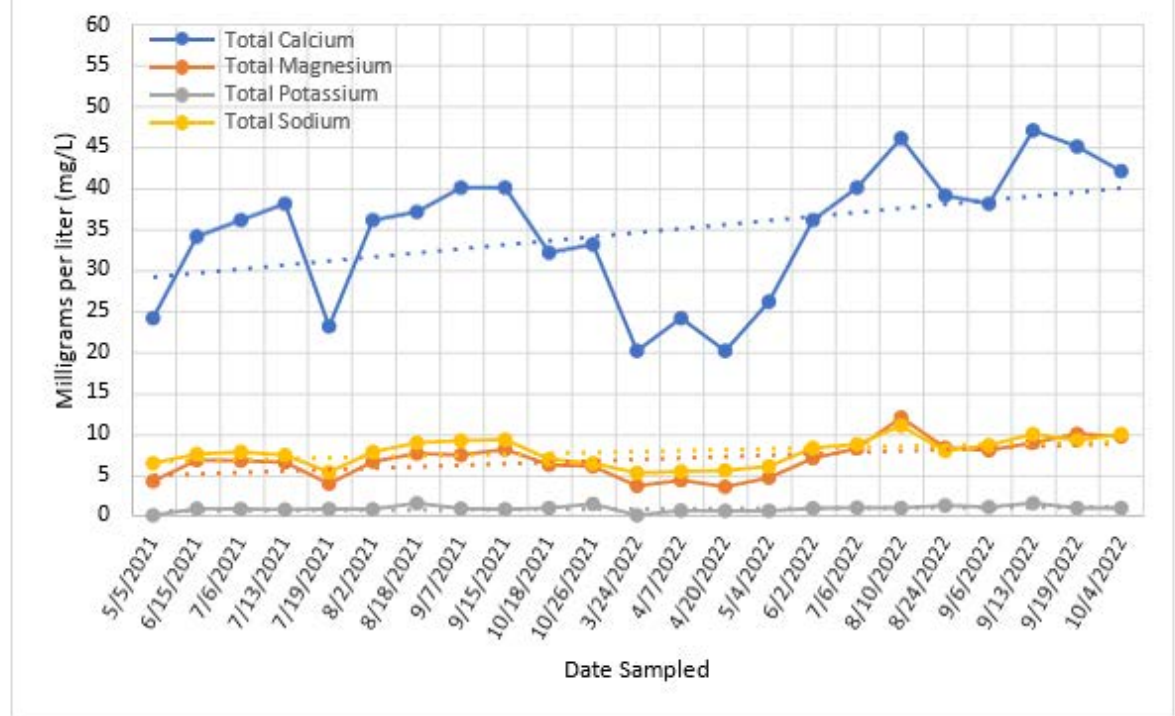
McKenzie Brook Downstream

Figure 1.3.1h: Total calcium, total magnesium, total potassium, and total sodium milligrams per liter (mg/L) concentrations from seasonal water quality sampling dates for McKenzie Brook downstream.

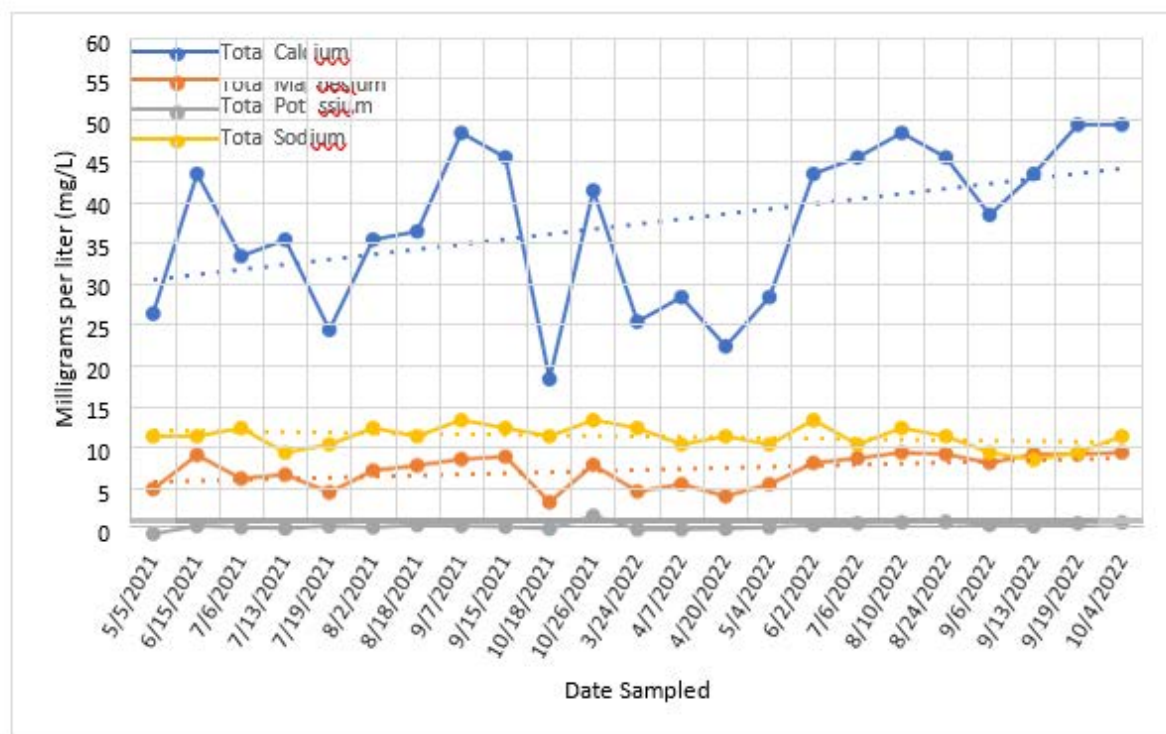
Stony Brook Upstream

Figure 1.3.1i: Total calcium, total magnesium, total potassium, and total sodium milligrams per liter (mg/L) concentrations from seasonal water quality sampling dates for Stony Brook upstream.

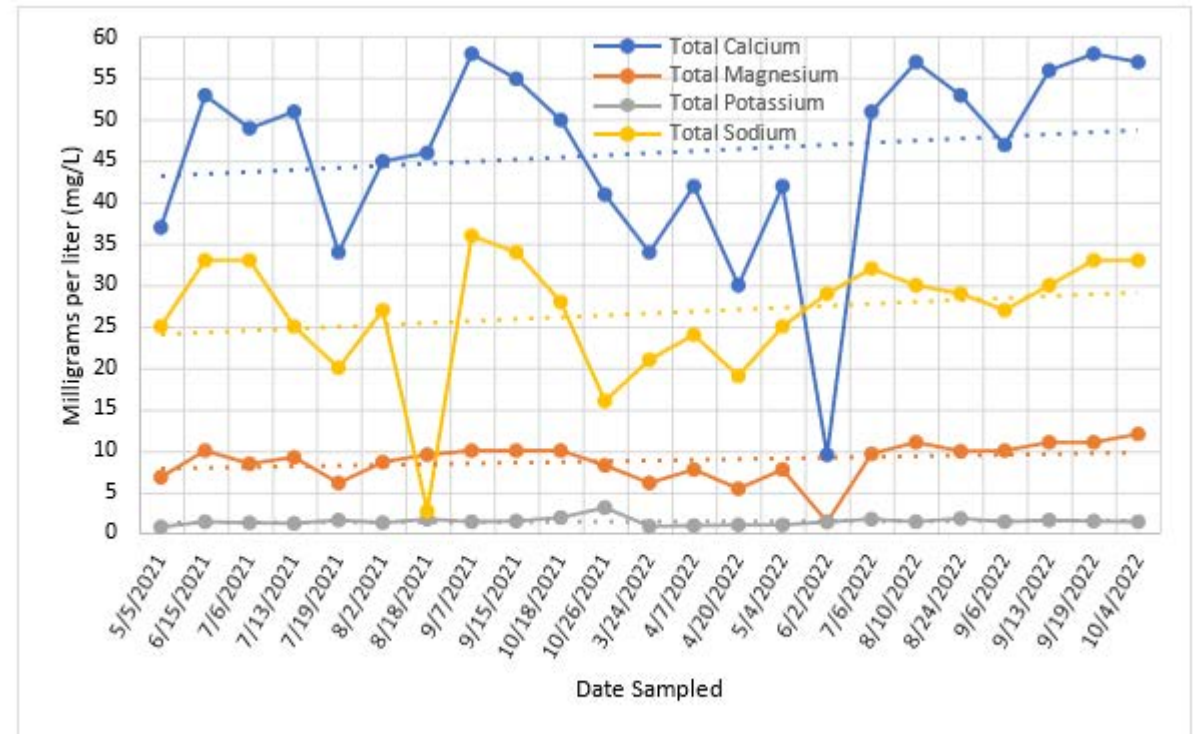
Stony Brook Downstream

Figure 1.3.1j: Total calcium, total magnesium, total potassium, and total sodium milligrams per liter (mg/L) concentrations from seasonal water quality sampling dates for Stony Brook downstream.

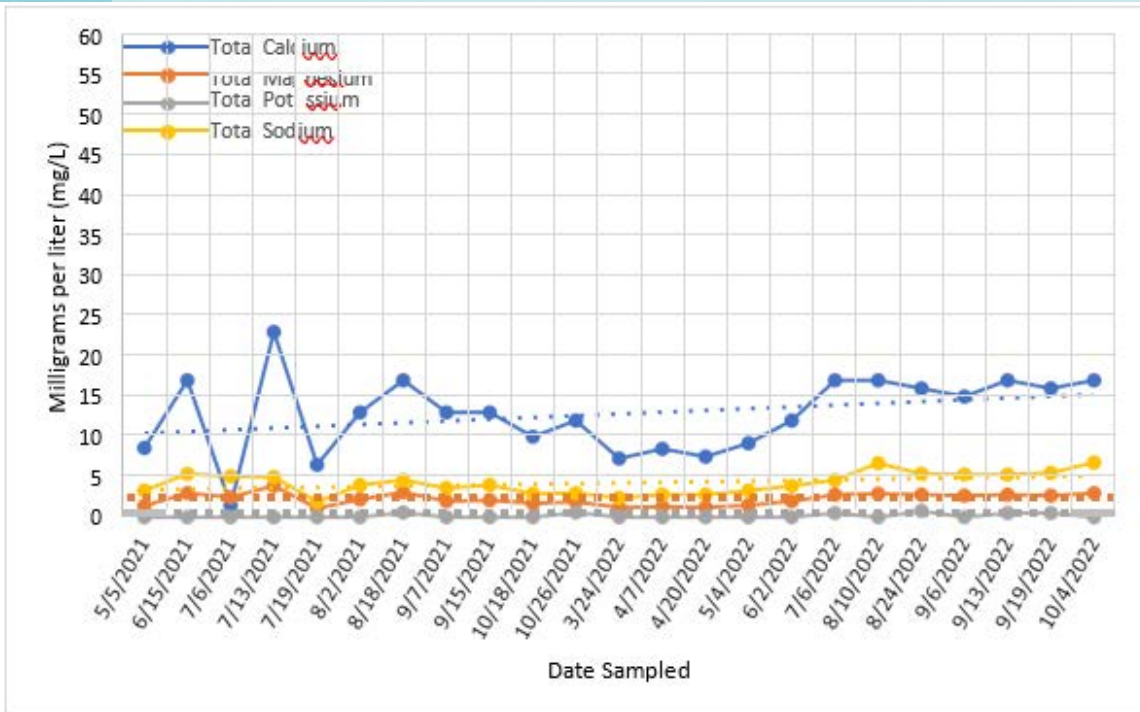
Mill Brook Upstream

Figure 1.3.1k: Total calcium, total magnesium, total potassium, and total sodium milligrams per liter (mg/L) concentrations from seasonal water quality sampling dates for Mill Brook upstream.

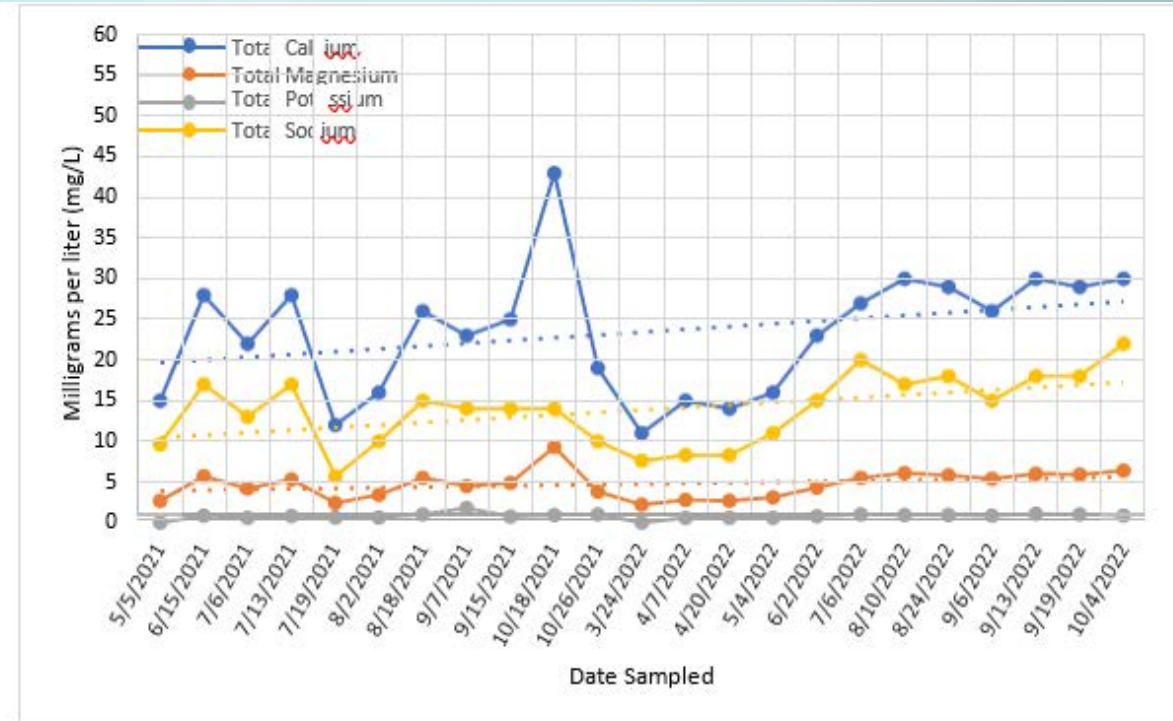
Mill Brook Downstream

Figure 1.3.1l: Total calcium, total magnesium, total potassium, and total sodium milligrams per liter (mg/L) concentrations from seasonal water quality sampling dates for Mill Brook downstream.

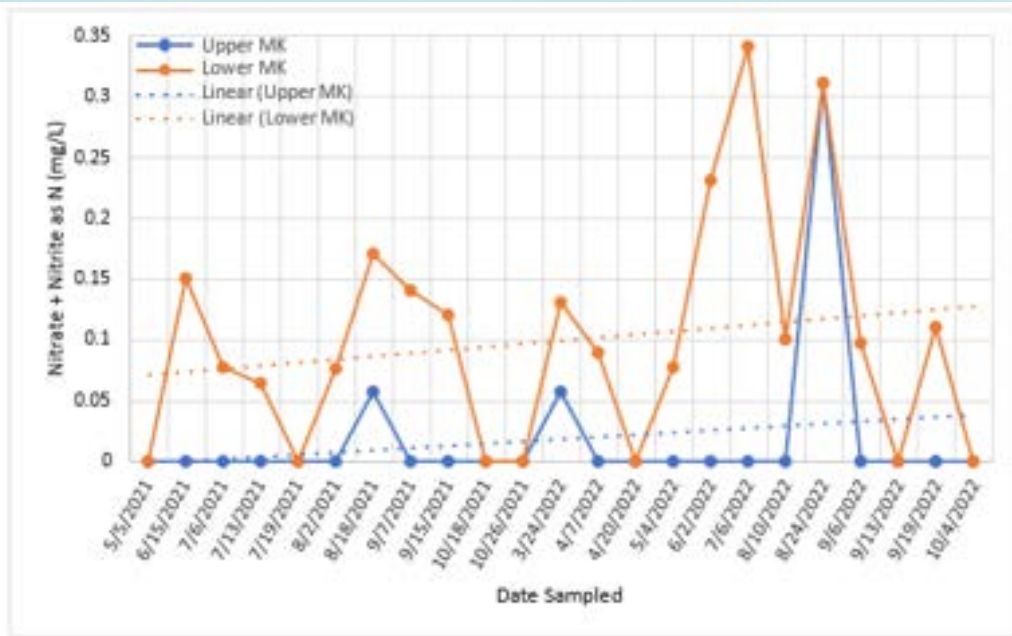
McKenzie Brook

Figure 1.3.2a: Nitrate + nitrite as N (mg/L) concentrations from seasonal water quality sampling dates for McKenzie Brook.

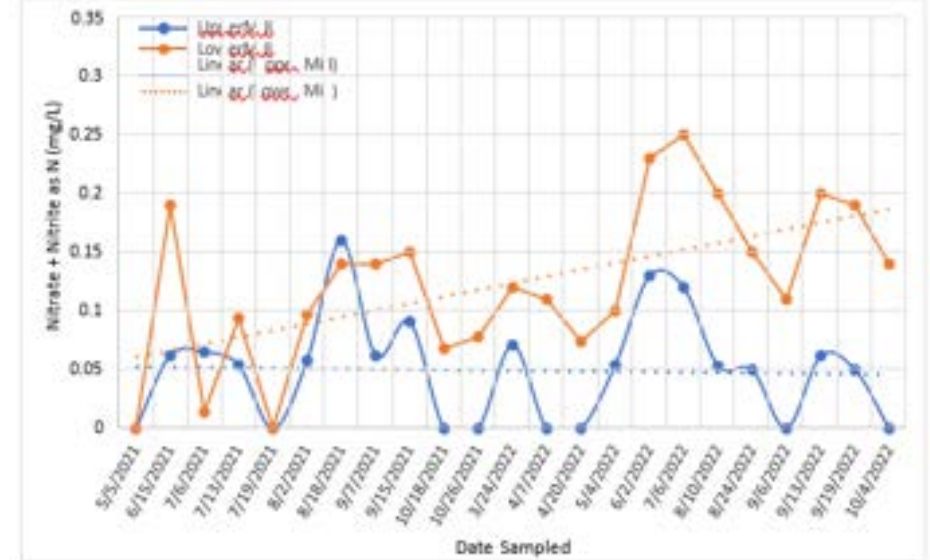
Mill Brook

Figure 1.3.2c: Nitrate + nitrite as N (mg/L) concentrations from seasonal water quality sampling dates for Mill Brook.

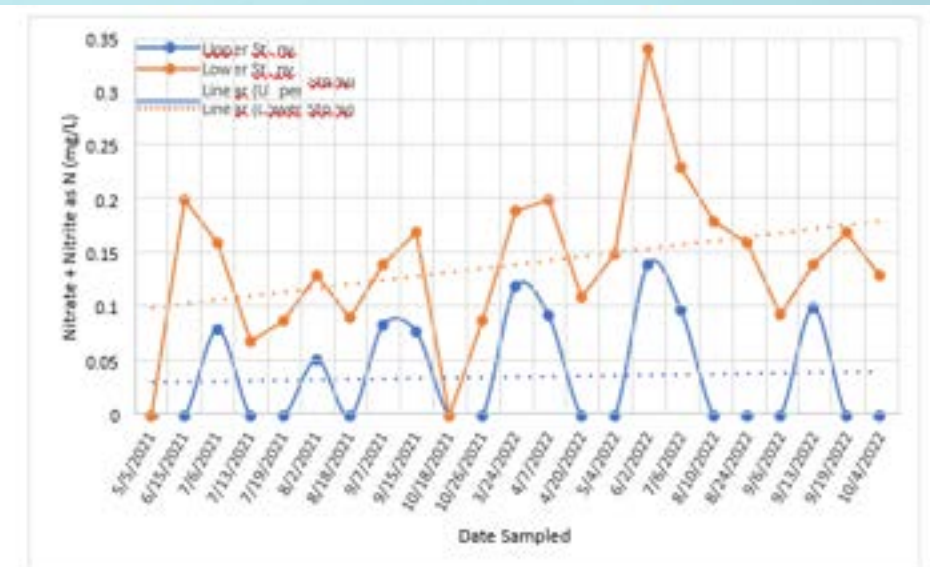
Stony Brook

Figure 1.3.2b: Nitrate + nitrite as N (mg/L) concentrations from seasonal water quality sampling dates for Stony Brook.

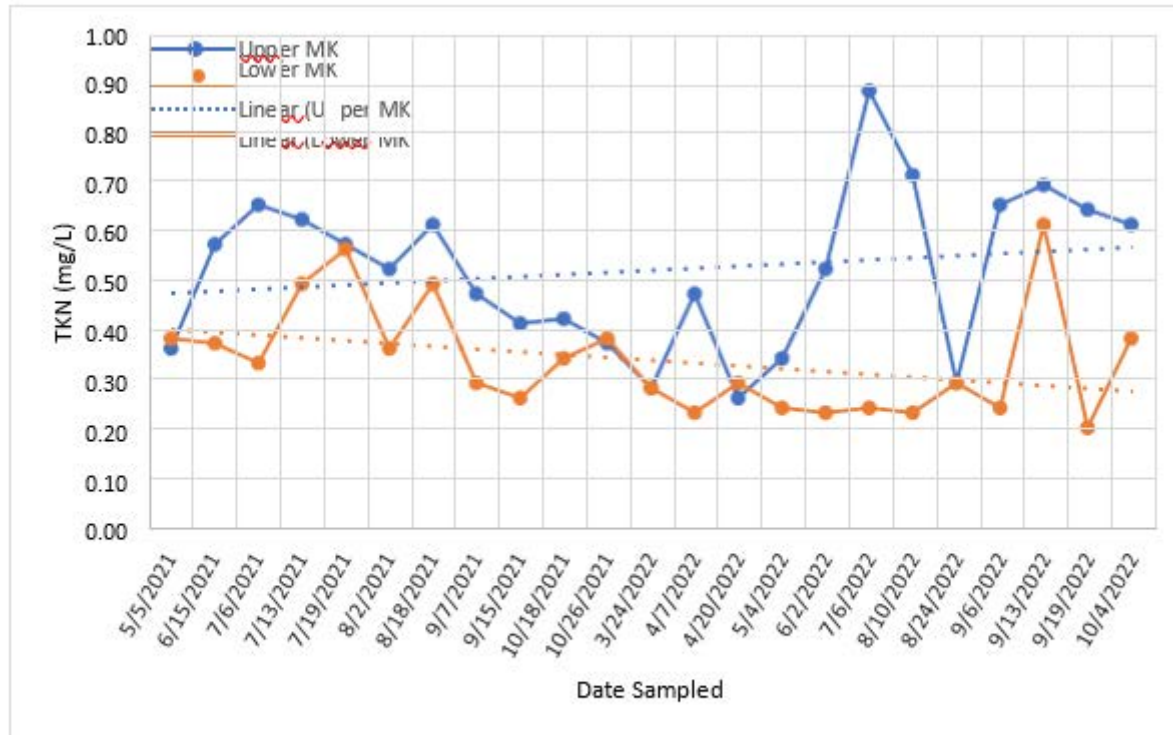
McKenzie Brook

Figure 1.3.2d: TKN (mg/L) concentrations from seasonal water quality sampling dates for McKenzie Brook.

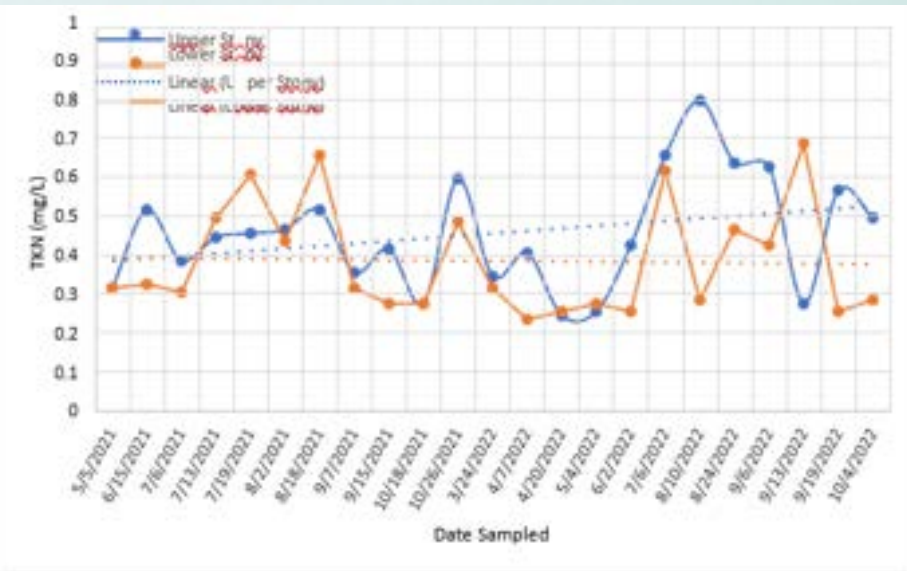
Stony Brook

Figure 1.3.2e: Total Kjeldahl nitrogen (mg/L) concentrations from seasonal water quality sampling dates for Stony Brook.

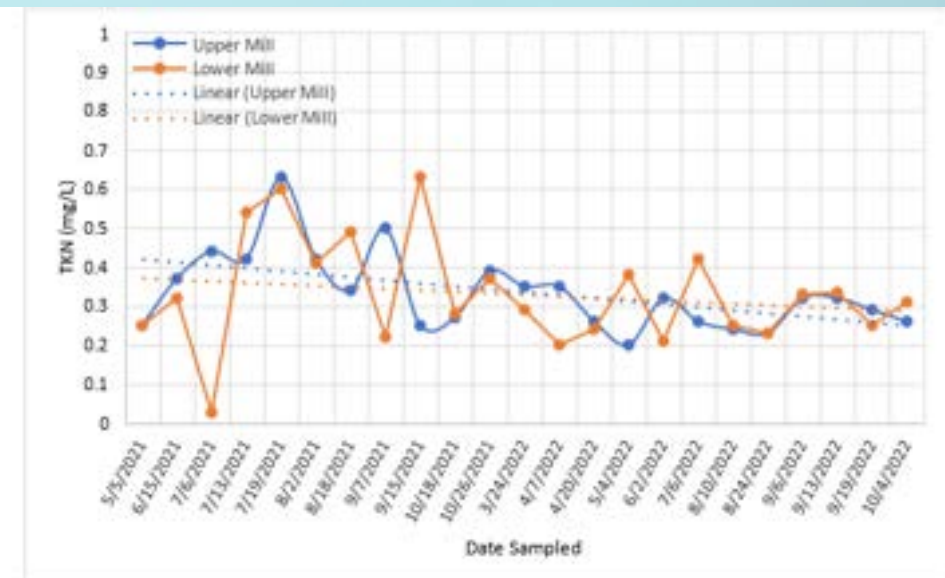
Mill Brook

Figure 1.3.2f: Total Kjeldahl nitrogen (mg/L) concentrations from seasonal water quality sampling dates for Mill Brook.

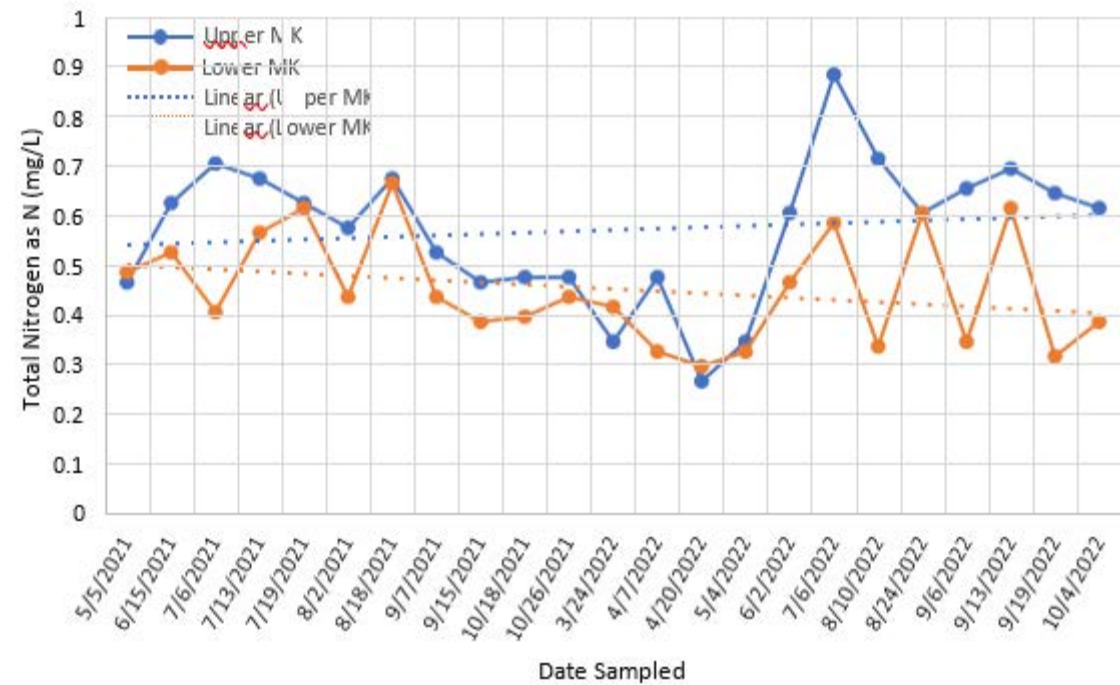
McKenzie Brook

Figure 1.3.2g: Total nitrogen (mg/L) concentrations from seasonal water quality sampling dates for McKenzie Brook.

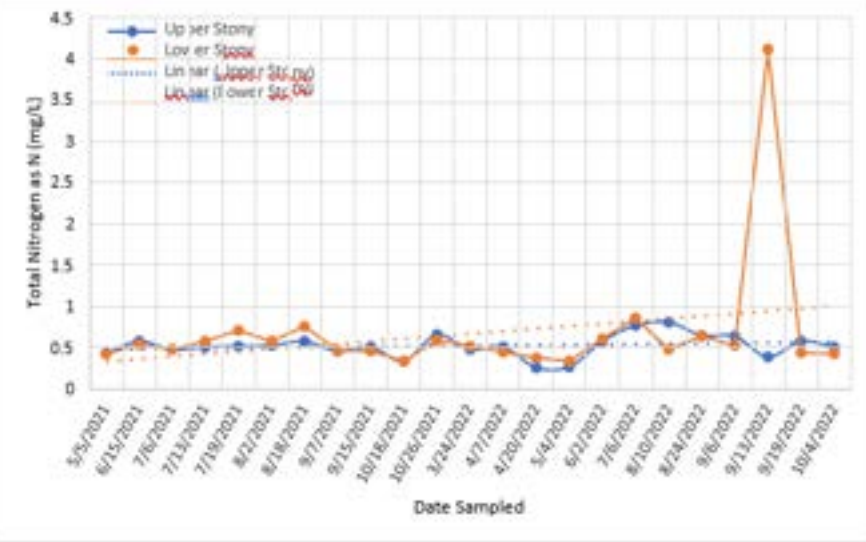
Stony Brook

Figure 1.3.2h: Total nitrogen (mg/L) concentrations from seasonal water quality sampling dates for Stony Brook.

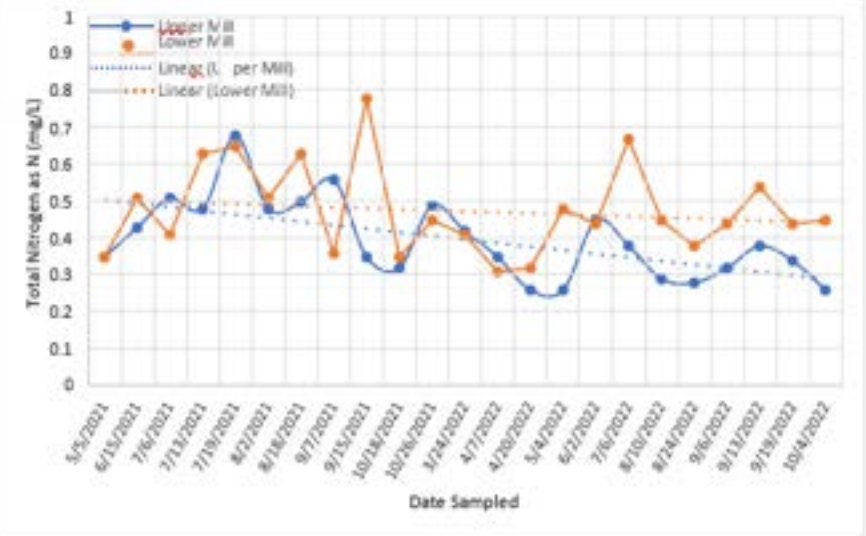
Mill Brook

Figure 1.3.2i: Total nitrogen (mg/L) concentrations from seasonal water quality sampling dates for Mill Brook.

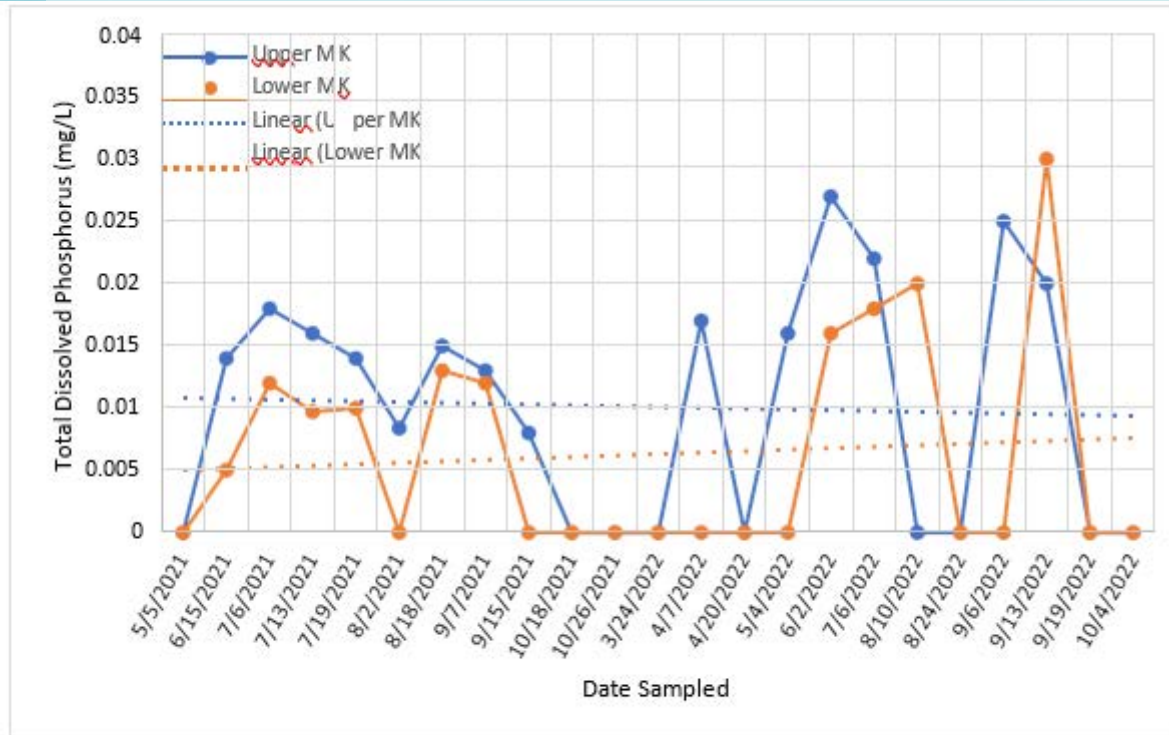
McKenzie Brook

Figure 1.3.3a: Total dissolved phosphorus (mg/L) concentrations from seasonal water quality sampling dates for McKenzie Brook.

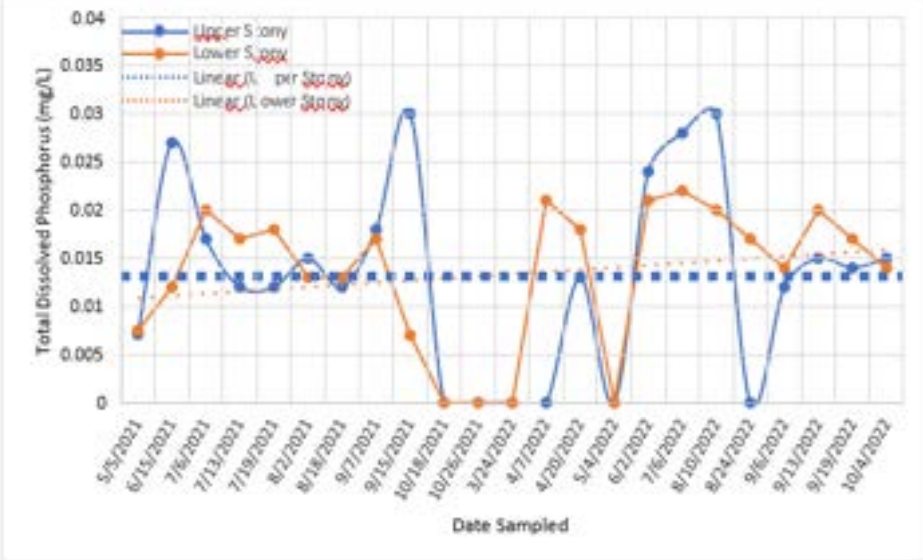
Stony Brook

Figure 1.3.3b: Total dissolved phosphorus (mg/L) concentrations from seasonal water quality sampling dates for Stony Brook.

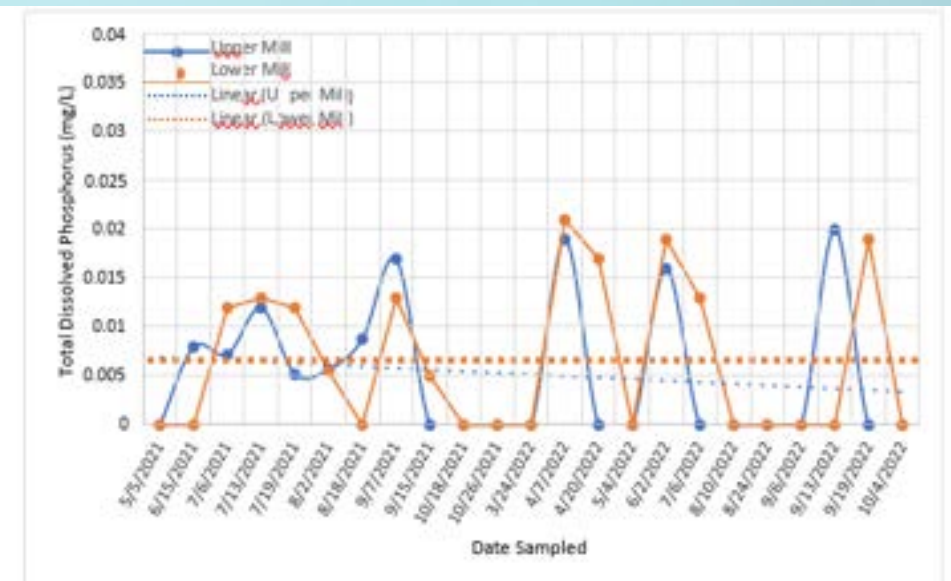
Mill Brook

Figure 1.3.3c: Total dissolved phosphorus (mg/L) concentrations from seasonal water quality sampling dates for Mill Brook.

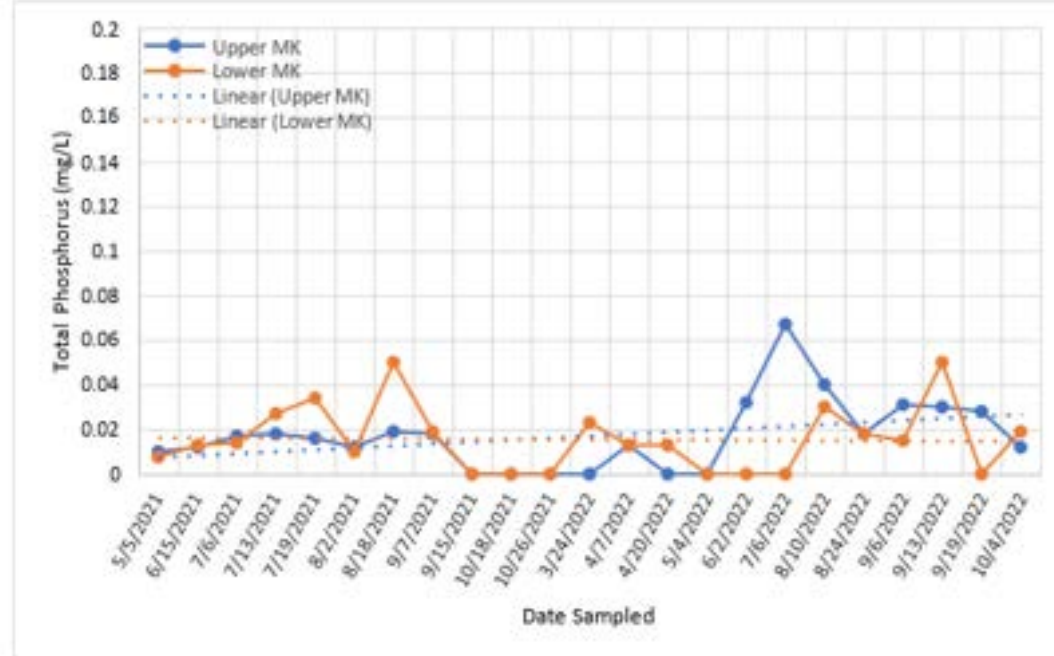
McKenzie Brook

Figure 1.3.3d: Total phosphorus (mg/L) concentrations from seasonal water quality sampling dates for McKenzie Brook.
