Port Henry Stream Study

A multi-year investigation of Mill, McKenzie, and Stony Brooks

Aims and Objectives

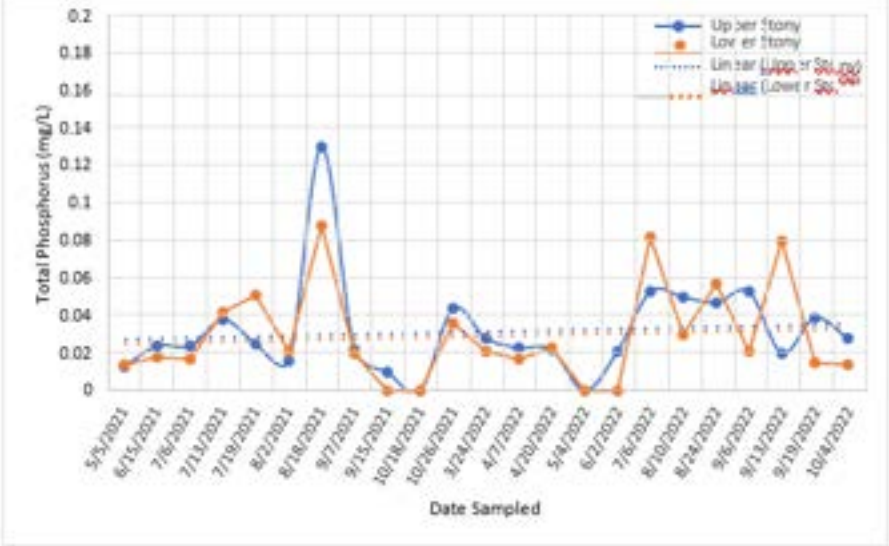
Stony Brook

Figure 1.3.3e: Total phosphorus (mg/L) concentrations from seasonal water quality sampling dates for Stony Brook.

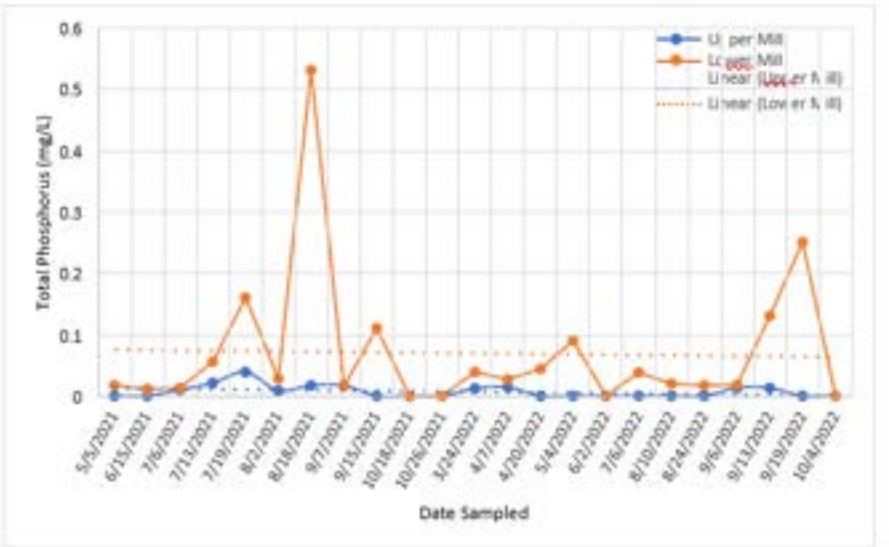
Mill Brook

Figure 1.3.3f: Total phosphorus (mg/L) concentrations from seasonal water quality sampling dates for Mill Brook.

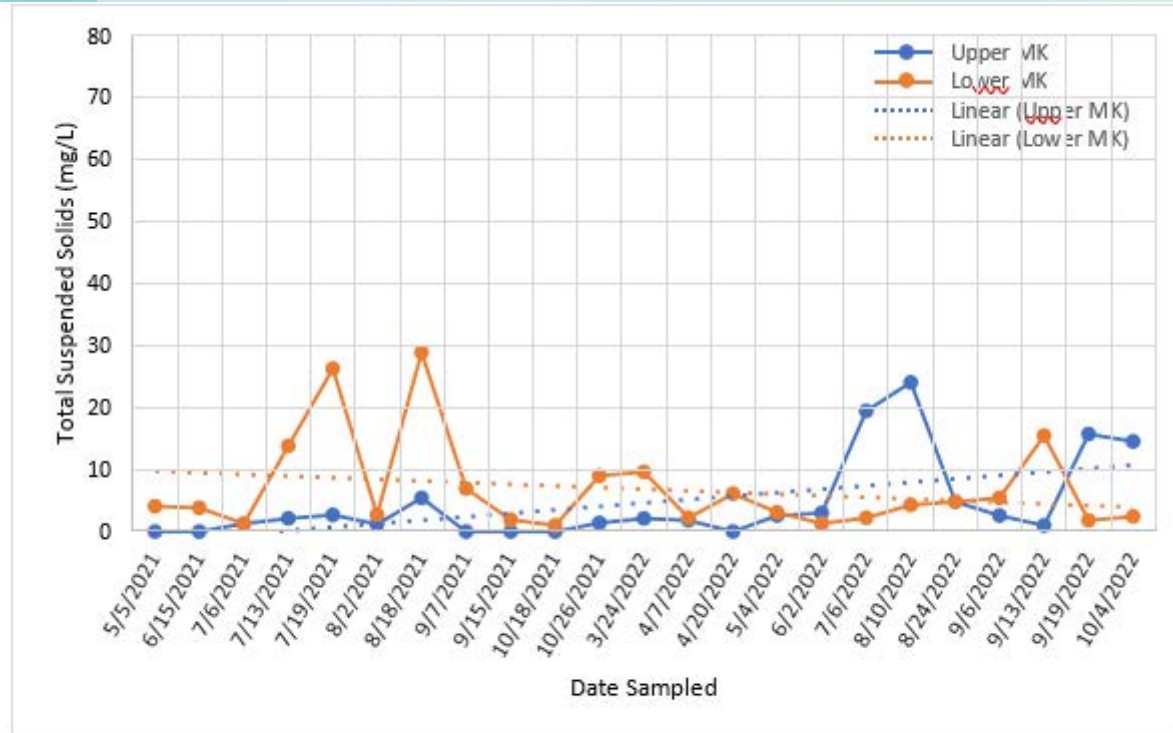
McKenzie Brook

Figure 1.3.4a: Total suspended solids (mg/L) concentrations from seasonal water quality sampling dates for McKenzie Brook.

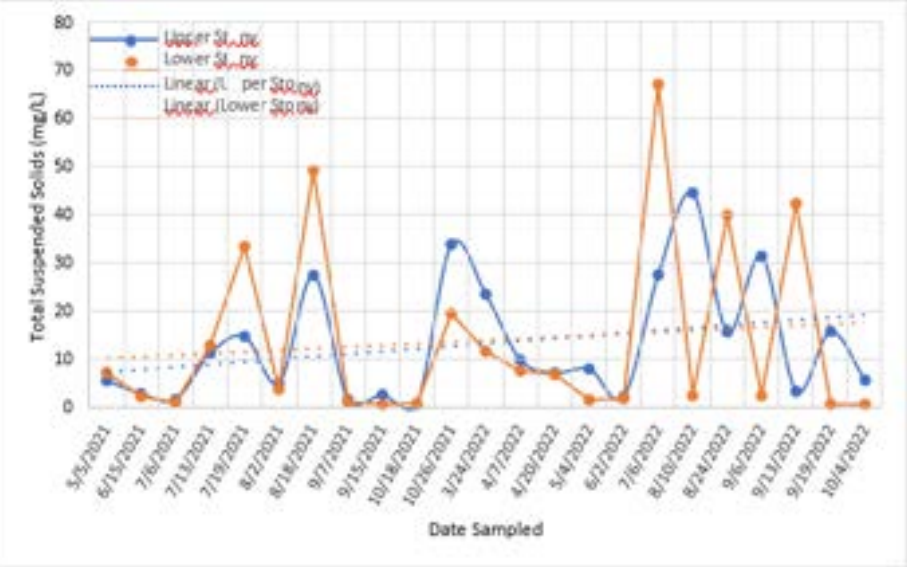
Stony Brook

Figure 1.3.4b: Total suspended solids (mg/L) concentrations from seasonal water quality sampling dates for Stony Brook.

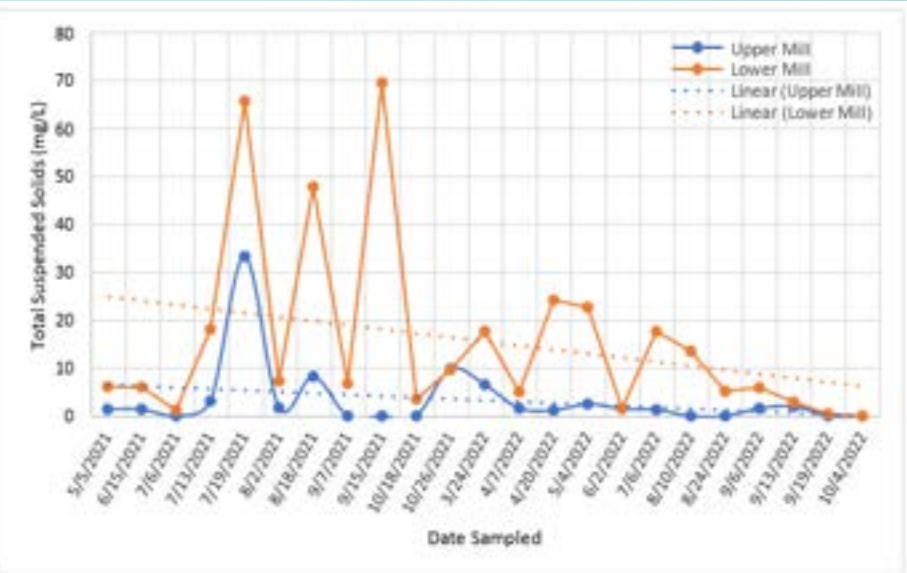
Mill Brook

Figure 1.3.4c: Total suspended solids (mg/L) concentrations from seasonal water quality sampling dates for Mill Brook.

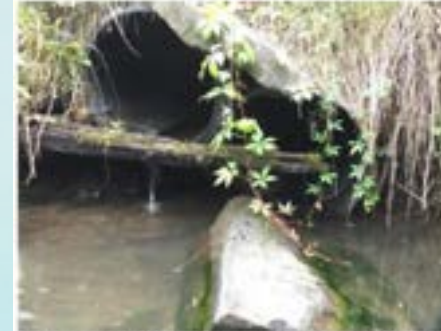
Stream:	NAACC Crossing #:	Structure Type:	Priority Rank:	Priority Points:
McKenzie Brook #11	xy4403007373541475	Multi-Culvert	1	12

Concern:	Crossing Score:
Structural	3 – deformed and inappropriate sizing
AOP	3 – severe limitation for AOP
Catchment	3 – high risk
Flood	3 – high risk

Specifics: McKenzie crossing #11 is a dual-culvert which is undersized and deformed, fails to provide AOP, is a catchment risk for debris, and lies within a flood-prone section of river. While this site has a low risk to the community if it were to fail, it is expected that this crossing would be a lower cost replacement and should be prioritized for future replacement.

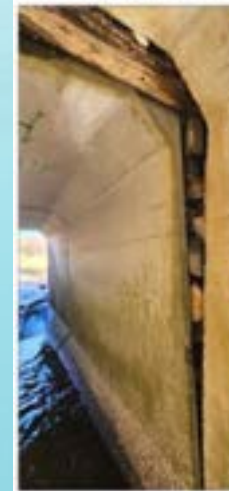
Stream:	NAACC Crossing #:	Structure Type:	Priority Rank:	Priority Points:
McKenzie Brook #7	xy4403630773502655	Box Culvert	2	11

Concern:	Crossing Score:
Structural	3 – deformed and fill beginning to fall through gap in structure
AOP	2 – limited AOP
Catchment	3 – debris clearly an issue as removal was necessary to take measurements
Flood	3 – flooded entrance to farm preventing access for days according to farmer

Specifics: McKenzie crossing #7 is a private entrance to a farm. This box culvert was washed away and replaced in July of 2024. The very same box culvert was recovered and reused by the landowner once the flooding subsided. It is expected that this culvert will create issues again, as its replacement already shows signs of structural failure. AOP is reduced and could be improved with an open bottom culvert or bridge. Failure of this structure would prevent access to the farm. It is recommended that this structure be upgraded and replaced.
