# Plattsburgh Illicit Discharge Detection and Elimination Project

**Prepared by:** Stone Environmental, Inc.  
David Braun

# Plattsburgh Illicit Discharge Detection and Elimination Project Final Report

Project Period: May 4, 2022 - August 22, 2024  
Date Submitted: August 22, 2024  
Date Approved: September 3, 2024

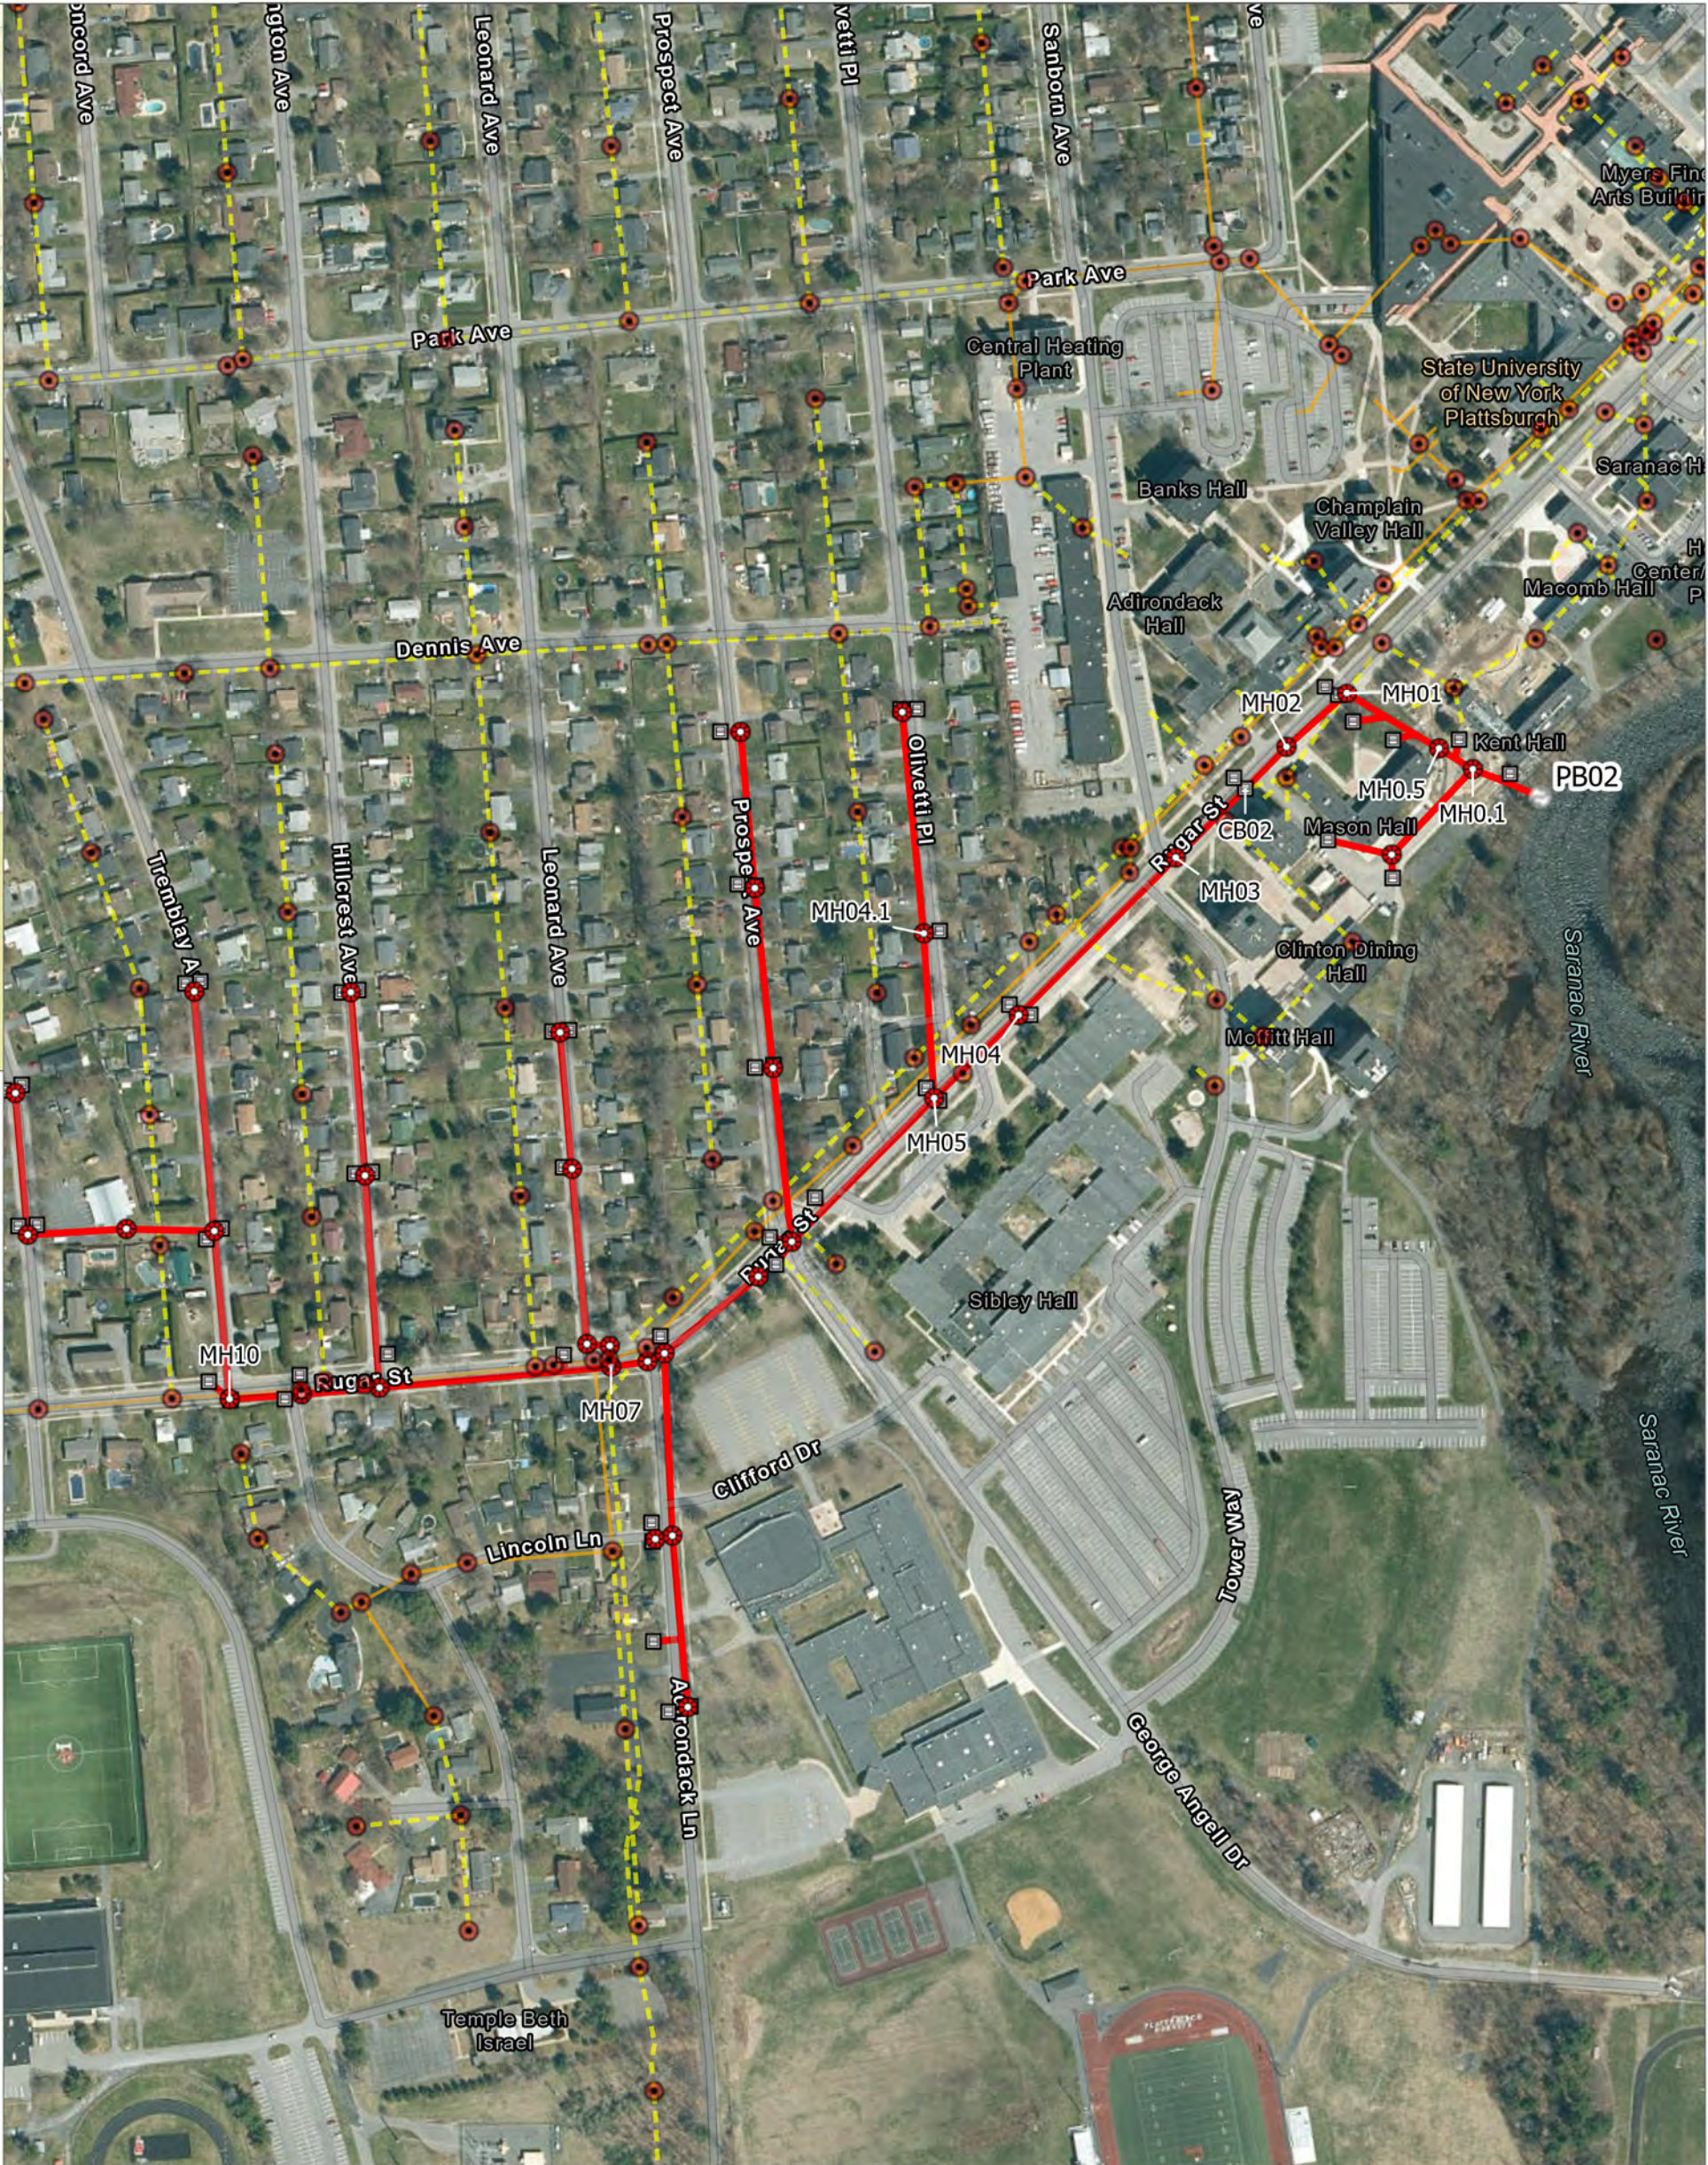
Map 2. PB02

| System ID | Focus area | Status |
|---|---|---|
| PB02 | Rugar Street | Contaminant source bracketed between stormwater manholes MH03 and MH04 on the south side of Rugar Street. No improper connections were observed during inspection of a segment of the stormdrain with a sewer camera in March 2024. PPCP testing is planned for this system in September 2024. |

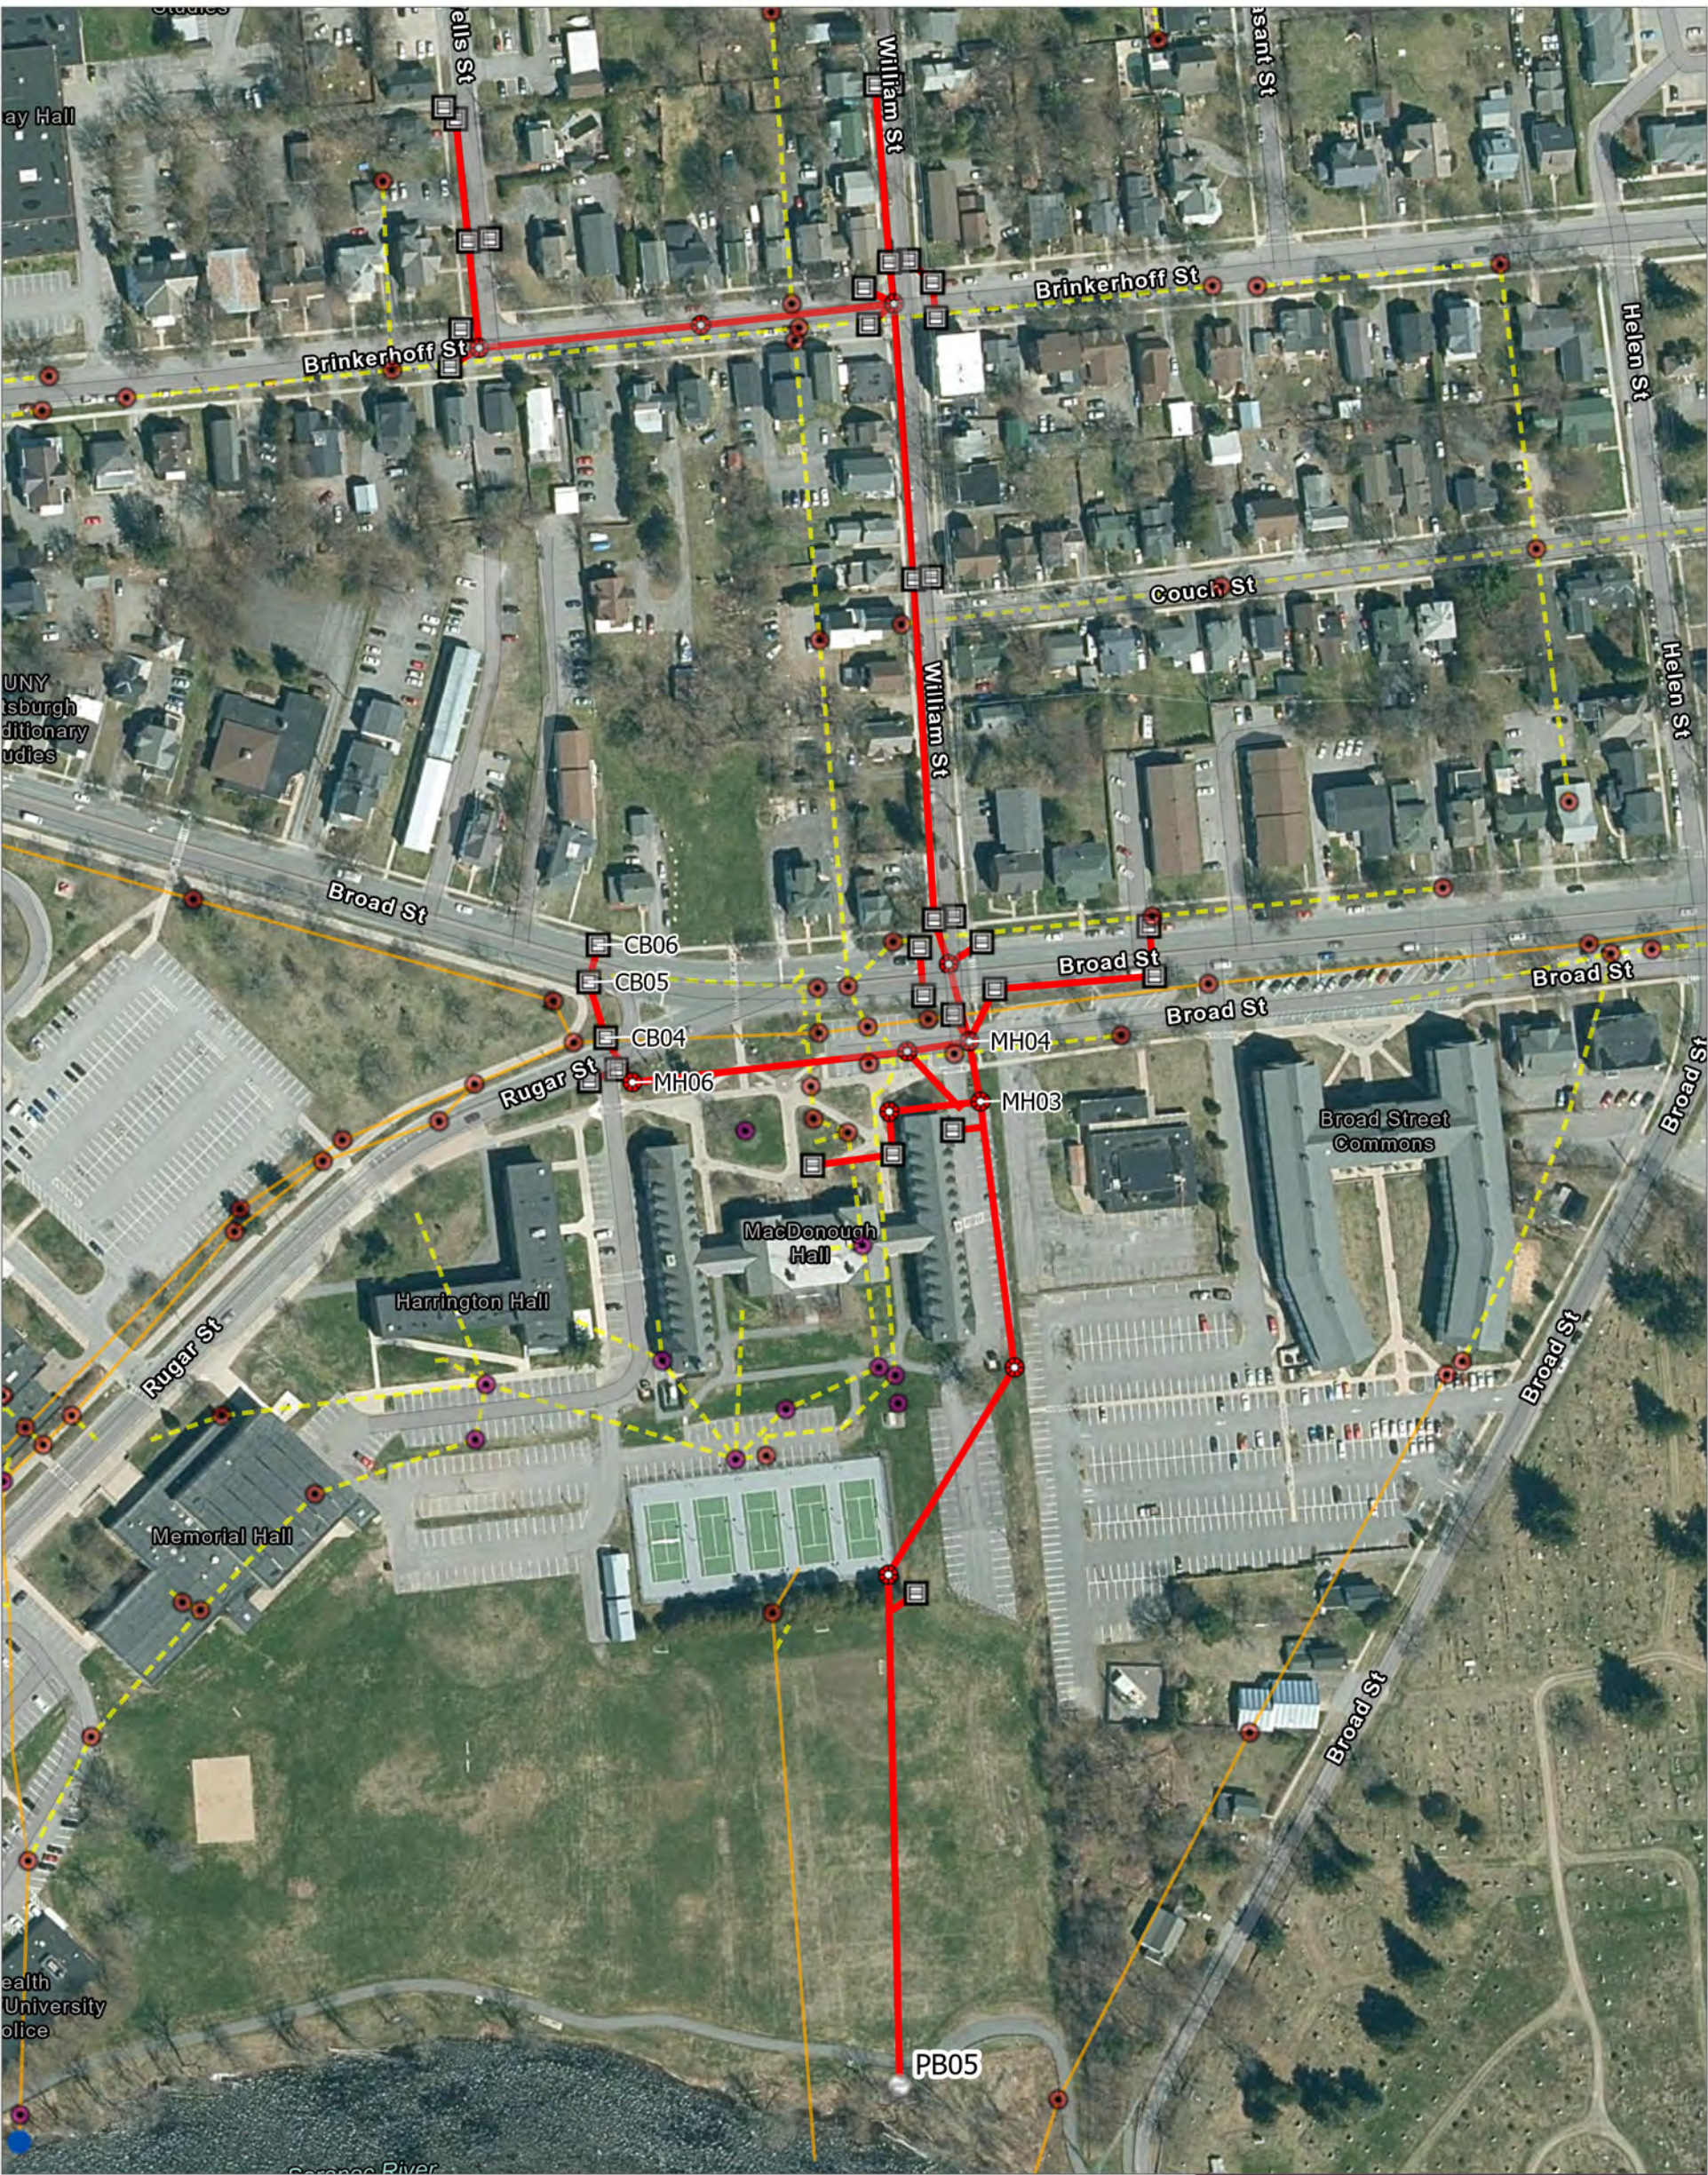
Map 4. PB04

| System ID | Focus area | Status |
|---|---|---|
| PB04 | Rugar Street | After repeated sampling and inspection, we conclude that there is no chronic illicit discharge in this stormdrain. The lower portion of the stormdrain is mis-mapped. There are no visible structures between PB04-CB01 and the outfall. We suspect contaminated groundwater containing chloride and a low concentration of ammonia infiltrates this line. Out of an abundance of caution, PPCP testing is planned for this system in September 2024. |

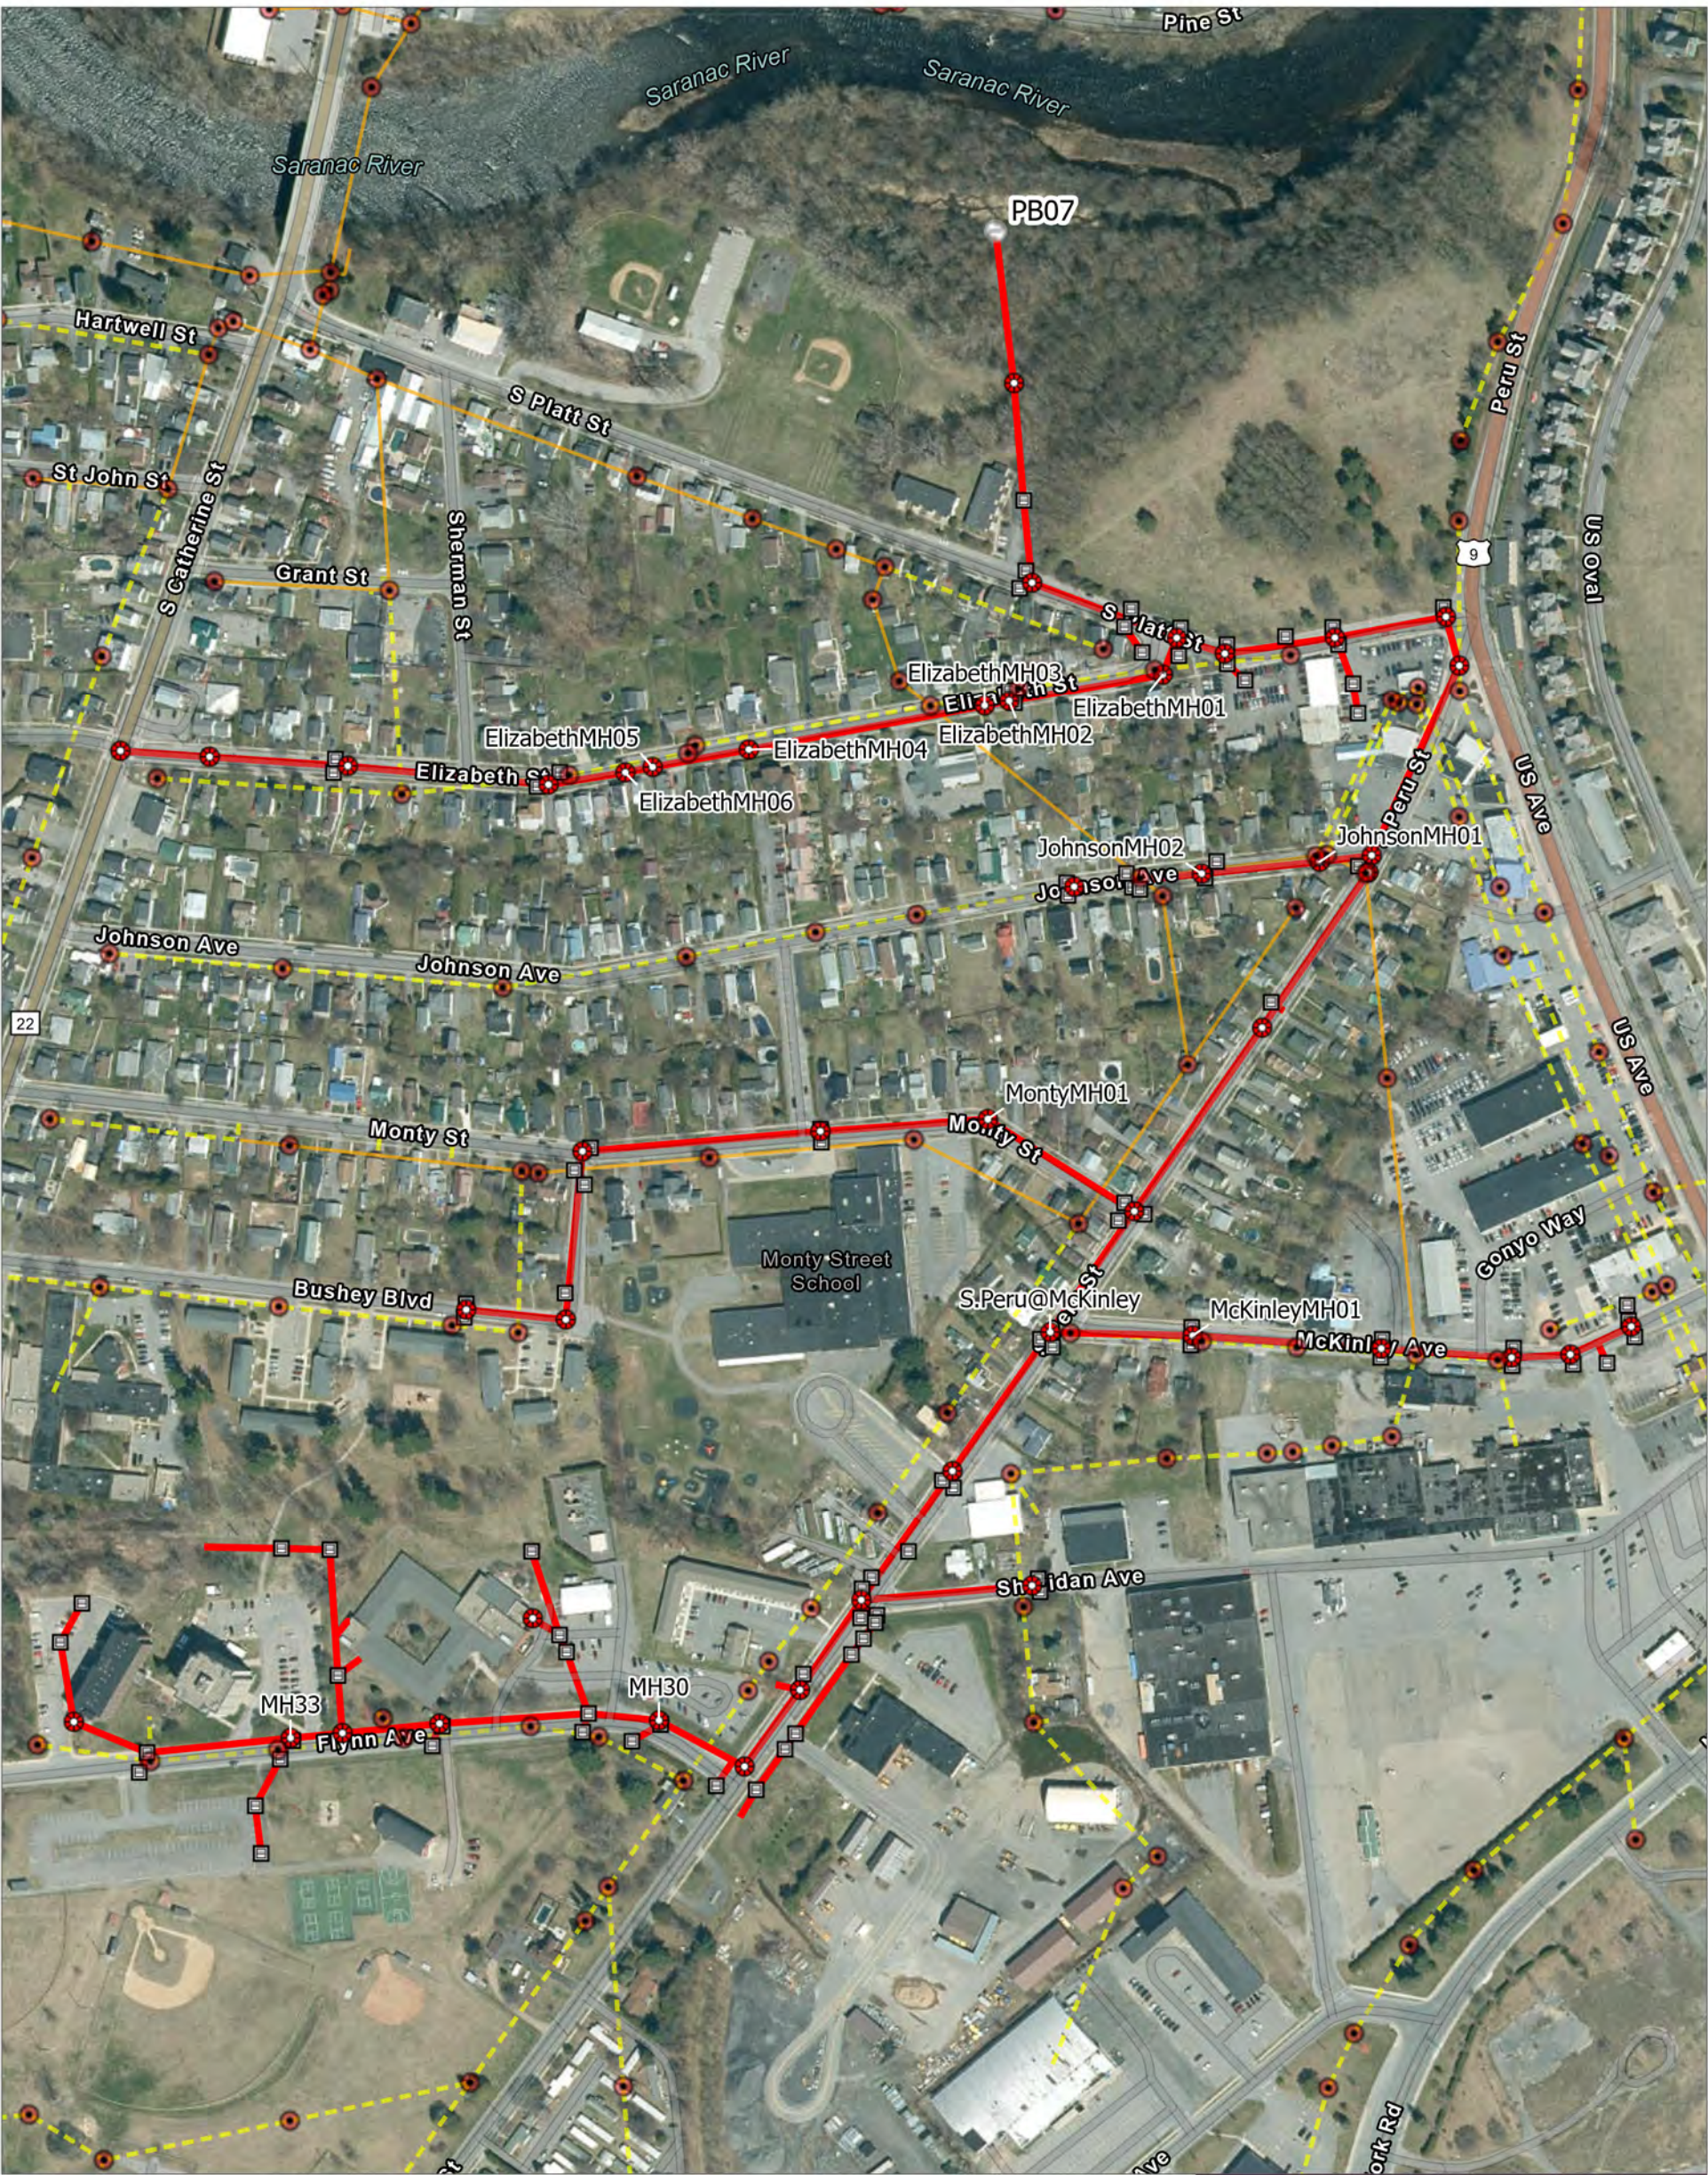
Map 5. PB05

| System ID | Focus area | Status |
|---|---|---|
| PB05 | Rugar Street/Broad Street | After repeated inspection and testing, we conclude that there is no chronic illicit discharge in this stormdrain. High concentrations of <i>E. coli</i> were measured in the CB04-CB06 branch of this system in 2021. There were large amounts of leaf litter and trash in the catchbasins, such that collecting a clear sample was difficult. No dry weather flow was observed in the CB04-CB06 line in 2022 in multiple visits. Samples collected from |
